VOLUME II-2
ADDENDUM TO
SYNOPTIC STUDIES OF THE PLUME OF SONGS
UNITS 2 AND 3

ECOSystems Management Assoc., Inc.
531 Encinitas Blvd., Suite 119
Encinitas, CA 92024

This addendum to ECO-M's Volume II-2, "Synoptic Studies of the Plume of SONGS Units 2 and 3", reports our results and conclusions from the two latest dye studies.

2.6 An Overall Description of Surface Water Movement at SONGS
on April 7, 1987

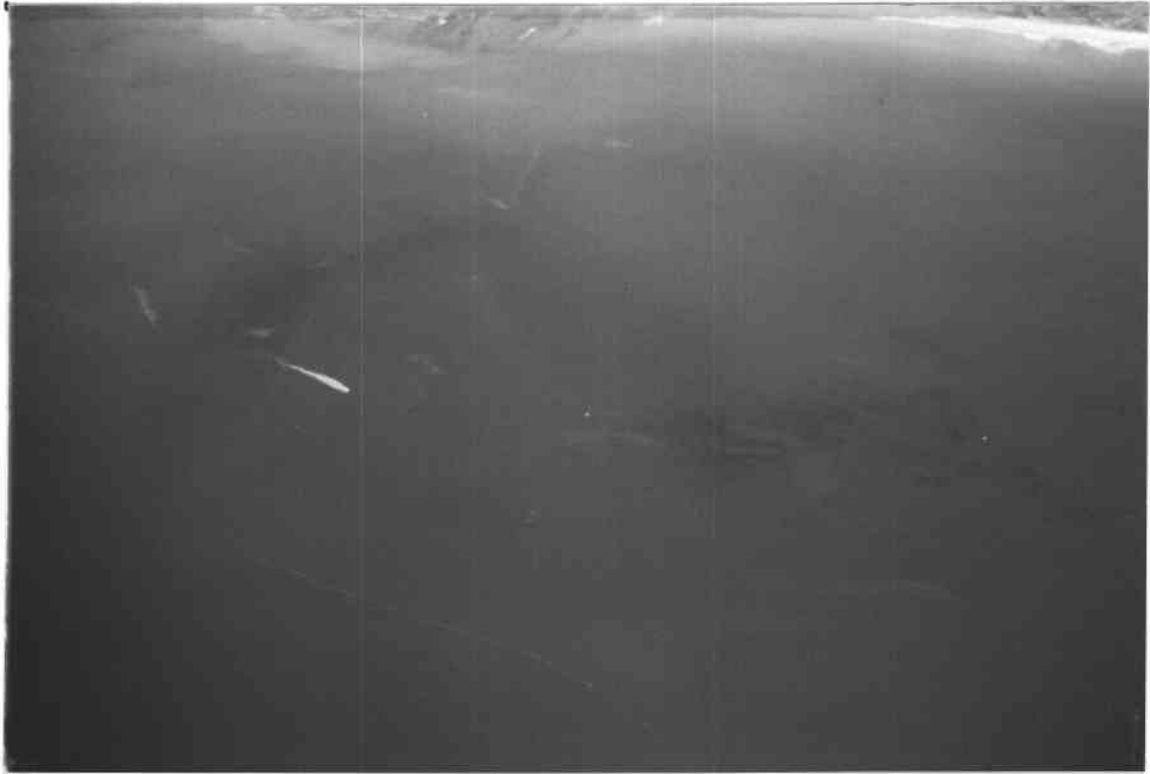
Figure 2-6-4: Dye patches A, B, C, D, 17 and Stripe 1. Notice dye patches 14 and 15 have already reached the south SOK kelp bed and dye patch 16 has not moved from its release location. Time: 14:28.

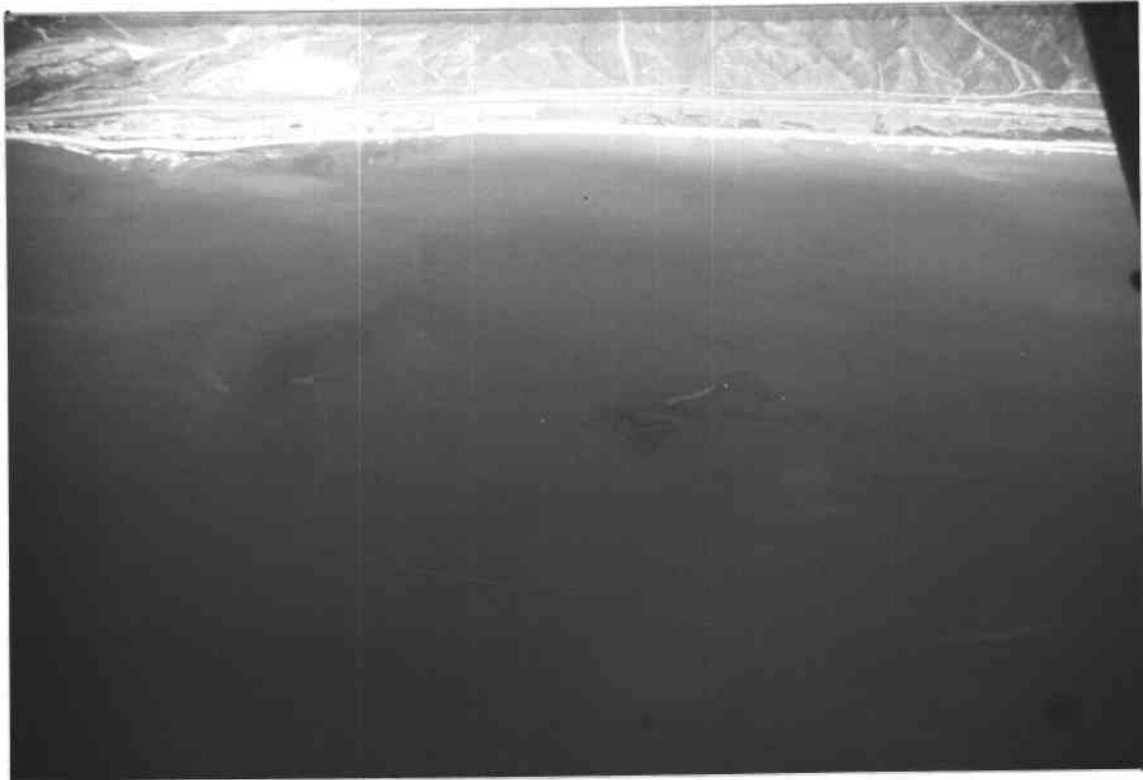
Figure 2-6-5: Starting location of Stripe 2 at the inshore part of the south SOK kelp bed. Notice dye patch A is on the Unit 3 diffuser line, dye patch 15 has joined the tail of dye patch 9, both deflecting into the less dense part of the kelp bed; dye patch 16 is still in the same location and dye patch 17 has moved downcoast. Time: 14:38
