VOLUME 11-2
ADDENDUM TO
SYNOPTIC STUDIES OF THE PLUME OF SONGS
UNITS 2 AND 3

September 25, 1987

2.6 An Overall Description of Surface Water Movement at SONGS
on April 7, 1987

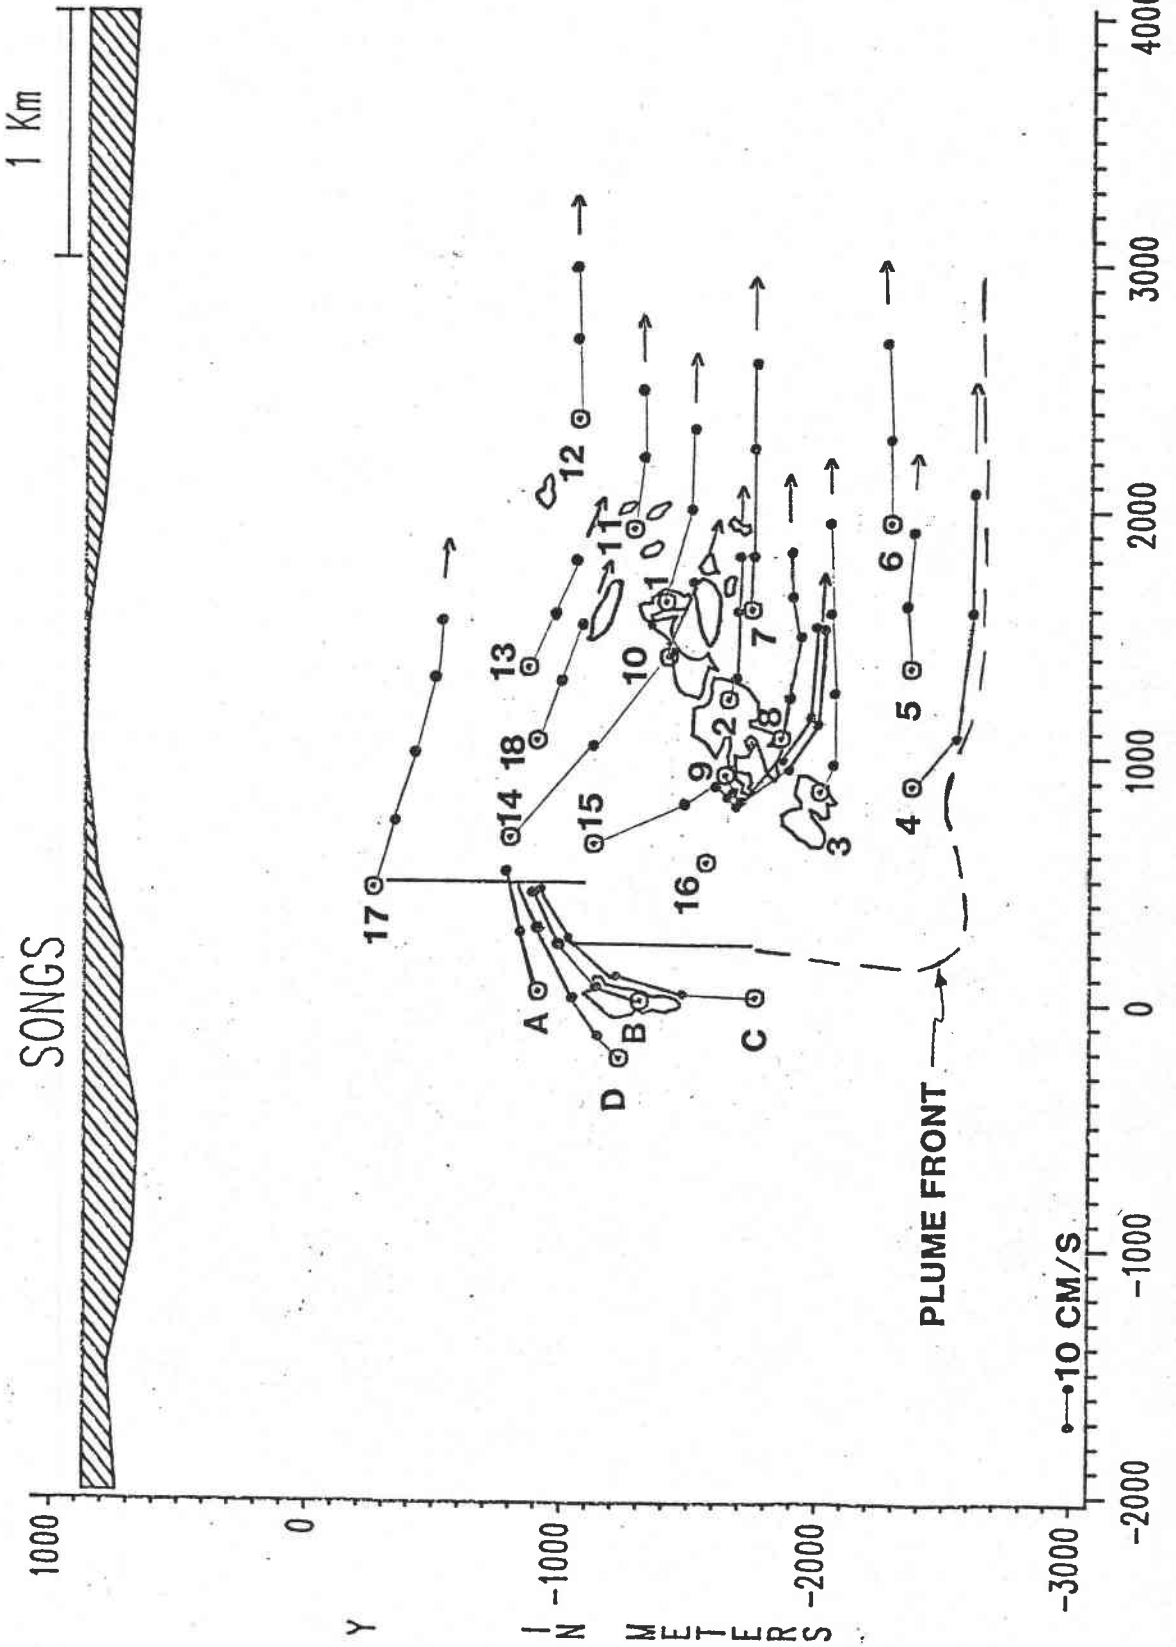
Patch 16 never moved appreciably from its release point.

Figure 1 Starting locations and trajectories for 22 dye patches. Dark circles represent half hour intervals.

Figure 1 displays the starting locations of various dye patches (22) with a circle. The trajectory for each dye patch has been indicated at half hour intervals by a small dark circle. Arrows indicate that patches have continued to move in the same direction at about the same speed.

1. Measurements from current meters indicate that the current pattern is steady throughout the study (see Figure 3).
2. The discharge water from Units 2 and 3, together with the ambient current, formed a plume front (see Figure 1).

3. Patch 4 moved offshore to the plume edge and remained along the plume front as it travelled downcoast.
4. Patches 5, 6, 7, 8, 11, and 12, located offshore and south of the SOK kelp bed, moved approximately parallel to the shore. They demonstrate no offshore velocity.

5. Patch 9 moved slowly along the inshore side of the south kelp bed, then offshore more quickly through a less dense channel of the kelp bed, indicating the effect of the kelp in deflecting the flow.

6. Patches 13, 14, 15 and 17 displayed an offshore velocity in the vicinity of the diffuser system. This indicates that SONGS' cooling system directs the flow towards the south kelp bed. Notice the offshore and longshore components of the current near the diffuser line decreased as the patches moved further from the diffuser line.

7. Patch 16 never moved appreciably from its release point, indicating a stagnation area caused by the interaction of the discharged water, entrained water, make-up flow, and the local currents. (Patch 16 dispersed somewhat by the end of the day).

8. Dye patches A, B, C, and D demonstrate clearly that the surface upcoast water moved inshore and downcoast towards the diffuser line of Unit 3. The movement of these patches towards the Unit 3 diffuser line, but not towards the Unit 2 diffuser line, indicates that Unit 2 entrained water from levels lower than the surface.

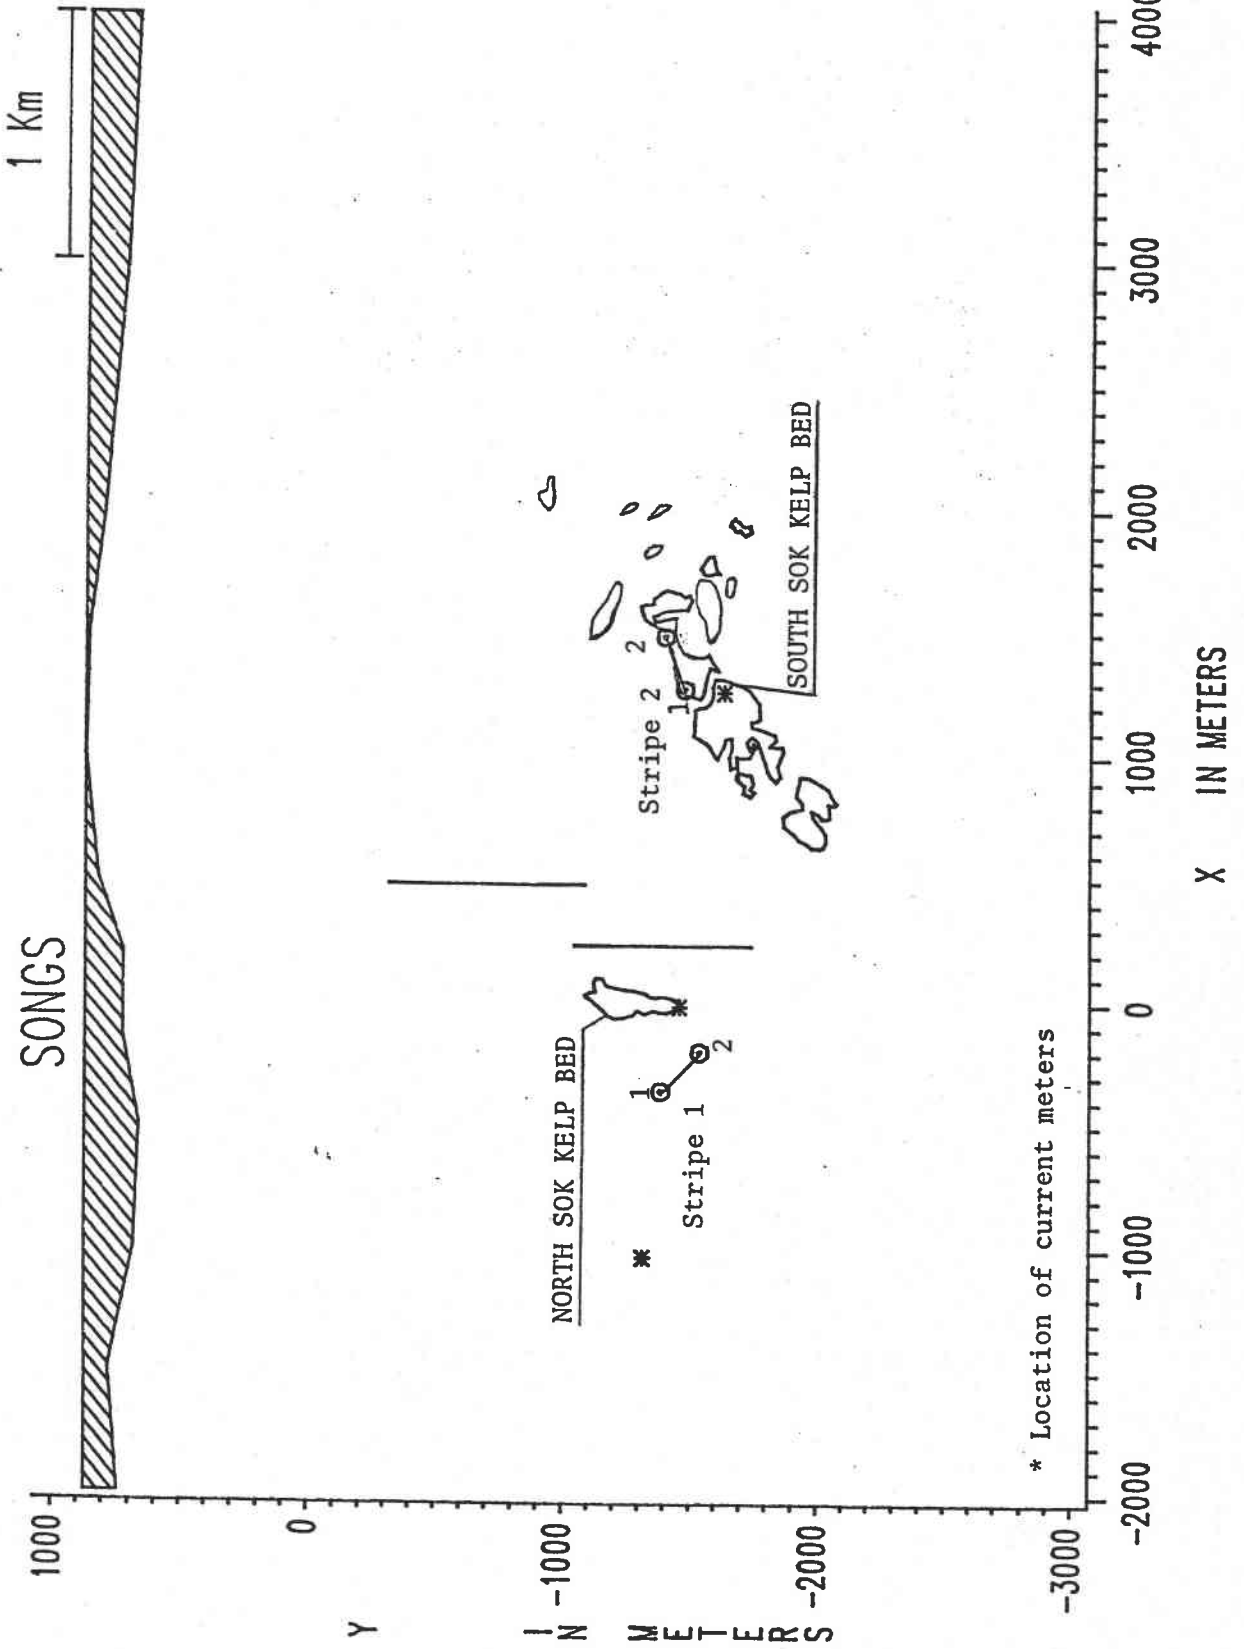
Figure 2 Starting locations of Stripe 1 and Stripe 2, and current meter locations.

In addition to the dye patches, we released two line injections of dye. We will refer to the dye stripe released upcoast of the north SOK kelp bed as Stripe 1 and the second stripe released on the inshore boundary of the south SOK kelp bed as Stripe 2. Figure 2 shows the starting locations of Stripe 1 and Stripe 2.

Prior to the study, we deployed three current meters in three locations at 3 m below the water surface. Inter-Ocean S4 instruments were used for the current measurements. The current meter locations are also shown in Figure 2. Measurements of the currents are displayed in Figure 3. On this day, all pumps were operating and the power levels for Units 1, 2 and 3 were 92%, 98% and 100% respectively.

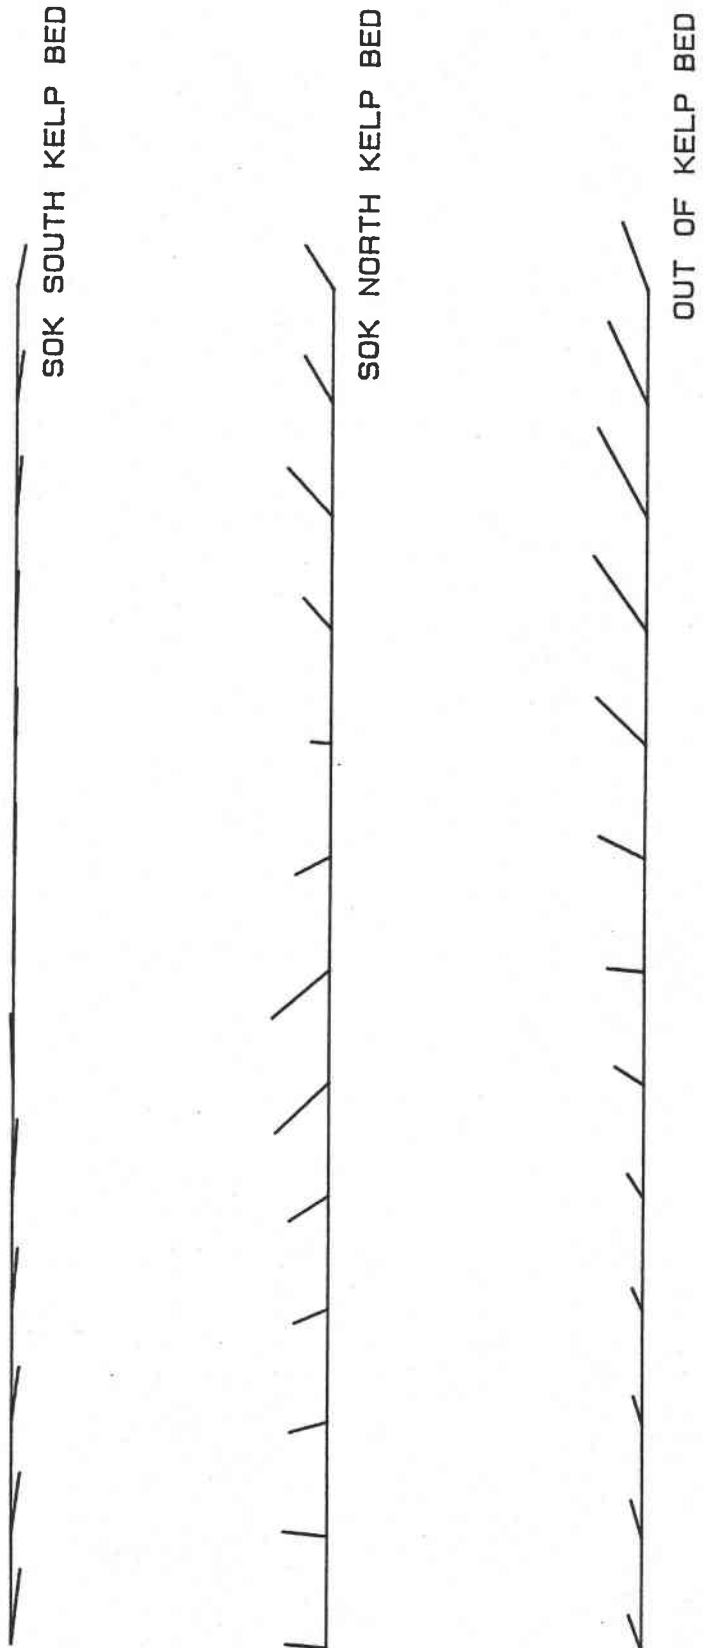
HOURLY CURRENT (CM/SEC)

AT 3 METERS BELOW SURFACE

Figure 3 Vector representations of current on 07apr87. Ambient current (out of kelp bed) shows a steady onshore/downcoast flow. Note that the flow in the south kelp bed is greatly reduced. 07APR87

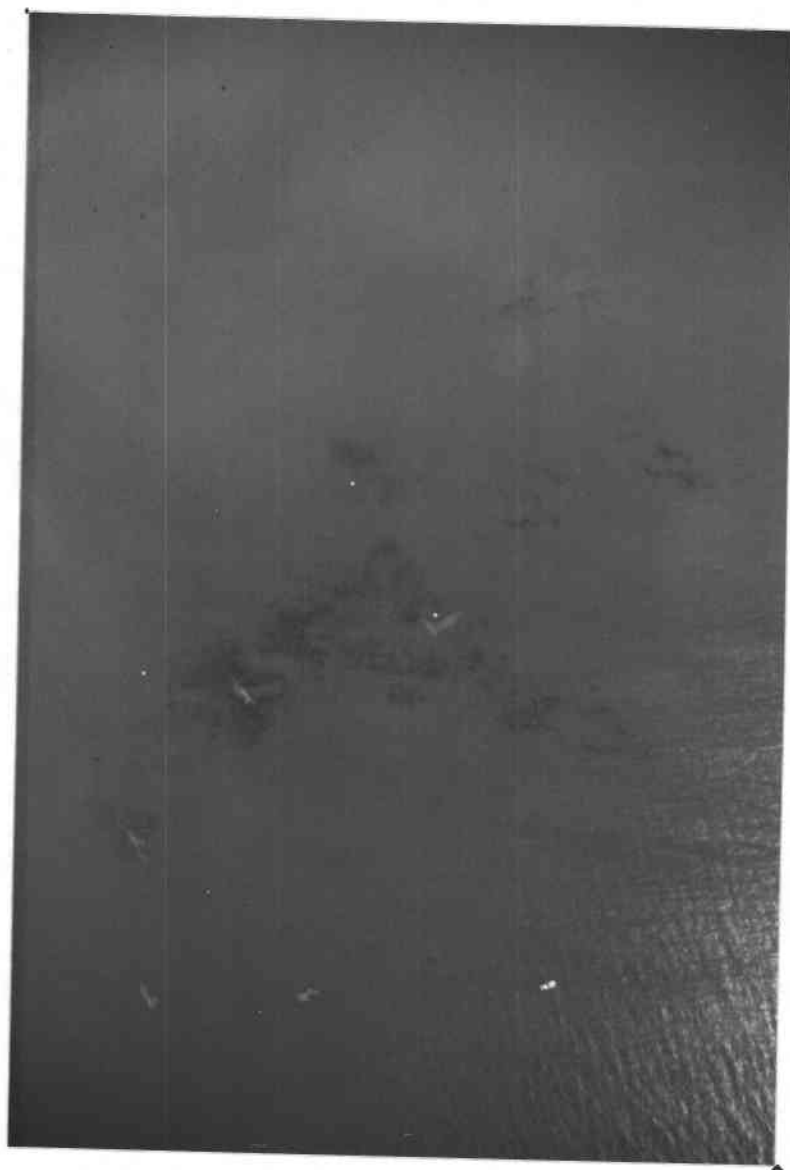
Figure 2-6-1: Starting locations of dye patches 1 through 6. Time: 12:52.

From the aerial photo collection, we have chosen a representative series (see Figures 2-6-1 through 2-6-10). These photos demonstrate the above points. With each photo, we have included a description of various events.

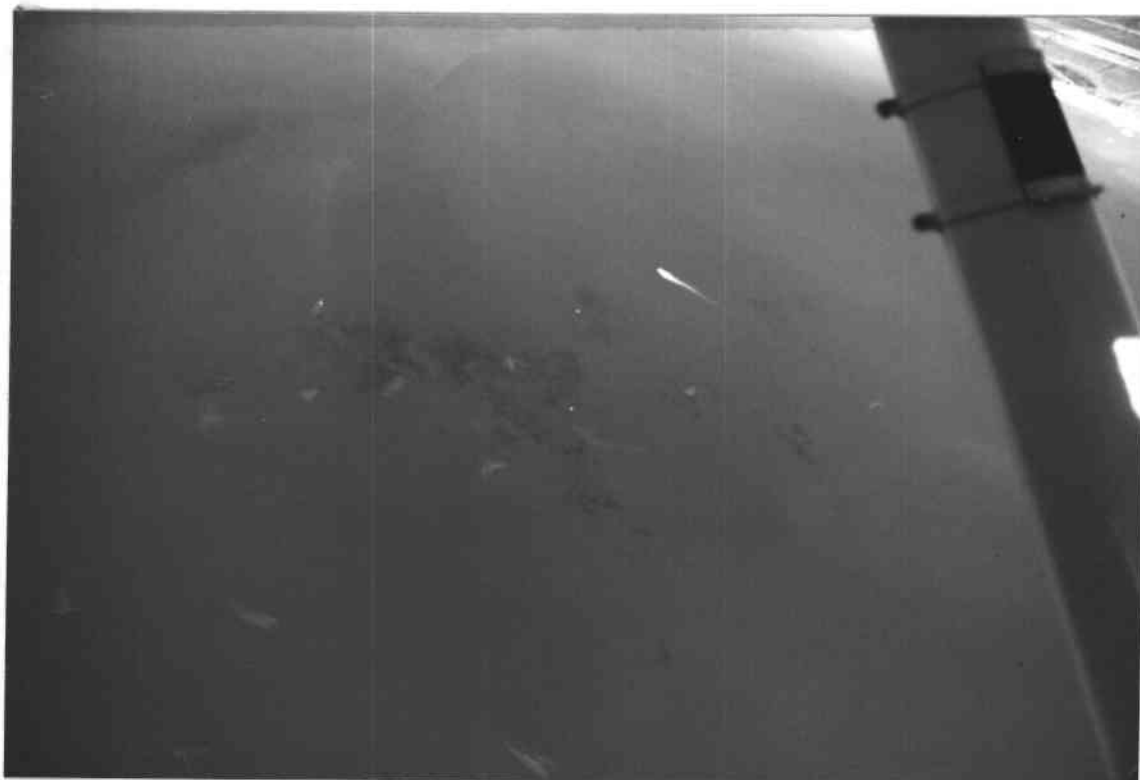
Figure 2-6-2: Dye patches 1 through 12. Notice dye patch 4 moving offshore and downcoast. Time: 13:18.

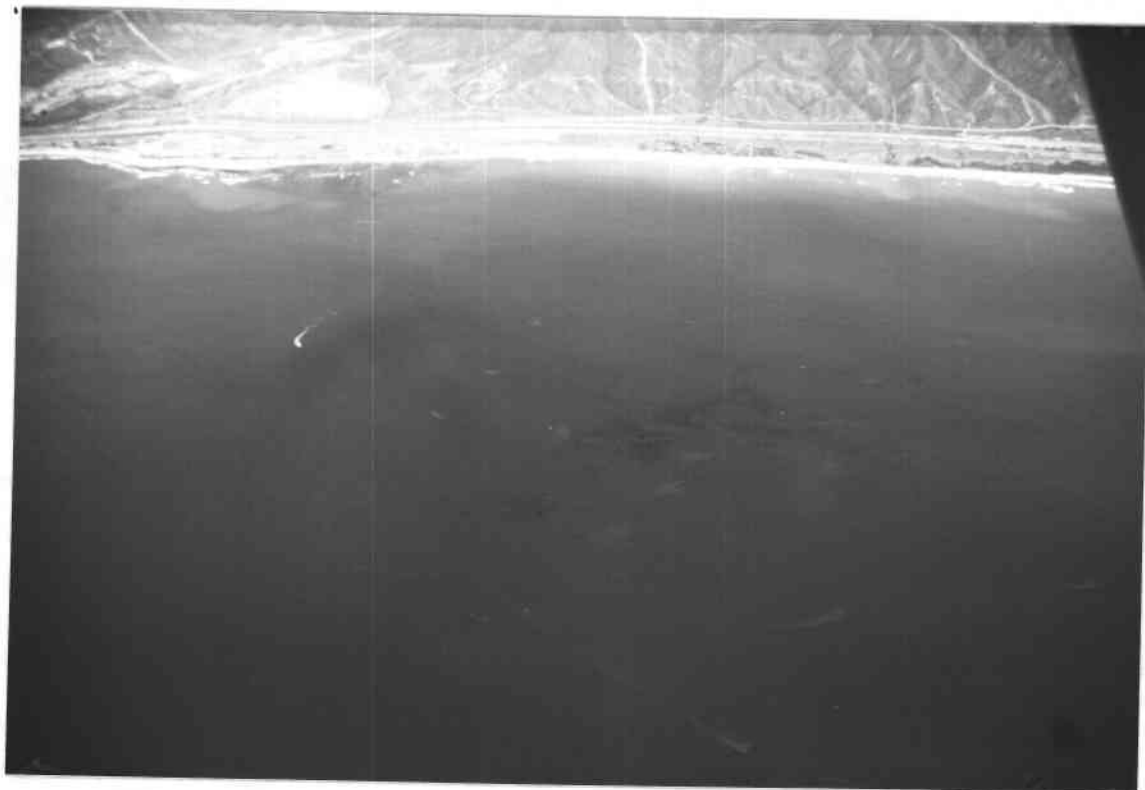
Figure 2-6-3: Dye patches 1 through 16. Notice the plume front, the movement of dye patch 4 along this front, and the slight movement of dye patch 9 from its release position. Time: 13:43.

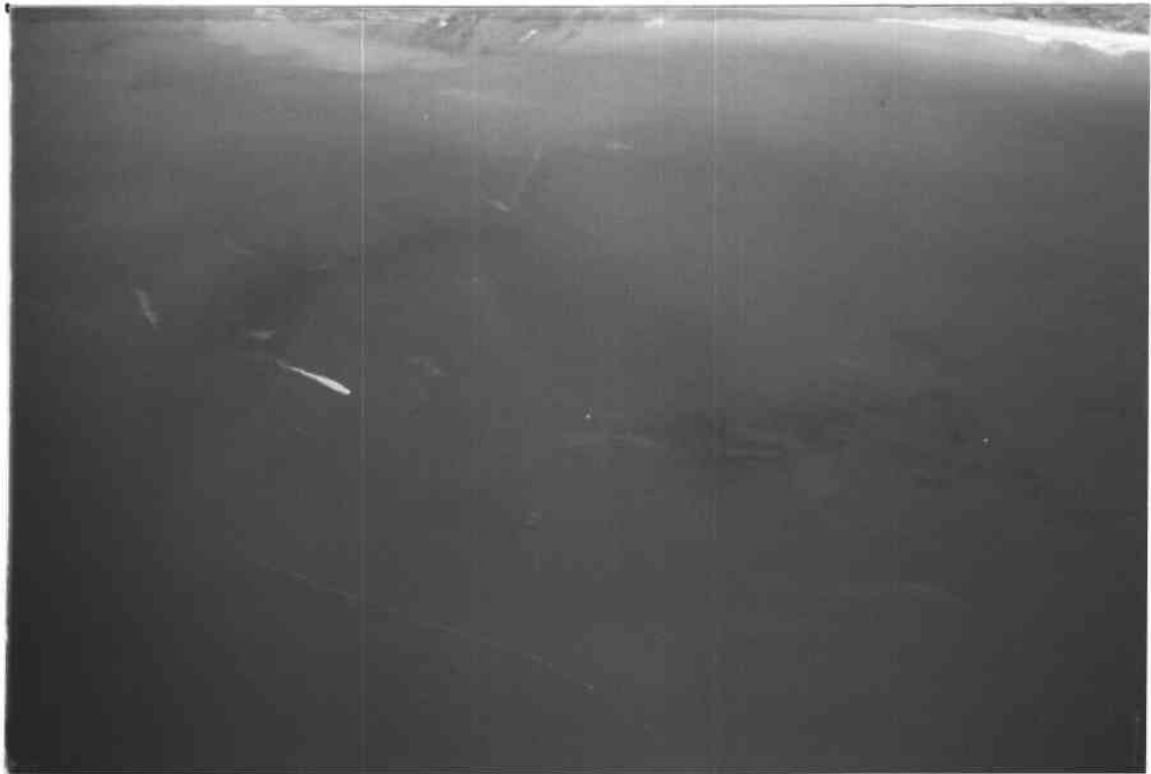
Figure 2-6-4: Dye patches A, B, C, D, 17 and Stripe 1. Notice dye patches 14 and 15 have already reached the south SOK kelp bed and dye patch 16 has not moved from its release location. Time: 14:28.

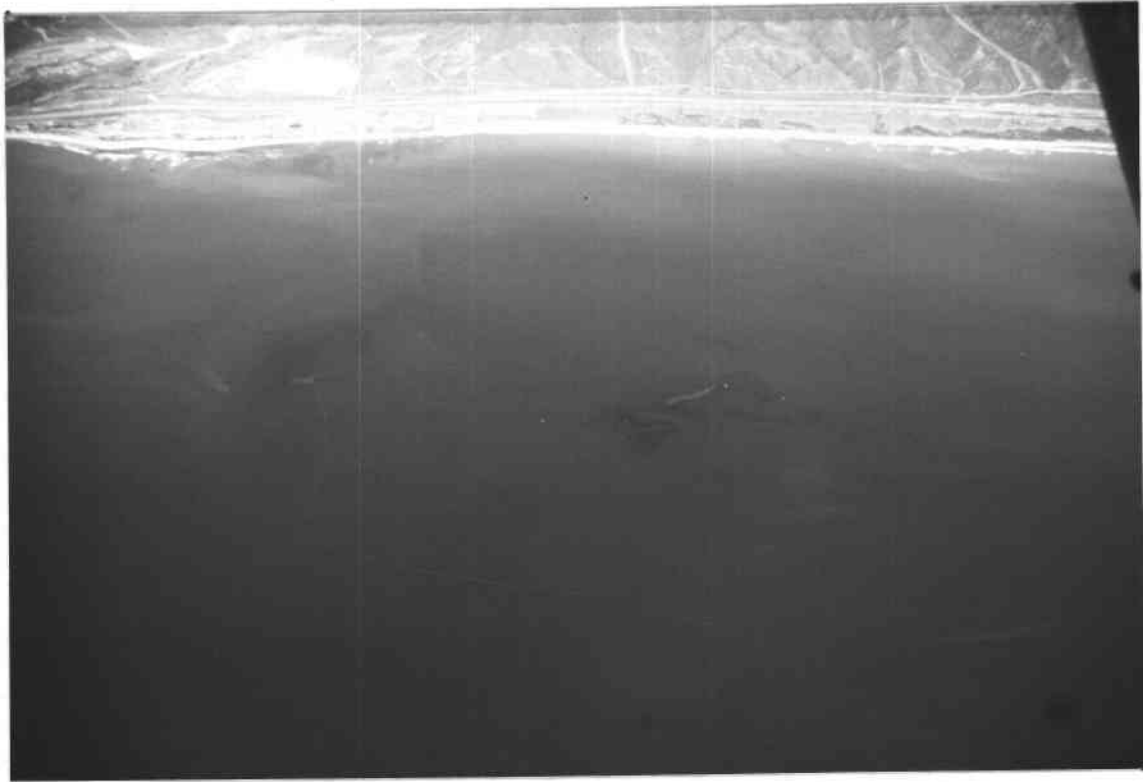
Figure 2-6-5: Starting location of Stripe 2 at the inshore part of the south SOK kelp bed. Notice dye patch A is on the Unit 3 diffuser line, dye patch 15 has joined the tail of dye patch 9, both deflecting into the less dense part of the kelp bed; dye patch 16 is still in the same location and dye patch 17 has moved downcoast. Time: 14:38

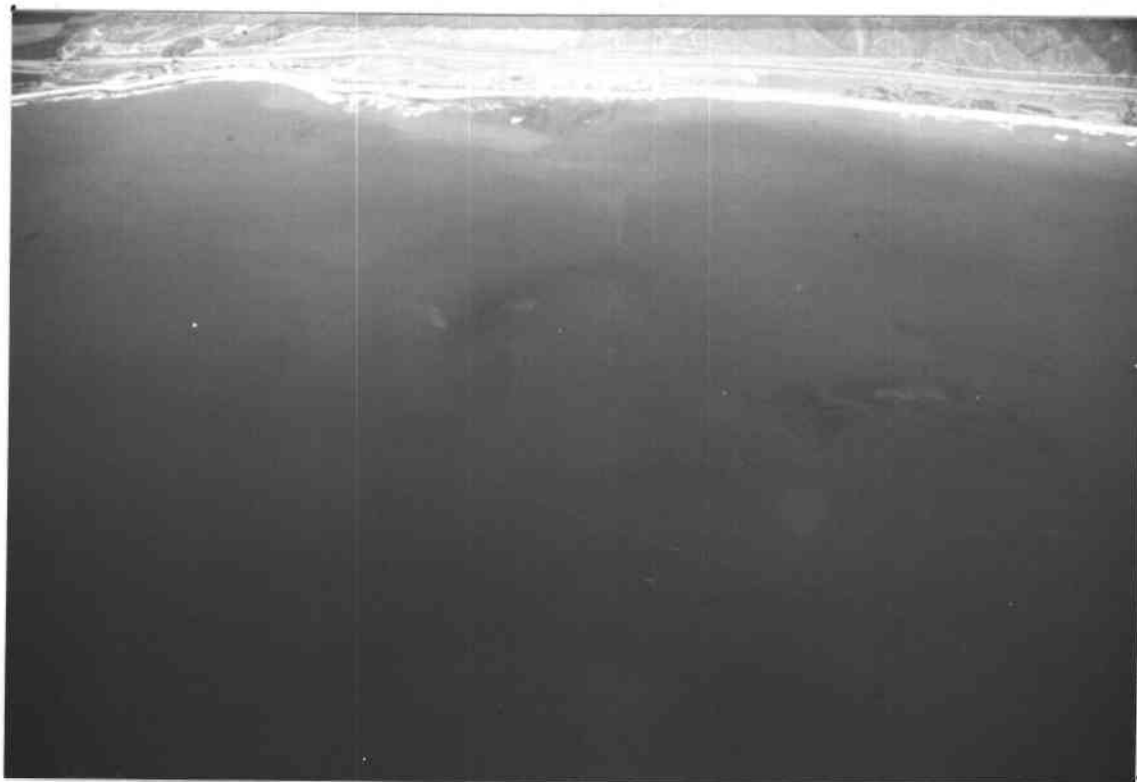
Figure 2-6-6: Starting location of dye patch 18. Notice that the dye patches north of SONGS have moved towards Unit 3 diffuser line, and Stripe 2 has quickly moved into the south SOK kelp bed. Time: 14:52.

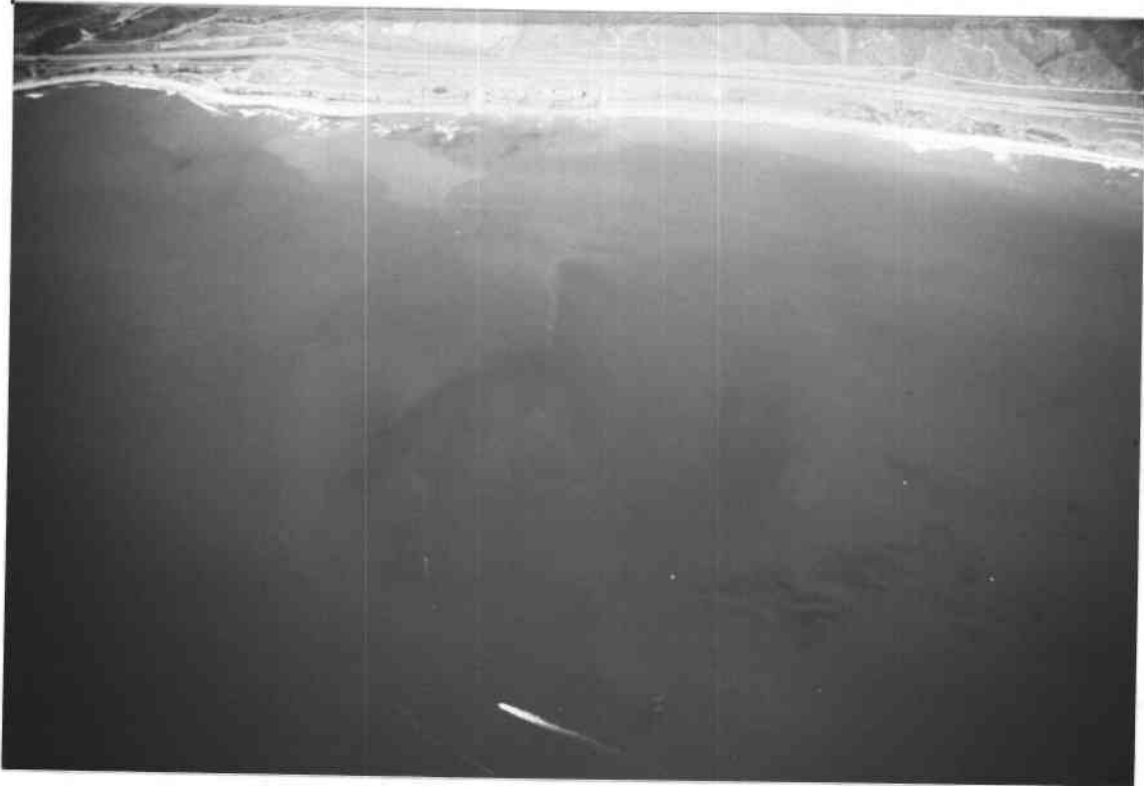
Figure 2-6-8: Dye patch D is on the Unit 3 diffuser line, dye patch 16 is still in the release vicinity, and Stripe 2 is slowly advancing out of the SOK kelp bed. Time: 15:44.

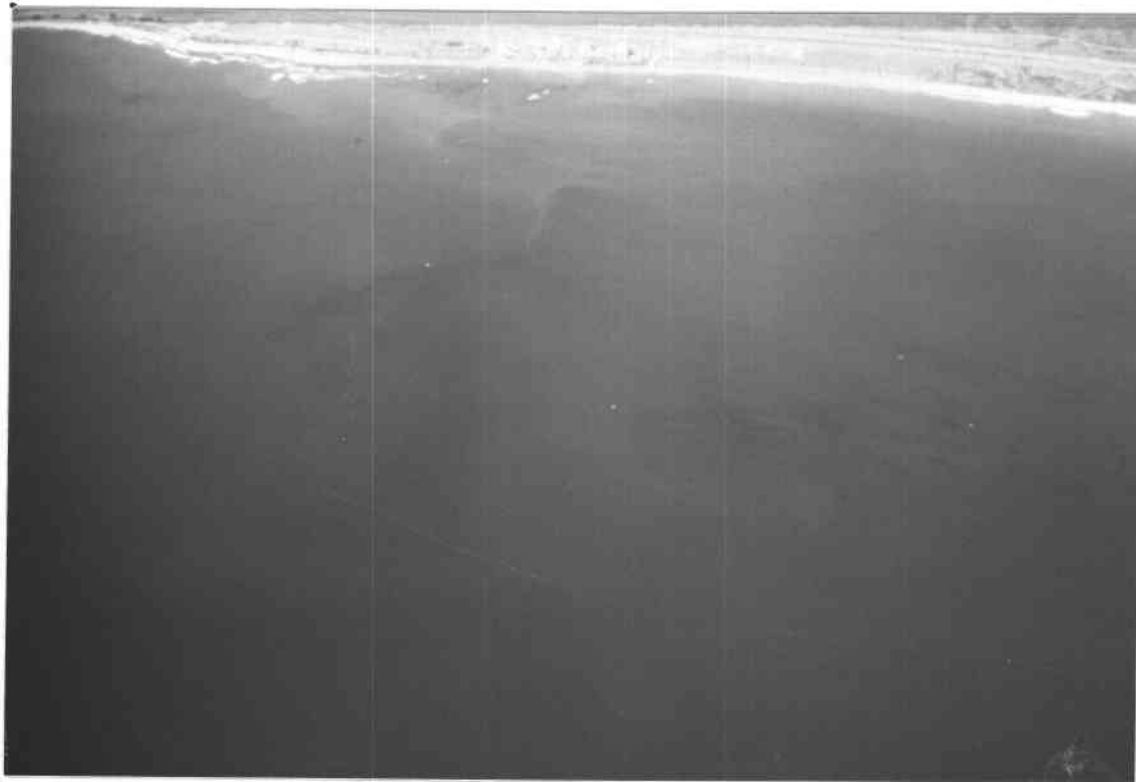
Figure 2-6-9: Stripe 1 is moving downcoast and inshore towards the Unit 3 diffuser line. Patch 16 is dispersing, and Stripe 2 is slowly moving to the offshore boundary of the south SOK kelp bed. Time: 15:55.

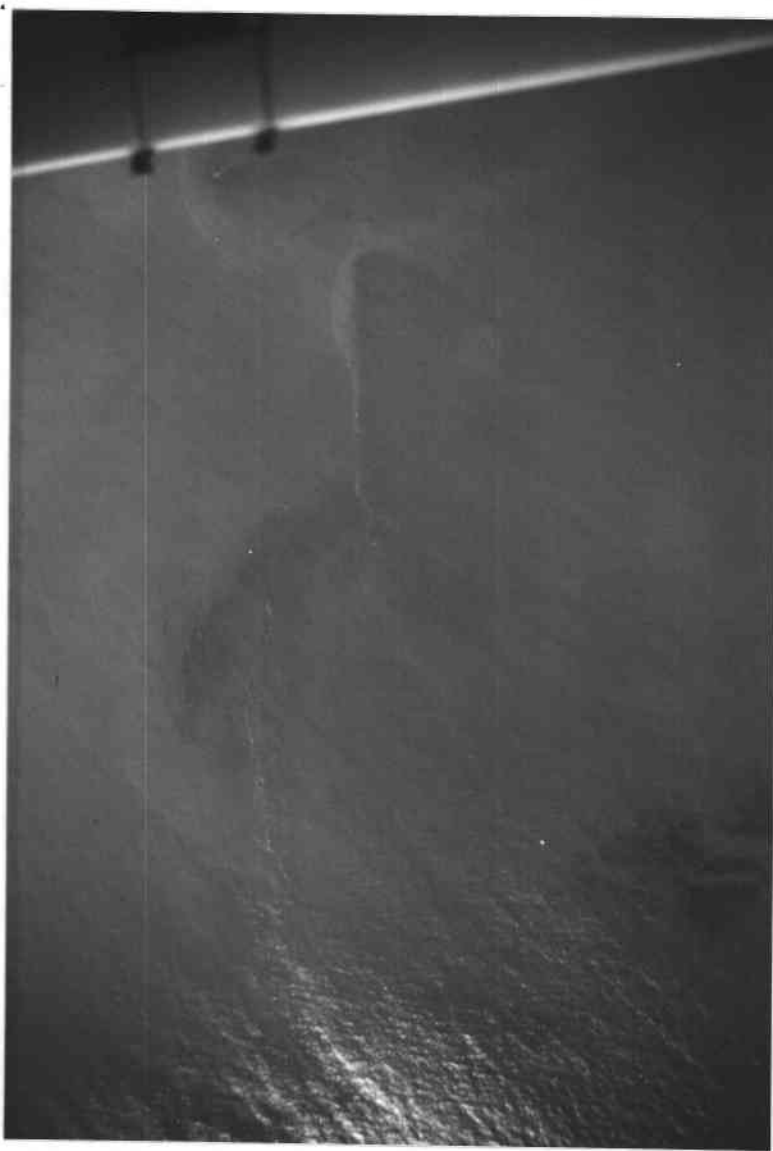
Figure 2-6-10: Stripe 1 is moving towards the Unit 3 diffuser line.
Dye patch 16 is still visible. Time: 16:17.
