Wheeler North Reef

Jenny McGee
Southern California Edison

SCAR - January 14, 2009
Module 17
(c) Richard Herrmann / SCE

Phase 3: Reef Expansion Project

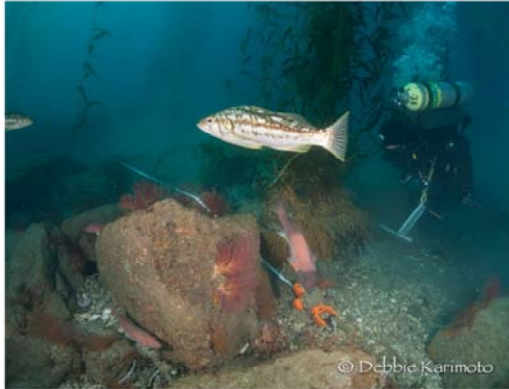
Conclusions from independent studies

The present configuration of Wheeler North Reef (174 acres of low relief reef with 48% rock coverage) is not sufficient to consistently meet the performance standard for fish standing stock

These studies, which we have discussed in detail at previous annual workshops, show that Wheeler North Reef is behaving like a natural reef, but that it is not big enough to consistently meet the performance standard pertaining to fish standing stock. This conclusion leads to the question – how much additional reef acreage is needed for the reef to consistently support 28 tons of fish?

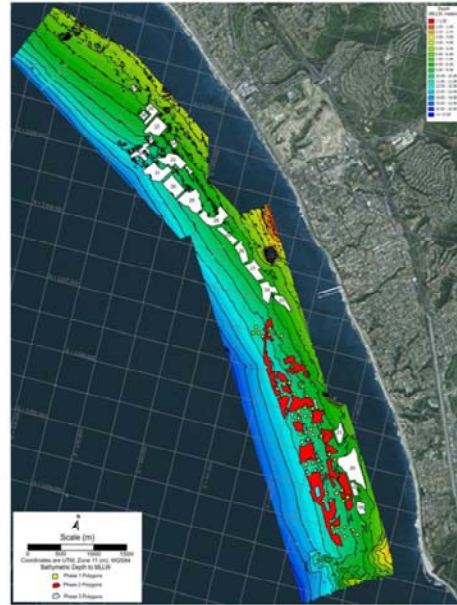
- 200-acre low relief/ low coverage reef
- Same design as Wheeler North Reef 12-15 meters deep
- Known performance
- 9 years of biological information
- Requires the least amount of rock
- 150 thousand tons of rock
- 44 barge trips
- 3 separate quarries

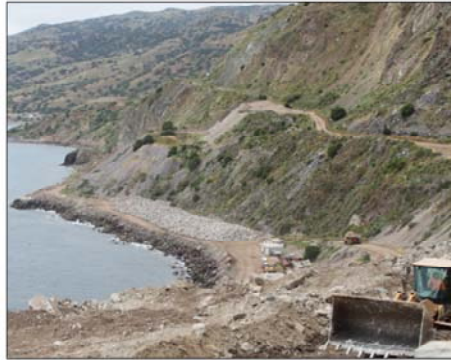
Season 1 Construction Summary

- Tons Placed: 91,895
- Acres Constructed: 119
- Polygons Constructed: 11
- Rock barges from Mexico: 4
- Rock barges from Catalina: 23
- Manhours worked: 18,981
- Construction dates: July 19 through September 30
- Tons placed per day: 1,600 av
- NO safety incidents or spills

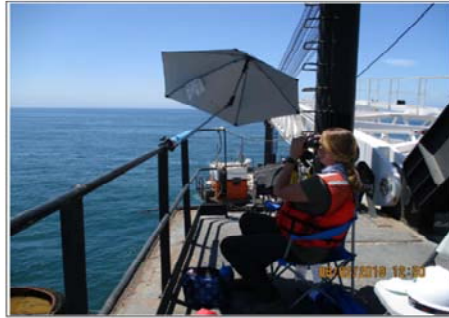
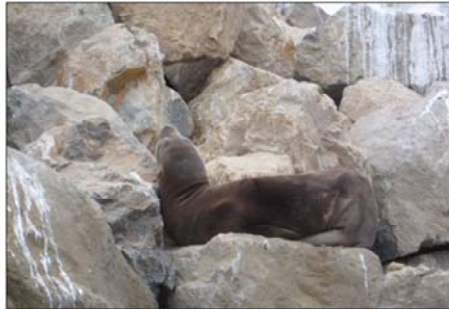
Marine Wildlife

- Species identification
- Monitor compliance with applicable laws
- Stop Work Authority to avoid marine animal collisions or harm
- Total number of sightings: 1,378
- Total number of animals: 1,253
- Total Stop Work orders: 17
- Exclusion Zone: 500 feet small mammals; 1,640 feet large mammals
- Trained dedicated boatmen to monitor transport vessels

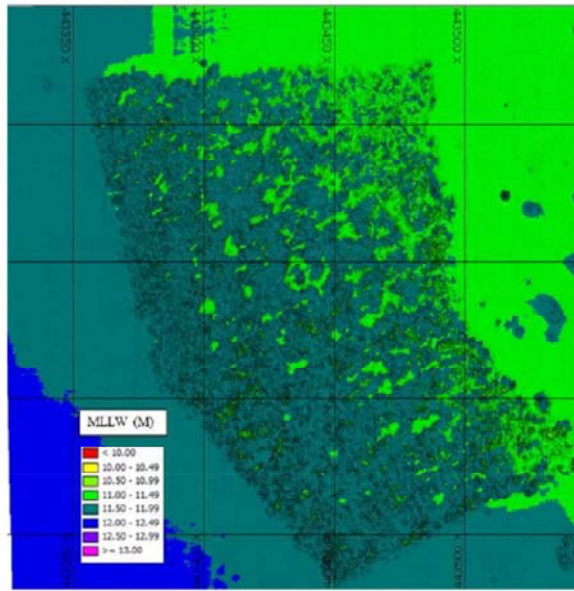
Photo: Sun-illuminated Color Shaded Relief Bathymetry – Polygon 18
Data collected by Coastal Environments

- Multi-Beam Sonar Surveys determine footprint of each polygon
- Dive surveys determine percent cover of hard substrate (rock)
