**FINAL CONSTRUCTION REPORT
FOR WHEELER NORTH REEF AT SAN CLEMENTE, CALIFORNIA
(FORMERLY THE SONGS ARTIFICIAL REEF MITIGATION PROJECT,
PHASE 2 MITIGATION REEF)**

Volume II: Data Report

5 November 2008
Revised 12 December 2008
CE Reference No. 08-34

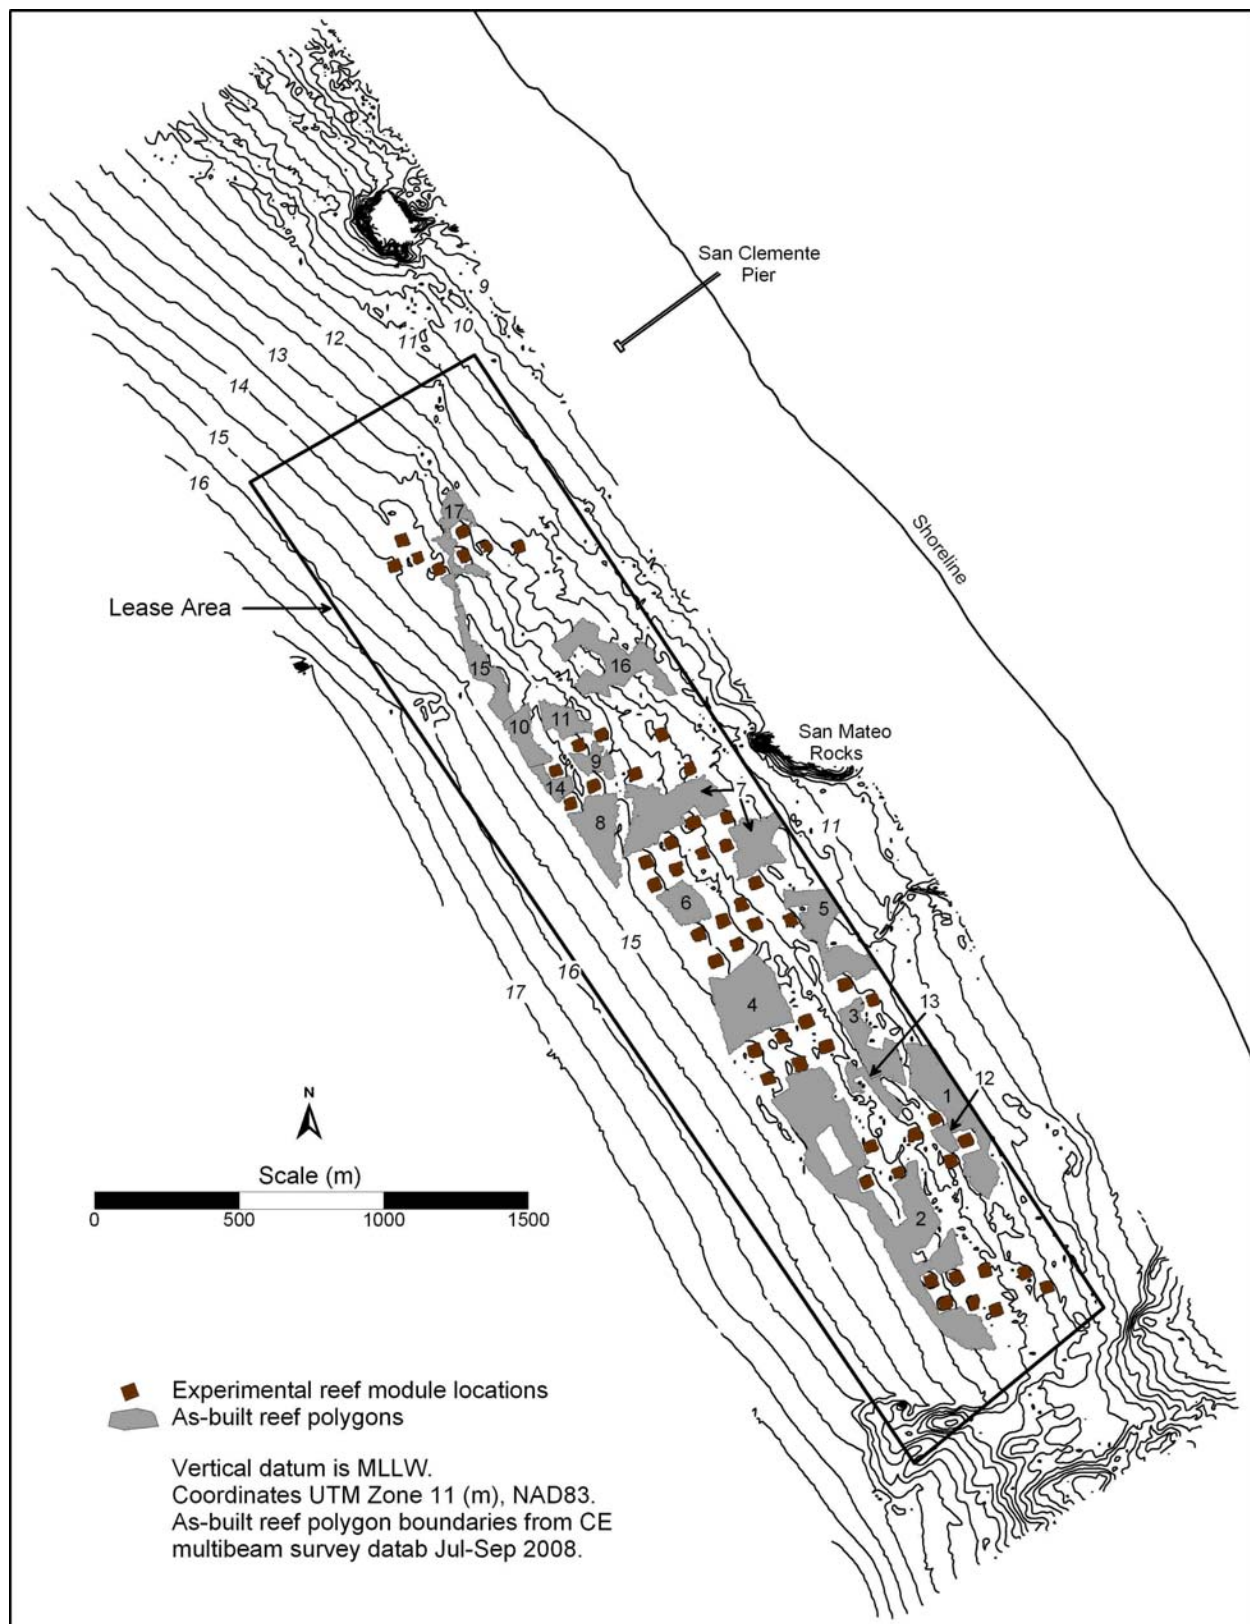
Figure 1-2. Polygon numbering system.

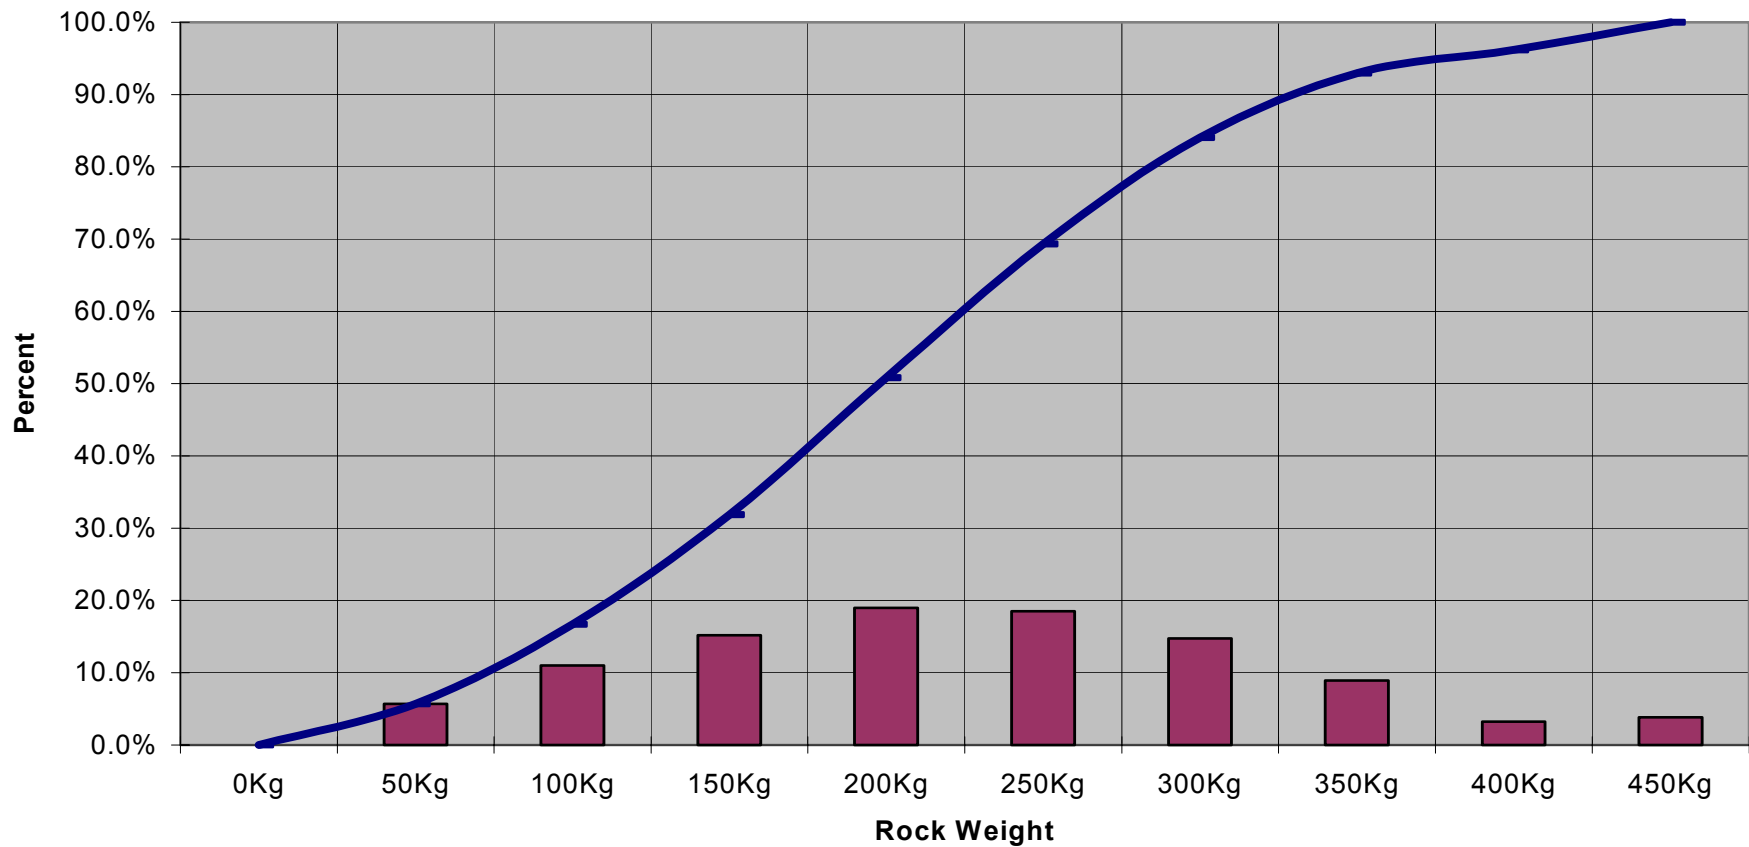
Pebbly Beach Quarry - Twinning Lab Rock Gradation Test - February 15, 2008

Figure A-1. Pebbly Beach Quarry rock gradation test, 15 February 2008.

Twining Laboratories also performed six random rock size tests (gradation tests) to ensure that the rocks being stockpiled at the quarries for use on the reef met the CE and CCC-CS specifications for size and quantity of each size for the rocks. The results of these six rock gradation tests (Figures A-1 through A-6) are included in Appendix A of this report. Figure A-7 compares the average from these six rock size gradation tests to the upper and lower limits presented in the Final Design Plan (CE, 2008a).

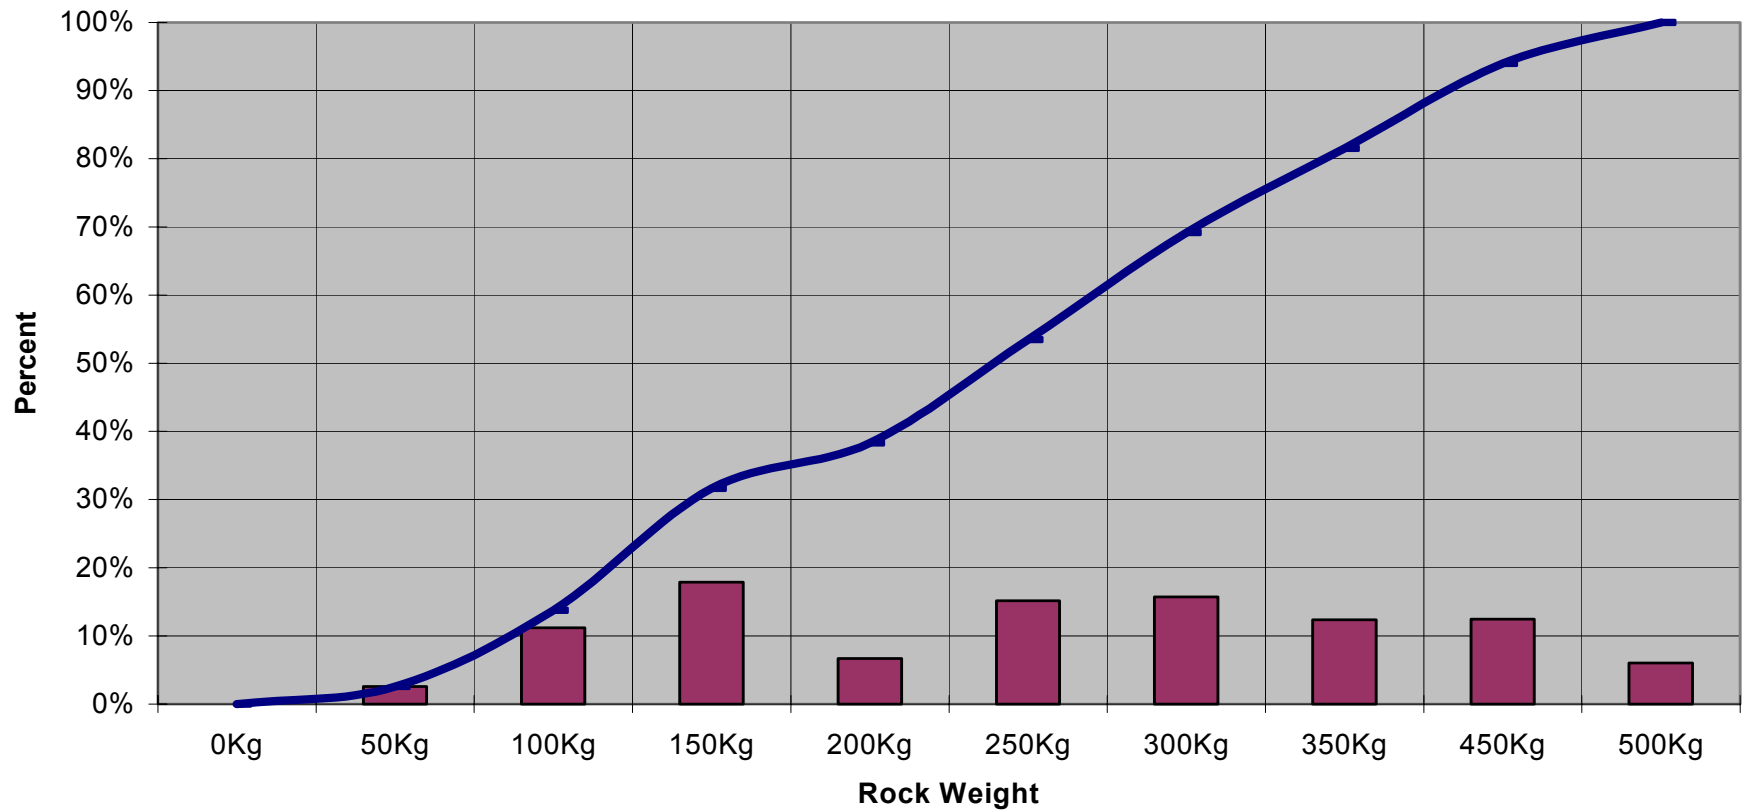
Pebbly Beach Quarry - Twinning Lab Rock Gradation Test - April 17,2008

Figure A-2. Pebbly Beach Quarry rock gradation test, 17 April 2008.

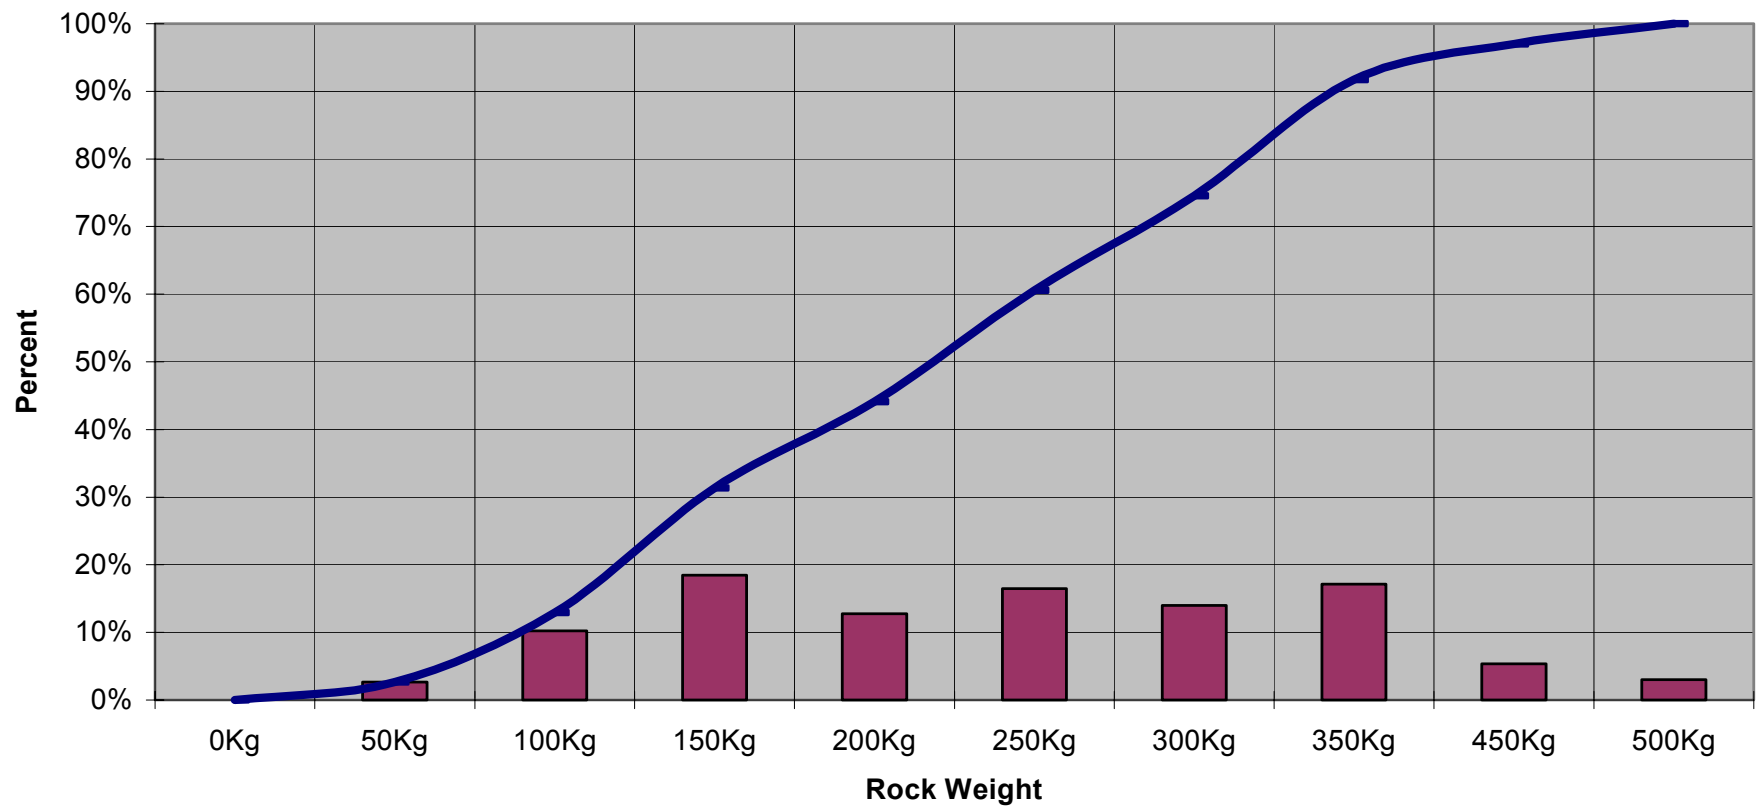
Pebbly Beach Quarry - Twinning Lab Rock Gradation Test - July 10, 2008

Figure A-4. Pebbly Beach Quarry rock gradation test, 10 July 2008.

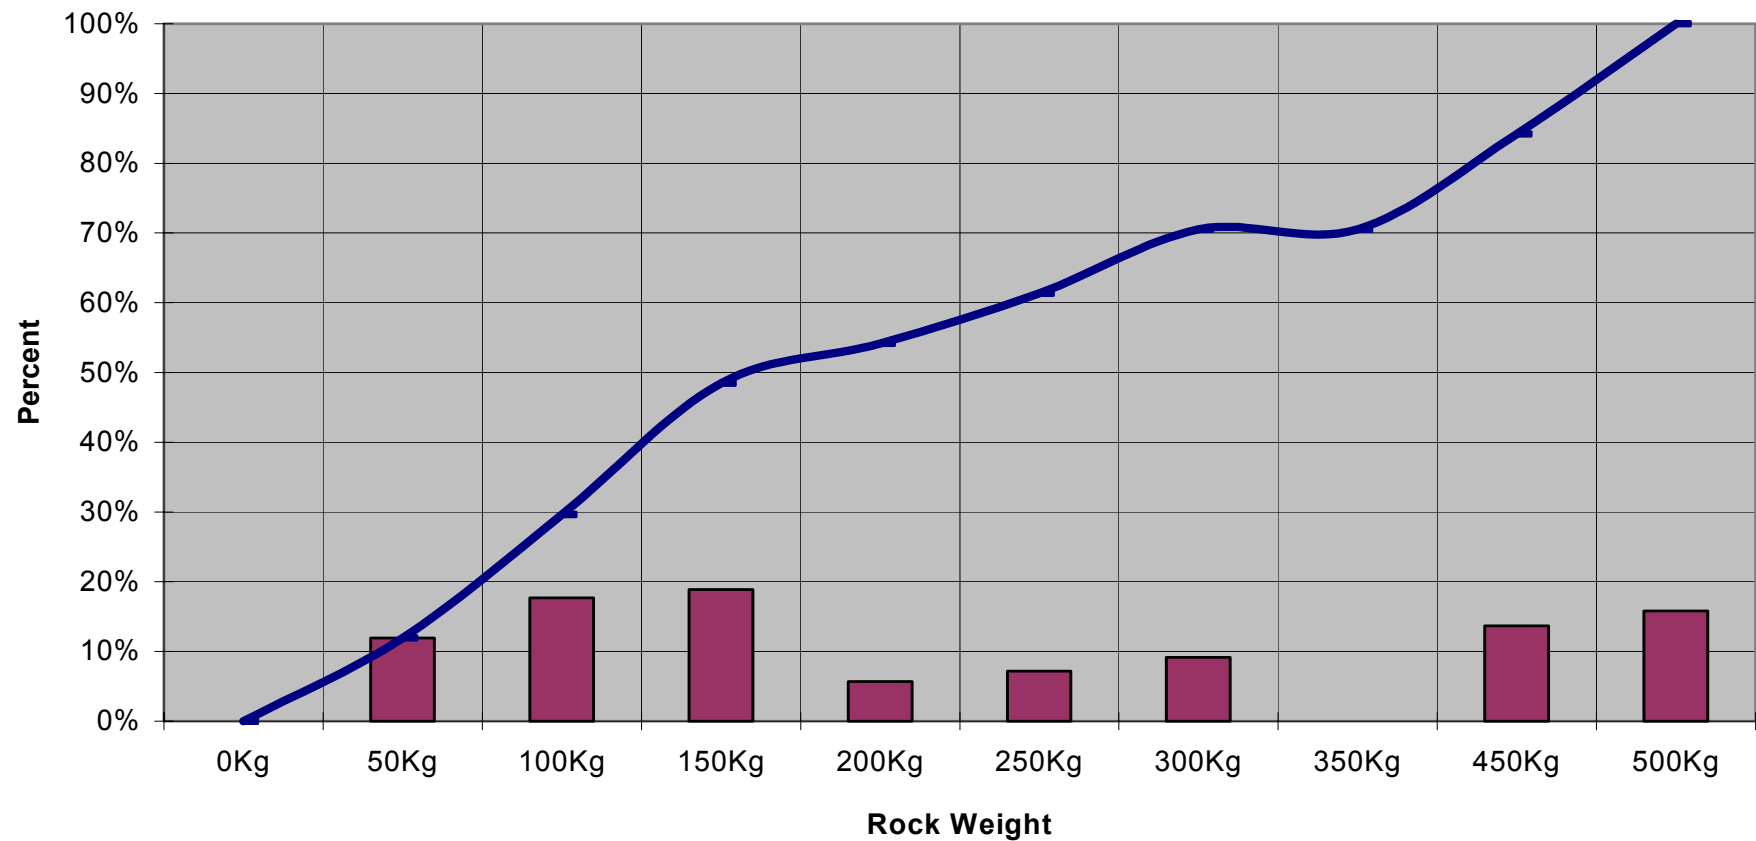
Petreros Del Pacifico Quarry - Twinning Lab Rock Gradation Test - July 16, 2008

Figure A-5. Petreros Del Pacifico Quarry rock gradation test, 16 July 2008.

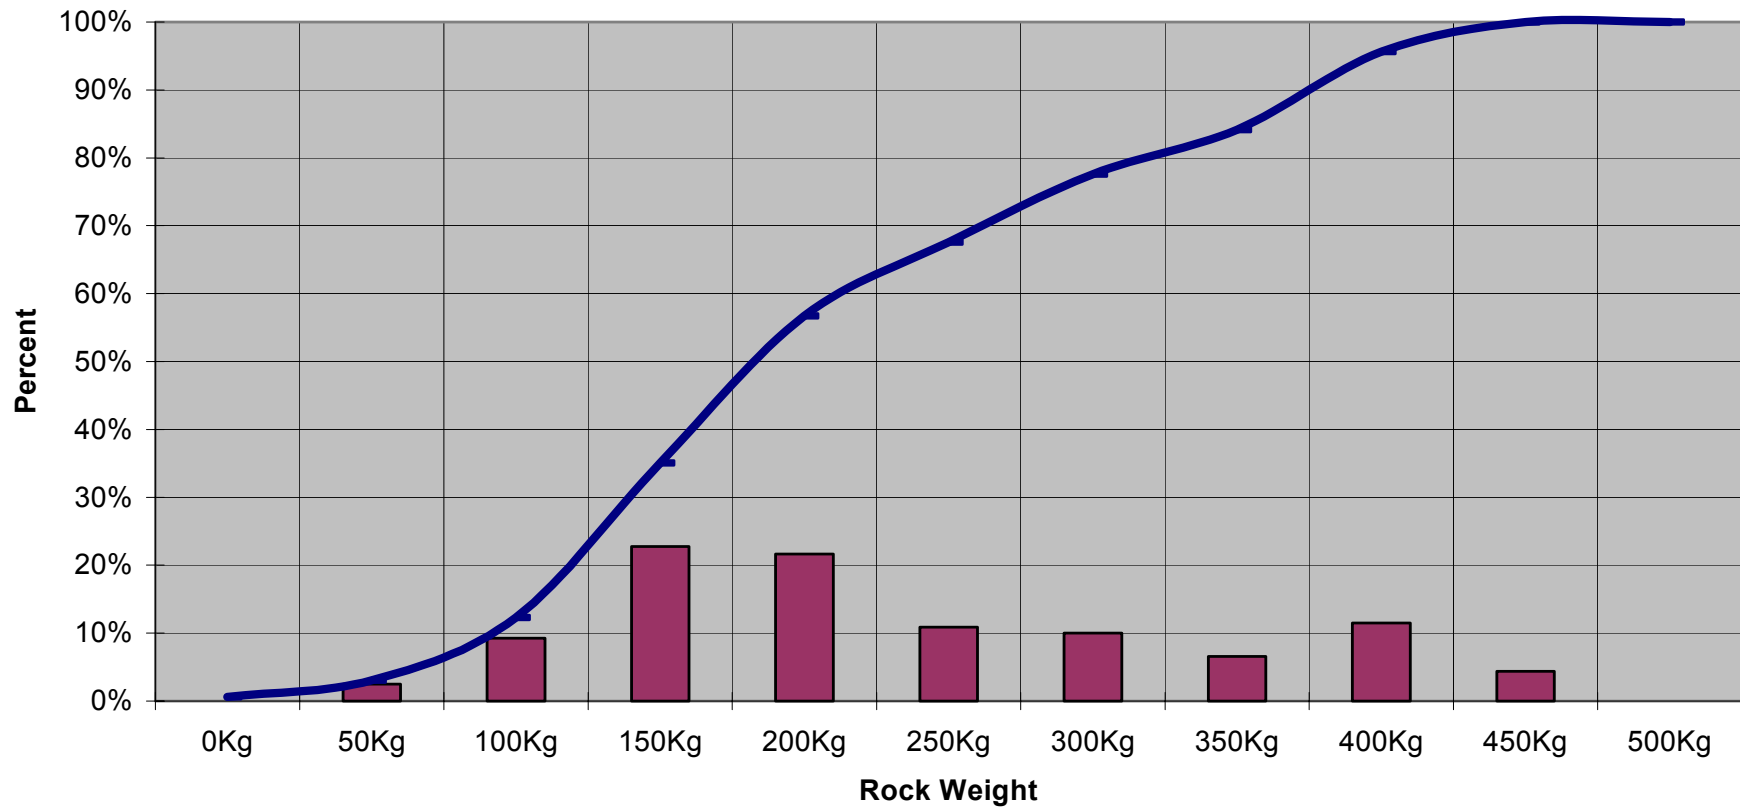
Pebbly Beach Quarry - Twinning Lab Rock Gradation Test - August 21, 2008

Figure A-6. Pebbly Beach Quarry rock gradation test, 21 August 2008.

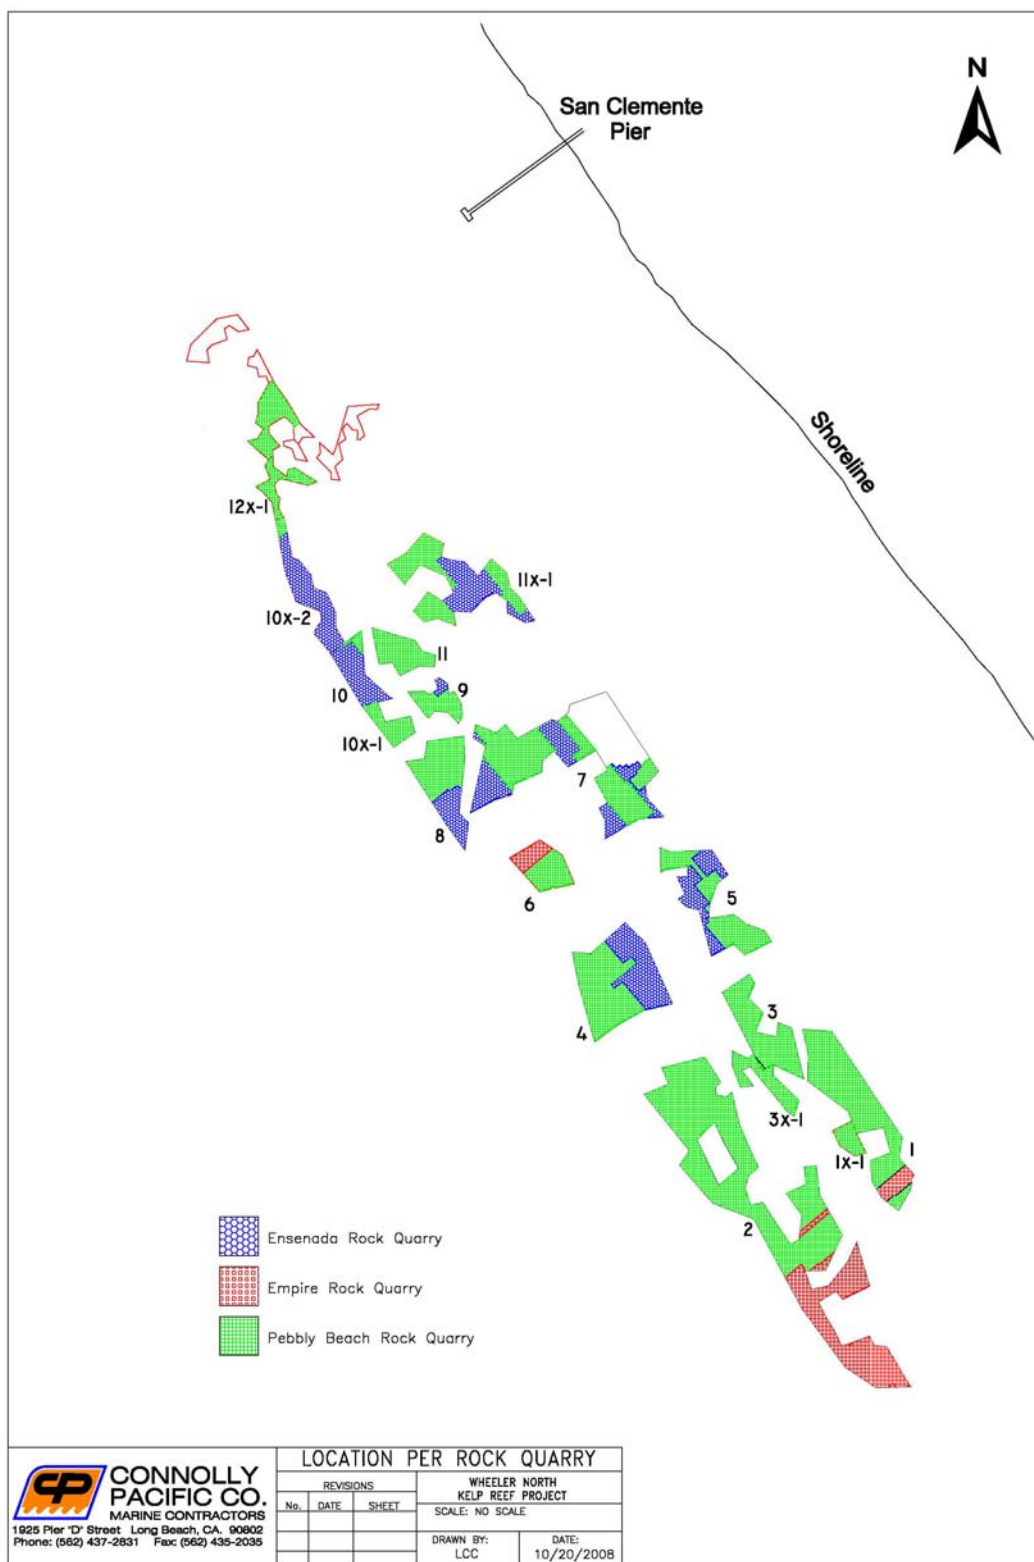
Figure B-1. Rock quarry type and location of placed rock for all polygons.

Appendices B and C present two sets of polygon completion diagrams. One shows the areas of each polygon that were constructed with each rock type (Appendix B), and the other shows the areas of each polygon completed on each individual work day (Appendix C). The tonnage per acre shown in Table 1-1 differs slightly from that shown in Figures B-2 through B-18 and C-2 through C-18 due to the use of multibeam surveyed as-built acreage for Table 1-1 and the use of the construction design areas in Appendices B and C.

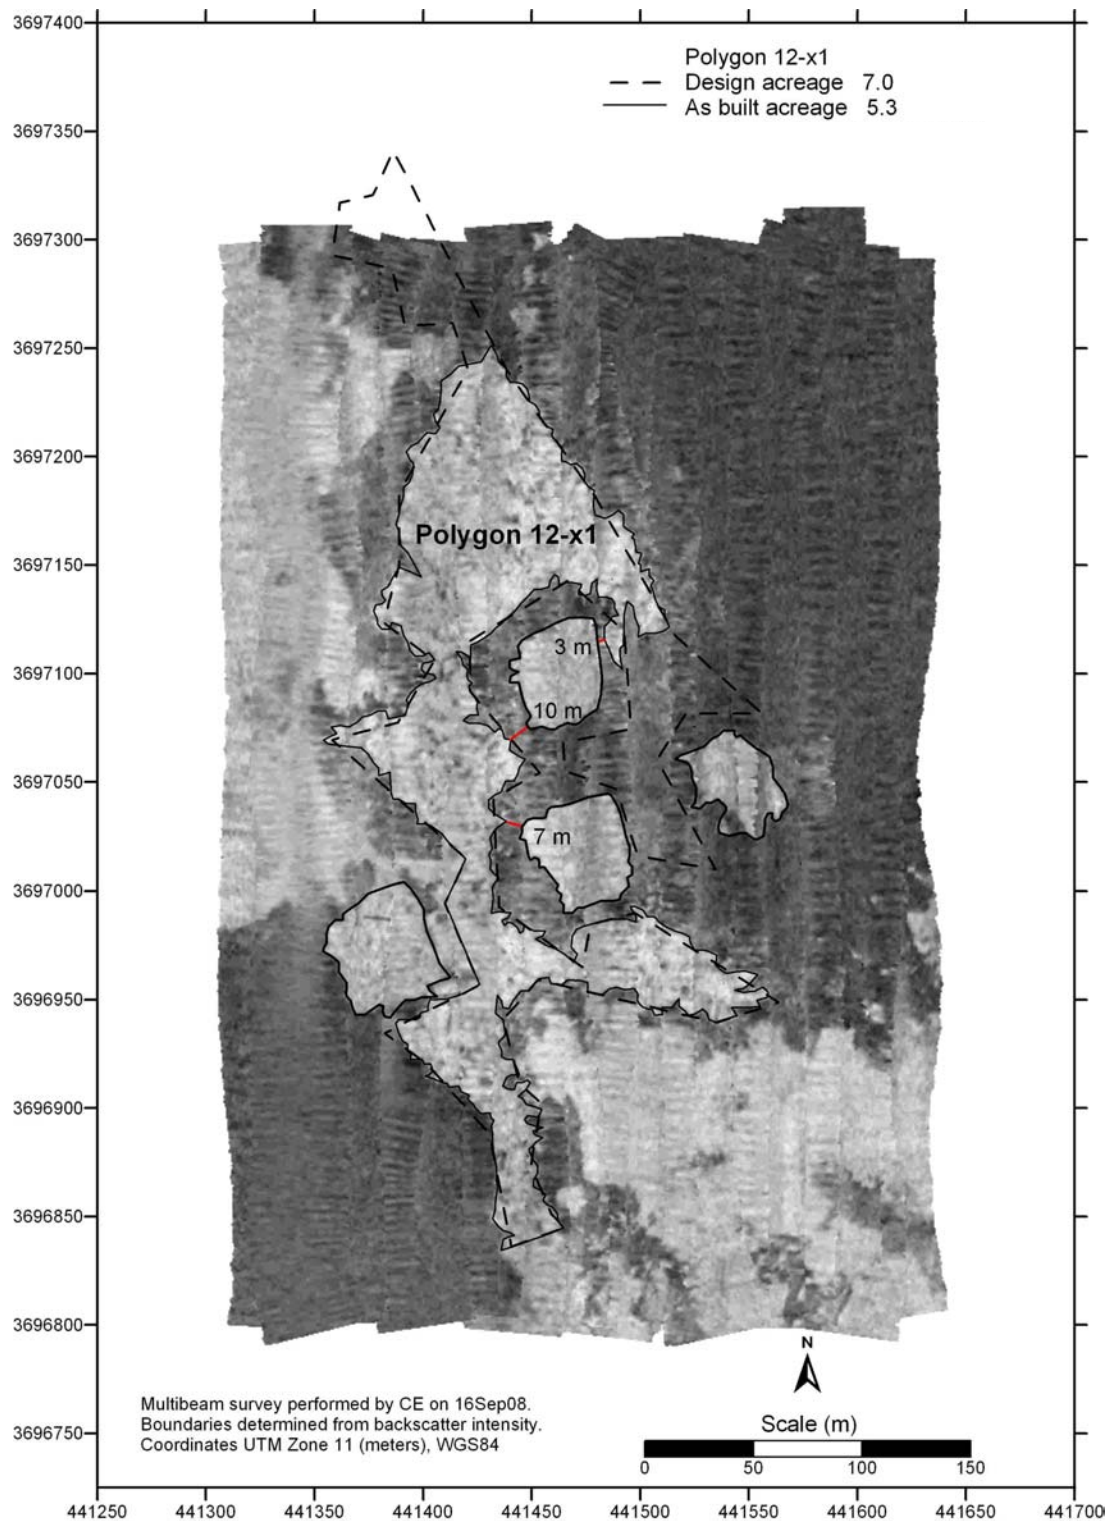
Figure E-10. Polygon 12-x1 boundary. From CE multibeam survey using backscatter data.

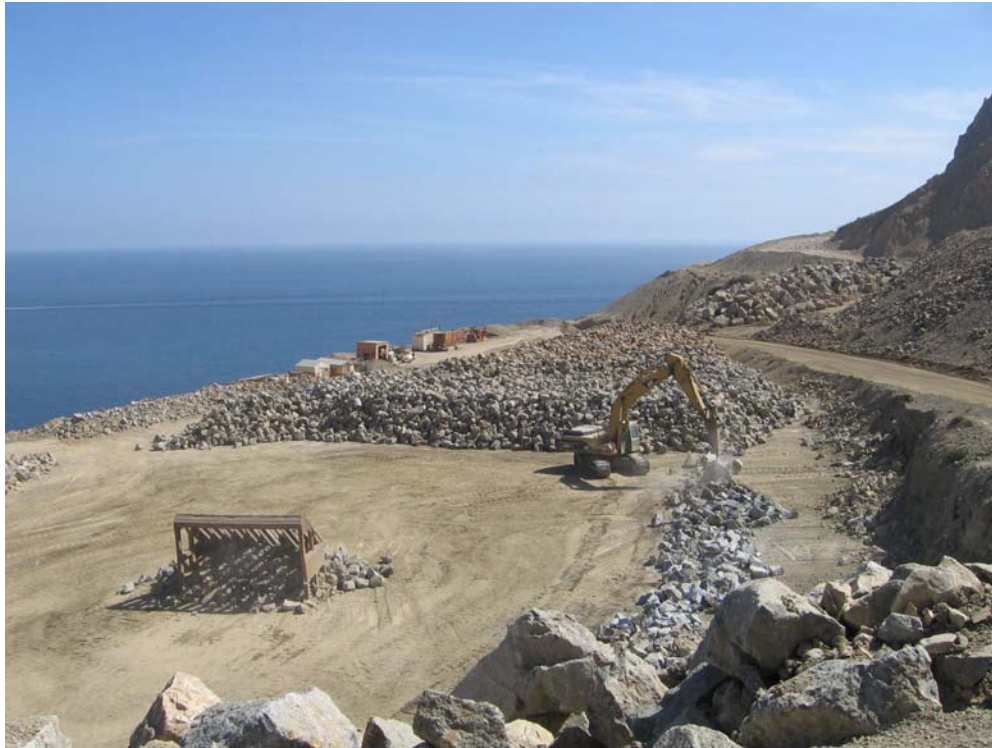
Photo G-3. Rock production at Pebble Beach Quarry. Large rocks were broken into smaller rocks by the breaker (right), and small rocks were separated out by the Grizzly (left).

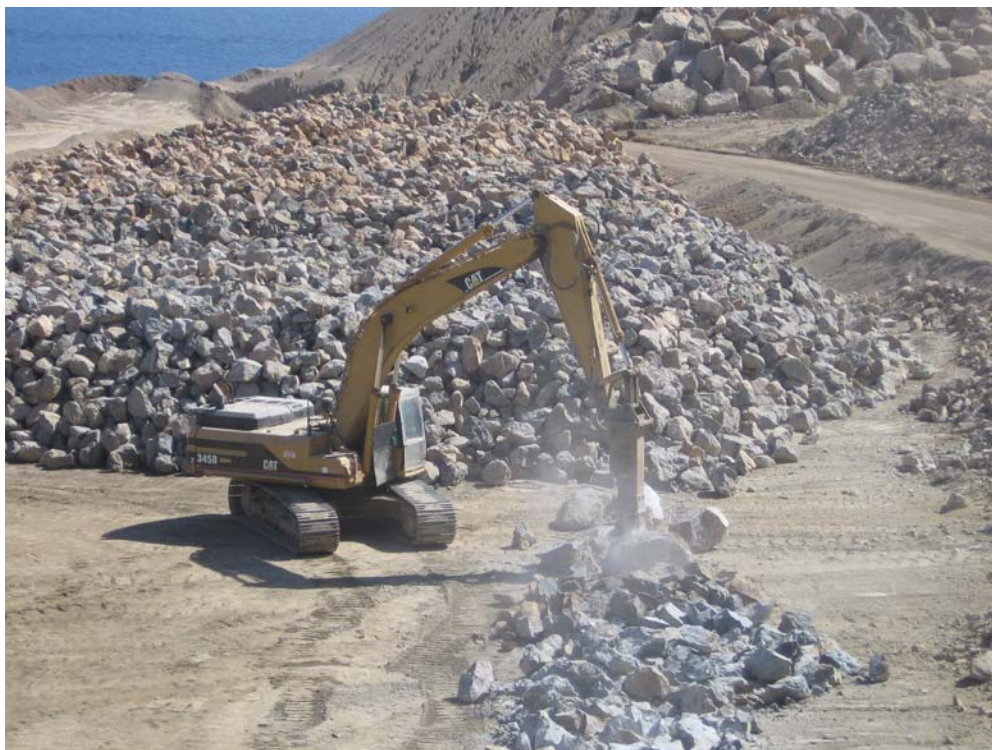
Photo G-4. Close-up photo of the breaker.

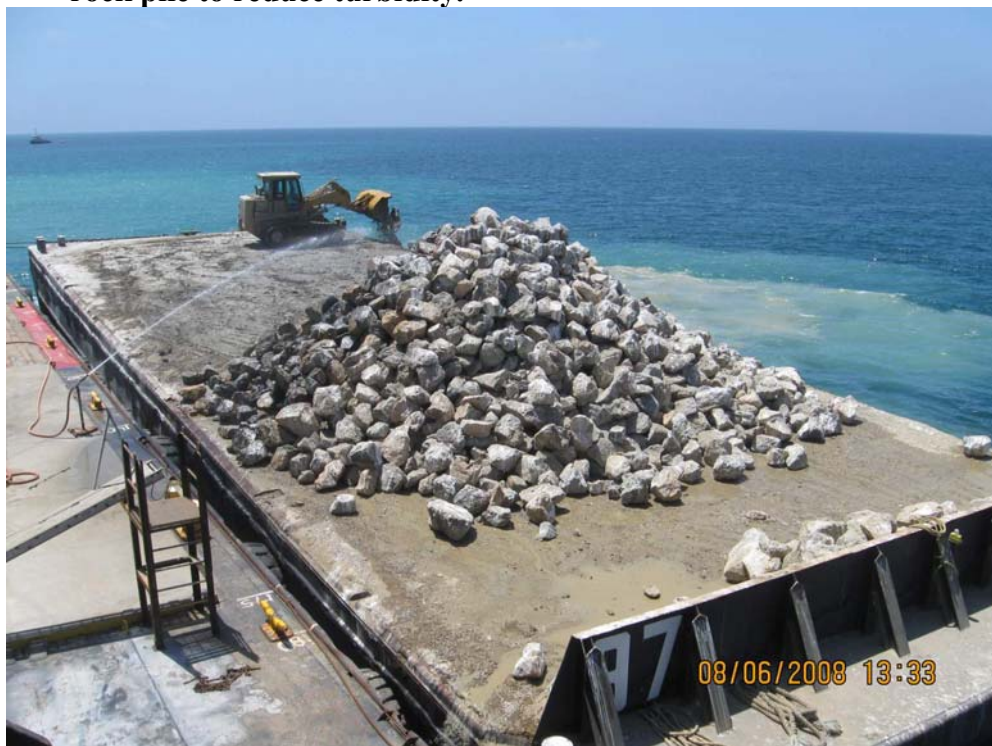
Photo G-20. Photograph taken on August 6, 2008, showing typical turbidity pattern caused by placing the rocks on the bottom of the ocean.

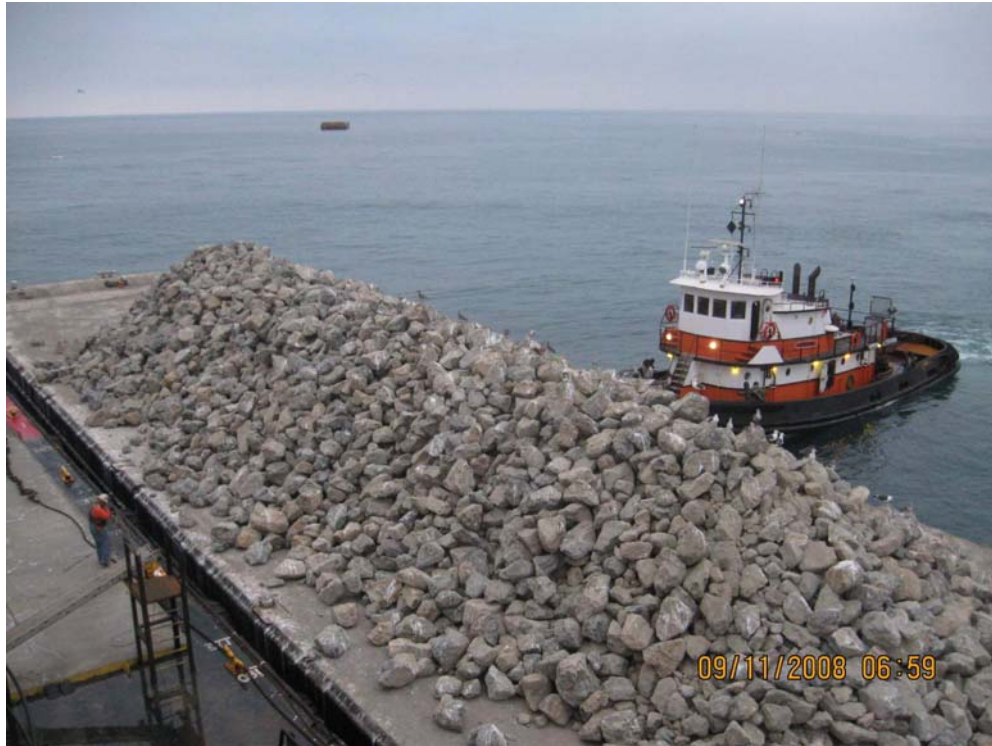
Photo G-21. Photograph taken on September 11, 2008, showing the rock materials used to construct Polygon 17 (12-x1).
