Annual Review Workshop for SONGS Wetland Mitigation

**SONGS Mitigation Monitoring Project
Marine Science Institute, University of California Santa Barbara**

Wetland Mitigation Linked to the Adverse Effects of the SONGS Cooling Water System

Update on Status of San Dieguito Wetlands Restoration

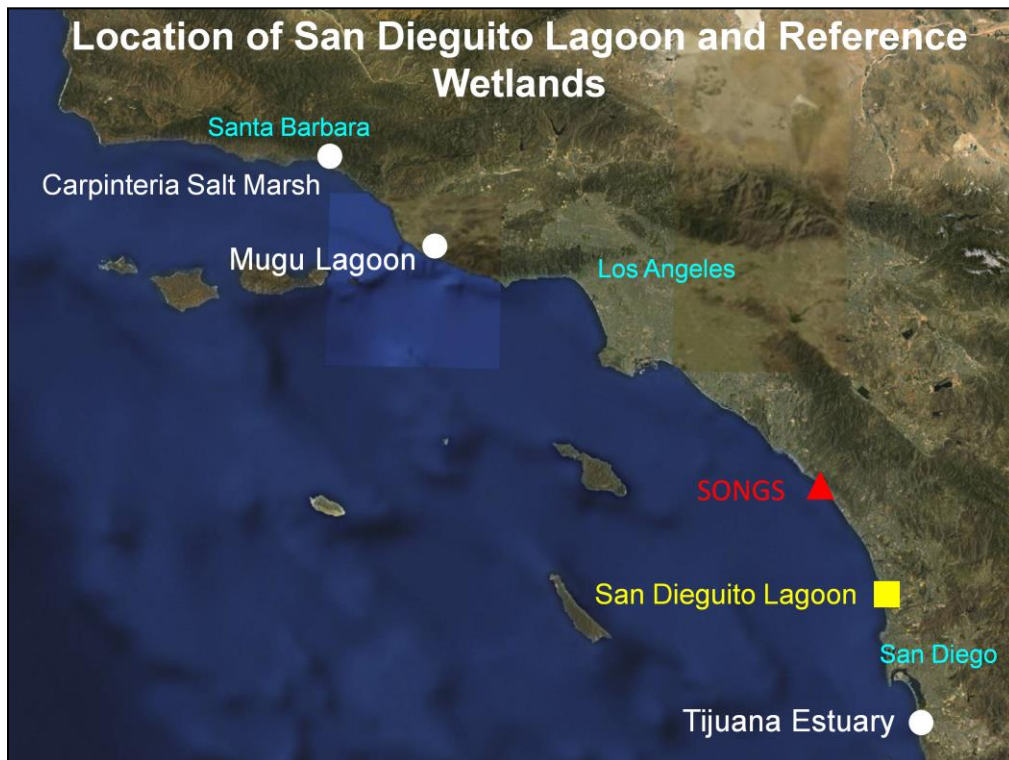
- This map shows the locations of SONGS, the impact site, the San Dieguito Lagoon Wetlands Restoration Project site and 3 wetlands that are used as reference sites to evaluate the performance of the restoration project: Carpinteria Salt Marsh, Mugu Lagoon, and Tijuana Estuary.

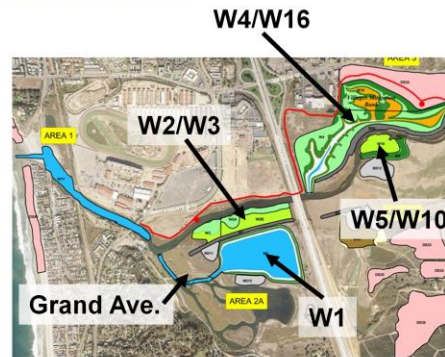
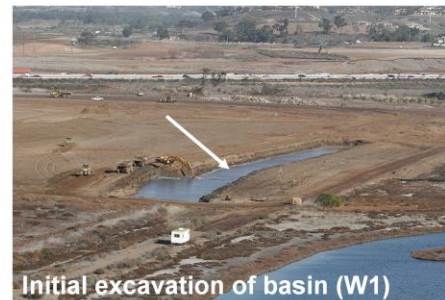
- This slide summarizes the construction timeline.
- Construction began in September of 2006.
- Wetland construction was organized by area and module -- most excavation and grading was completed by 2008, with the addition of tidal creeks in W2/3 completed in November 2010 and additional wetland in February 2011.
- Planting of salt marsh plants, including cordgrass, *Spartina* in the low marsh was completed in 2011.
- Final inlet channel dredging was completed in September 2011.

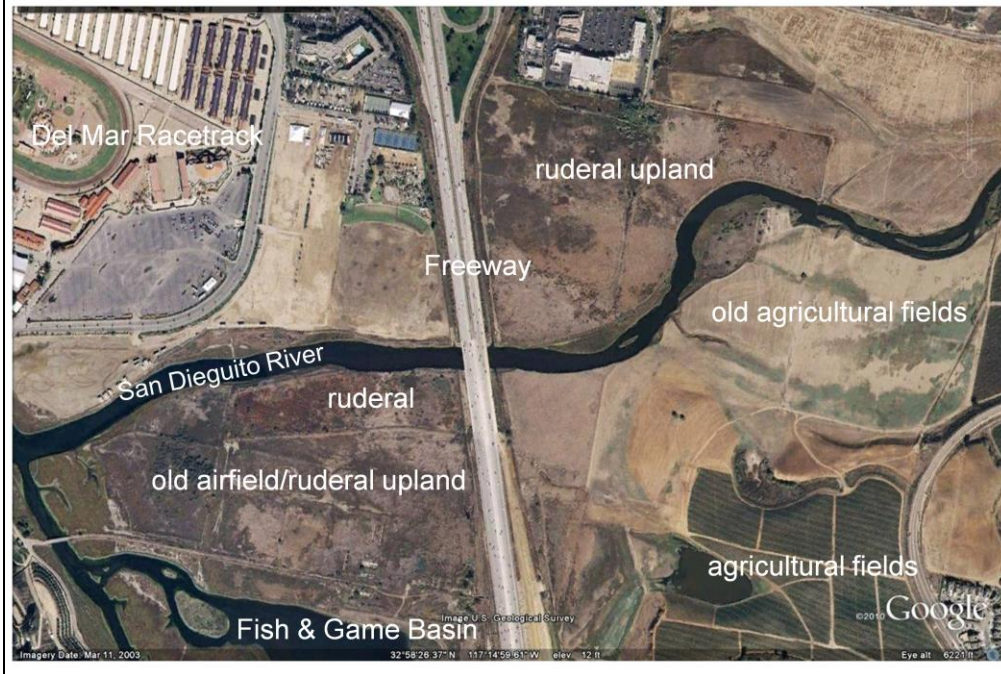
San Dieguito Lagoon before excavation and grading (2003)

- This slide shows a satellite view of the project site before excavation and grading.
- You can see the San Dieguito River and adjoining ruderal upland, including the site of an old WWII airfield, and old agricultural fields.
- You can also see a portion of a basin that was constructed in the 1980's termed the Fish and Game Basin.

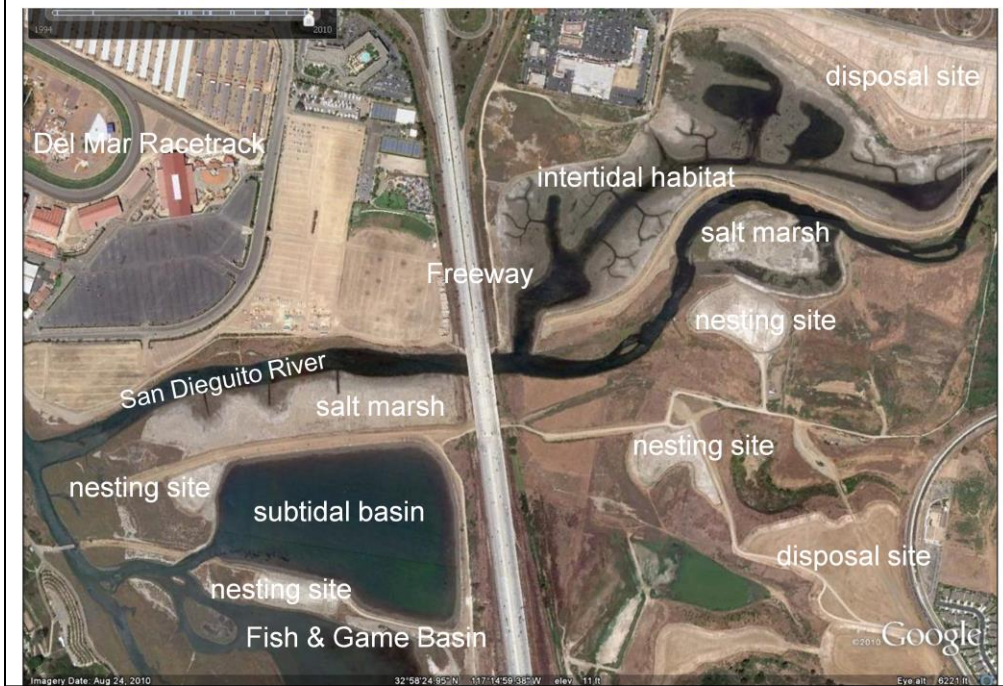
San Dieguito Lagoon after excavation and grading (2010)

- During construction, the ruderal areas and old agricultural fields were excavated and graded to create the planned intertidal and subtidal wetland habitats of the restoration project.

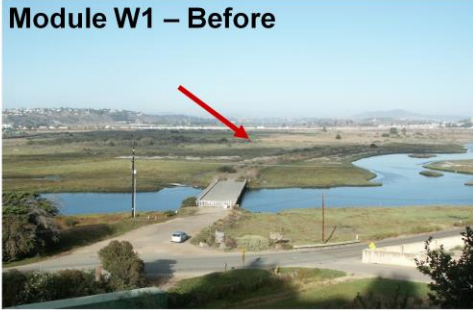
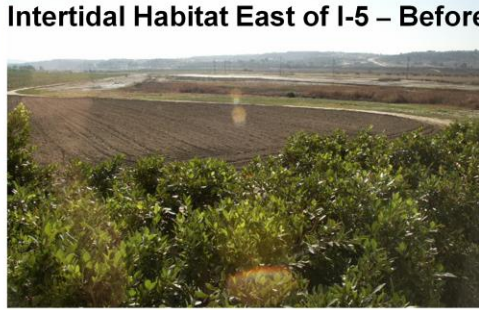
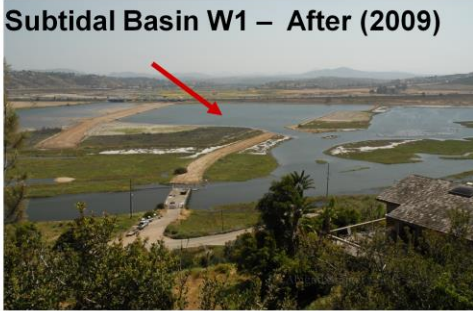
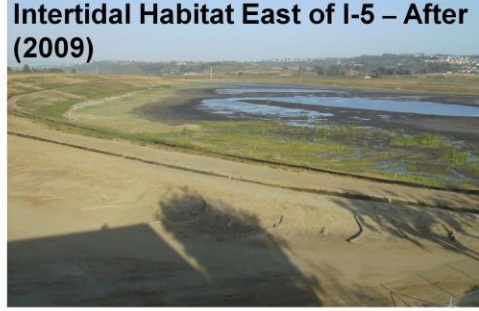
Module W1 – Before

Intertidal Habitat East of I-5 – Before

Subtidal Basin W1 – After (2009)

Intertidal Habitat East of I-5 – After (2009)

- A couple of on the ground views of the Module W1, location of the subtidal basin before and after construction
- Intertidal habitat east of the I5 freeway before and after construction.

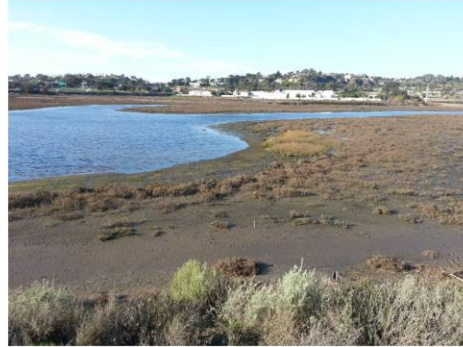
**View of constructed habitat
(March 2013)**

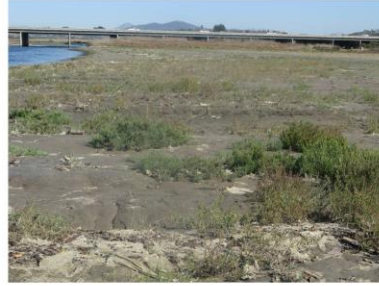
Natural recruitment at lower elevations in W2/3

- Two methods were proposed in the Final Restoration Plan to achieve plant establishment.
- Rely on natural recruitment of vegetation in the mid and high salt marsh.
 - Expected that pickleweed and other species would recruit naturally.
- Plant plugs or fragments in small patches to allow for natural spread
 - Cordgrass plugs planted in low marsh.
 - Fragments or plugs of pickleweed and other species planted in the high marsh where natural recruitment is likely slow.

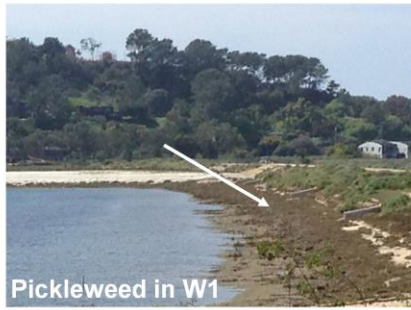
Pickleweed in W1

Development of vegetation is promising in some areas

- The development of vegetation has been very promising in some areas.
- Notably the growth of pickleweed, *Salicornia*, along the border of the basin, module W1 and the growth of *Spartina* in some areas of module W4.

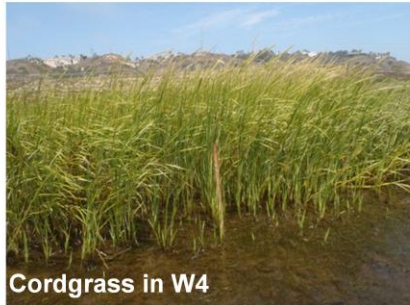
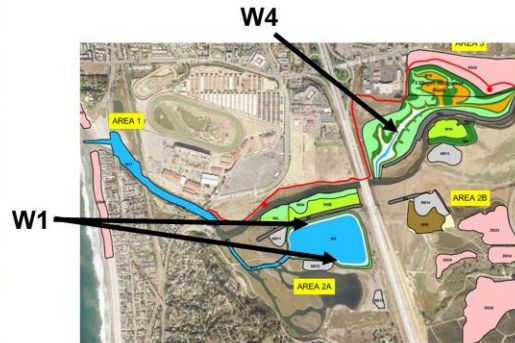
Cordgrass in W4

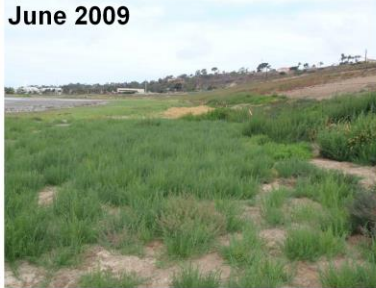
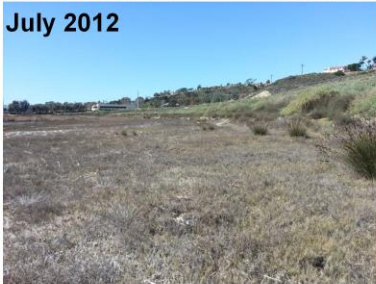
Northern border of W16

Development of vegetation was initially promising along the northern border of W16 but plants now remain brown and appear stressed

June 2009

July 2012

- Vegetation planted along the northern border of W16 January-March 2009
- Plants remained brown during the growing season in July 2012

- In other areas, particularly along the northern border of W16, development of vegetation was initially very promising, but more recently plants have turned brown and remained brown during the growing season, suggesting that they are stressed.
- The top photo shows the initial growth of plants planted in early 2009.
- The bottom photo shows what the plants looked like in July 2012, at a time of year when one would expect that they would be green.
- However, inspection of stems indicated that only a small percentage of the brown plants were actually dead.

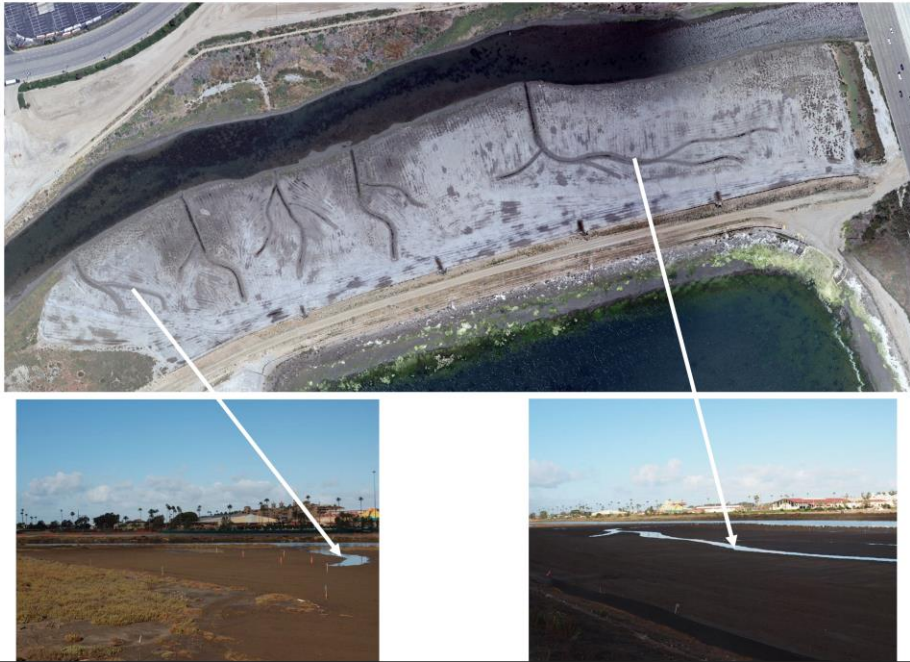
Construction of Tidal Creeks in Modules W2/3 Completed November 2010

- One possible solution to improve inundation of the marsh plain was to extend the linear channels that were initially constructed to better convey tidal water further away from the river channel.
- In November 2010, SCE extended the linear channels to form tidal creeks shown here, and did some re-grading lowering elevations of some areas around the creeks.

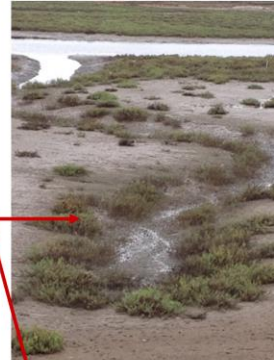
- Tidal creeks improved movement of tidal waters away from river channel
- Recruitment of vegetation has occurred along the edges of the constructed creeks
- Vegetation cover on the high marsh plain remains sparse

pickleweed

little recruitment of vegetation on the high marsh plain

- Tidal creek extensions improved movement of tidal waters away from the river channel.
- Recruitment of vegetation has occurred along the edges of the constructed creeks.
- However, vegetation cover on the high marsh plain remains sparse.
- SCE is aware of the problem and is evaluating options to address the poor plant establishment in these modules.

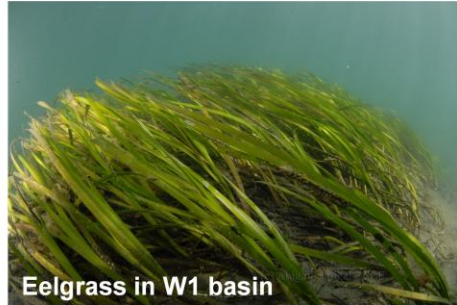
Eelgrass in W1 basin

- Eelgrass recruited to inlet channel and entrance to W1 prior to the final inlet opening in September 2011.
- Eelgrass impacted by final inlet channel construction transplanted to W1 in January 2011.
- Eelgrass now covers ~80% of the bottom in W1.

- Eelgrass, which provides habitat for invertebrates and fish, recruited to the inlet channel and entrance to the basin, W1 prior to the final inlet opening in September 2011.
- Eelgrass impacted by final inlet channel construction was transplanted to W1 in January 2011.
- There has been considerable recruitment of eelgrass.
- Eelgrass now covers ~80% of the bottom in W1.

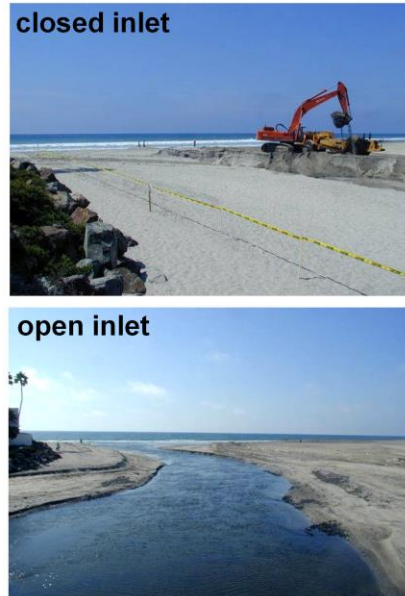
Inlet Maintenance

- Inlet closure can adversely affect dissolved oxygen concentration.
- Partial blockage of the inlet by sand can affect drainage during low tides, leading to ponding.
- SCE has a maintenance plan to keep the inlet open to tidal exchange.

- There are important on-going management tasks associated with ensuring that the restoration project is successful.
- One task concerns inlet maintenance.
- Inlet closure can adversely affect dissolved oxygen concentration in the lagoon.
- Low DO concentrations can lead to invertebrate and fish kills.
- Partial blockage of the inlet by sand can affect drainage during low tides, leading to ponding, and the death of cordgrass, which requires good tidal flushing and cannot tolerate continued submergence..
- SCE has an inlet maintenance plan that will keep the inlet open to avoid degradation in water quality, ponding, and loss of biological resources.

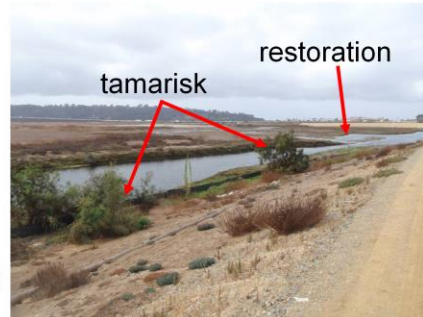
- **Non-native species of plants are present around the edges of the restoration site.**
- **Some non-native species such as tamarisk tolerate high soil salinity and could move into the restoration site.**
- **SCE has an active weed abatement program to control weeds on the berms and disposal sites.**

- Another on-going management task is the control of non-native plants, which are present around the edges of the restoration site.
- Some non-native species such as tamarisk can tolerate high soil salinity and could move into the restoration site.
- Tamarisk has recruited into the restoration site, but was immediately removed.
- SCE has an active weed abatement program to control weeds on the berms.
