Annual Review Workshop for SONGS Wetland Mitigation

May 11, 2015

**SONGS Mitigation Monitoring Project
Marine Science Institute, University of California Santa Barbara**

Wetland Mitigation Linked to the Adverse Effects of the SONGS Cooling Water System

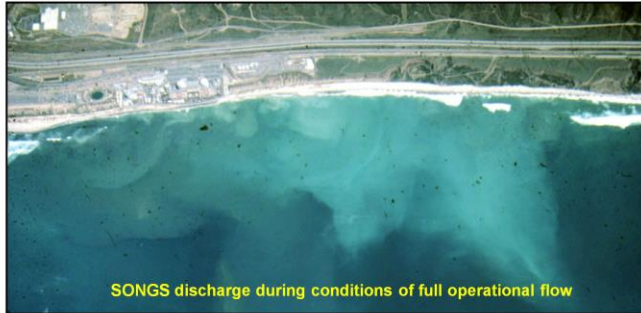
SONGS Units 2 & 3 Intake Flows

Full Operational Flow

- 1287 Million Gallons per Day (MPD) per unit = 2574 MGD total
- Represents total allowable flows

Current Offline Flow

- 49 MGD per unit = 98 MGD total

Projected offline Flow (January 2016)

- 42 MGD

- Under normal operating conditions the flow rate of the cooling water systems of each Unit is about 1300 million gallons per day,
- This amounts to about 2.6 billion gallons a day for both units.
- Since the shutdown, the flow in each unit has been reduced to about 49 million gallons a day or roughly 4% of the normal operating flow.
- Marine impacts caused by SONGS cooling water system are thus expectedly much less under the current flow conditions.

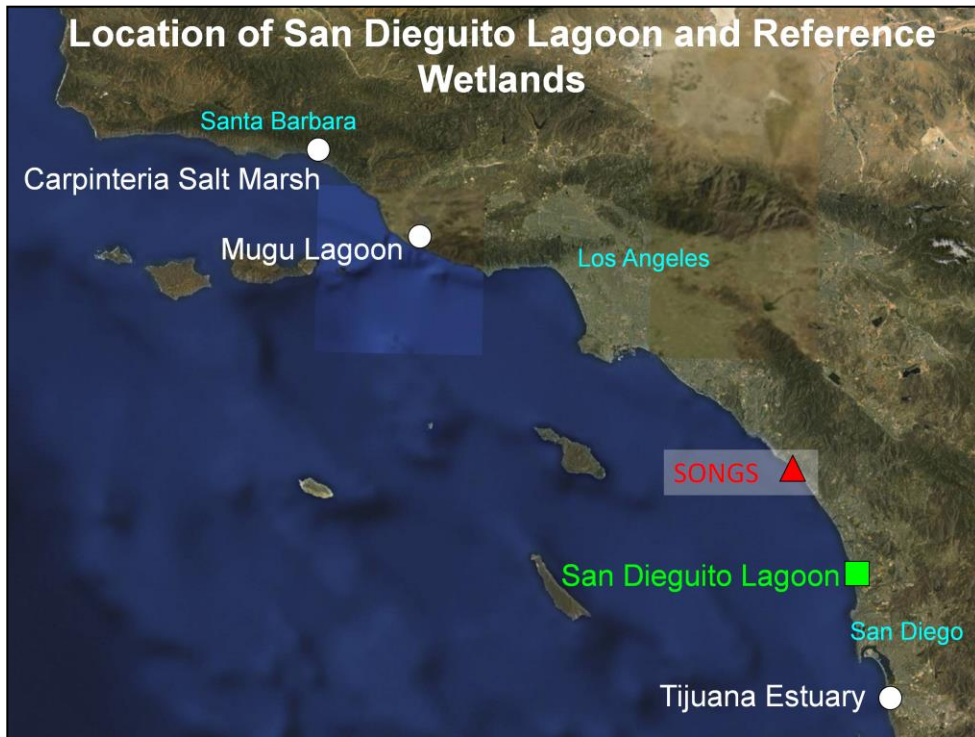
- This map shows the locations of SONGS, the impact site, the San Dieguito Lagoon, site of the San Dieguito Wetlands Restoration Project, and 3 wetlands that are used as reference sites to evaluate the performance of the restoration project: Carpinteria Salt Marsh, Mugu Lagoon, and Tijuana Estuary.

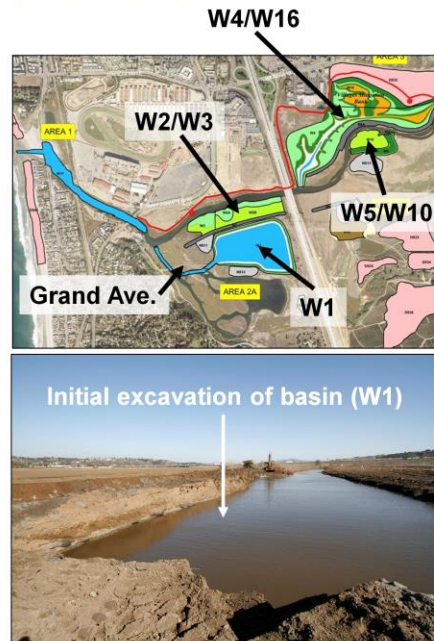
Construction Timeline

Start date	September 2006
Project Task	Completion Date
Construction of:	
W1	January 2008
W4/W16 & W5/W10	December 2008
W2/W3	
Initial grading	February 2008
Tidal creeks	November 2010
Re-grading	March 2014
Berms	February 2009
Additional wetland (Grand Ave)	February 2011
Planting:	
W1	November 2011
W4/W16 & W5/W10	November 2011
W2/W3	November 2009
Final inlet dredging	September 2011

- This slide summarizes the construction timeline.
- Construction began in September of 2006.
- Wetland construction was organized by area and module -- most excavation and grading was completed by 2008, with the addition of tidal creeks in W2/3 completed in November 2010, and re-grading of this area to lower elevations in March 2014.
- Planting of salt marsh plants, including cordgrass, *Spartina* in the low marsh was completed in 2011.
- Final inlet channel dredging was completed in September 2011.
- We've completed the third year of performance monitoring, which is what we will be talking about today.

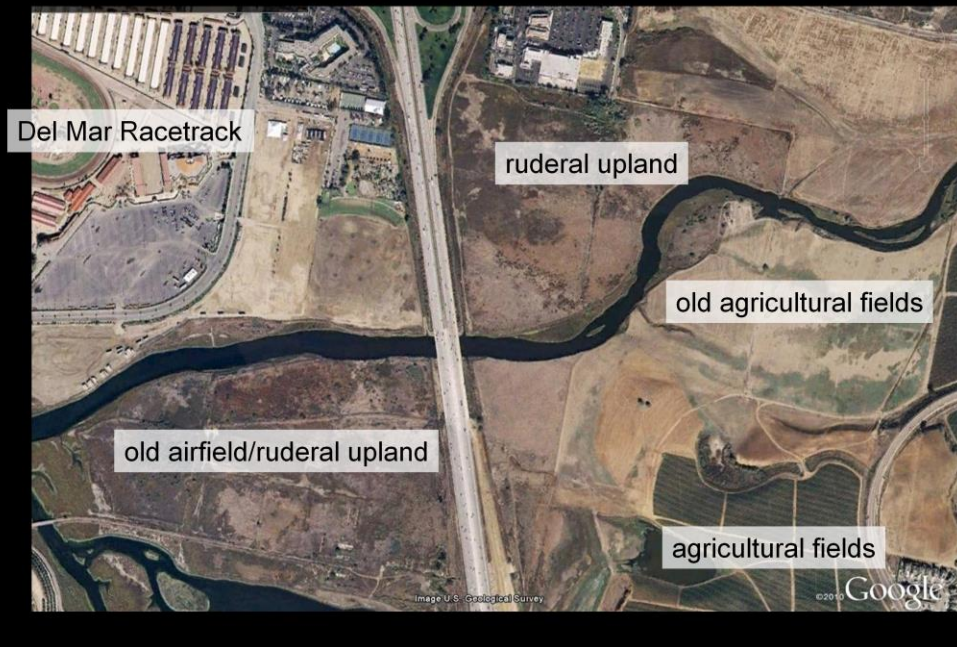
San Dieguito Wetlands before excavation and grading (2003)

- This slide shows a satellite view of the project site before excavation and grading.
- You can see the San Dieguito River and adjoining ruderal upland, including the site of an old WWII airfield, and old agricultural fields.
- You can also see a portion of a basin that was constructed in the 1980's termed the Fish and Game Basin.

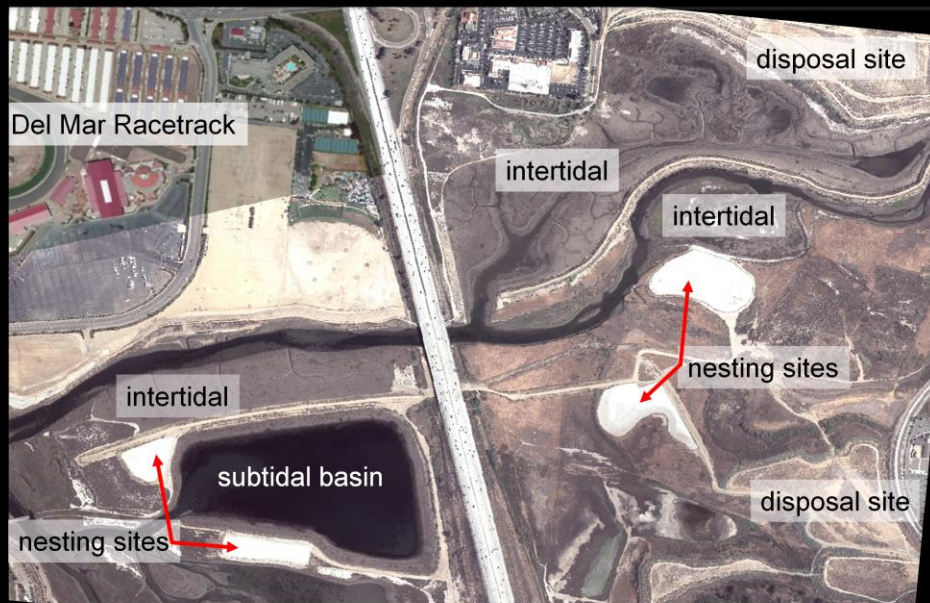
San Dieguito Wetlands (2014)

- During construction, the ruderal areas and old agricultural fields were excavated and graded to create the planned intertidal and subtidal wetland habitats of the restoration project visible in this image taken the past year.

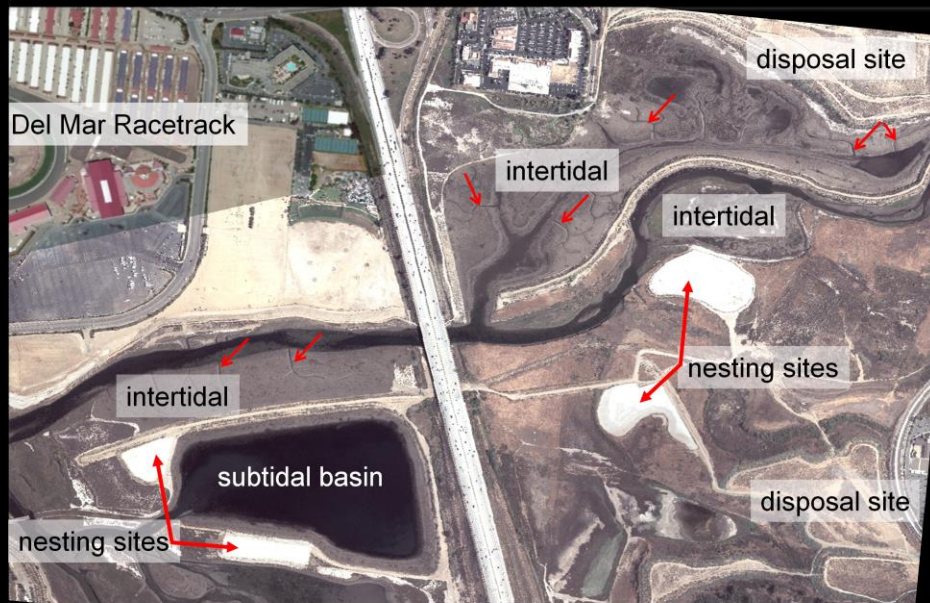
San Dieguito Wetlands (2014)

- Notice also examples of the tidal creek networks located in restoration modules on the west and east side of the freeway.
- In addition, you can see nesting and disposal sites.

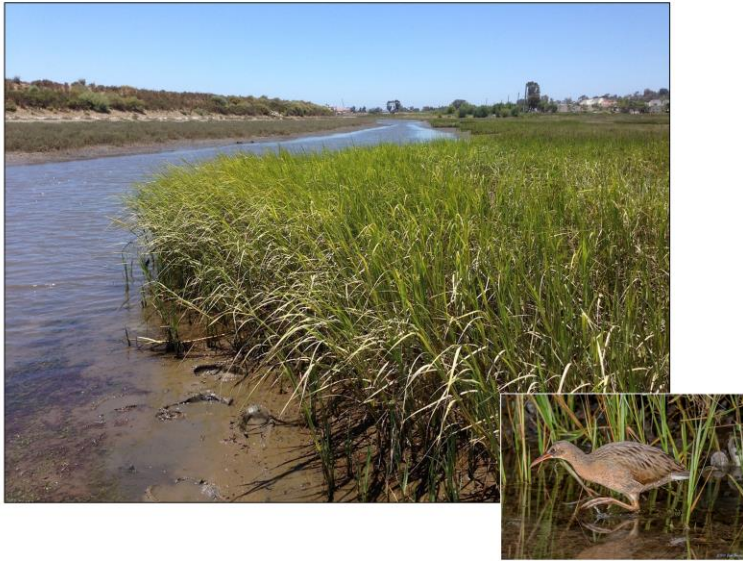
Salt Marsh Vegetation - Cordgrass

- Taking a look at vegetation, cordgrass is important nesting habitat for the Federally listed endangered Light-footed Clapper Rail.

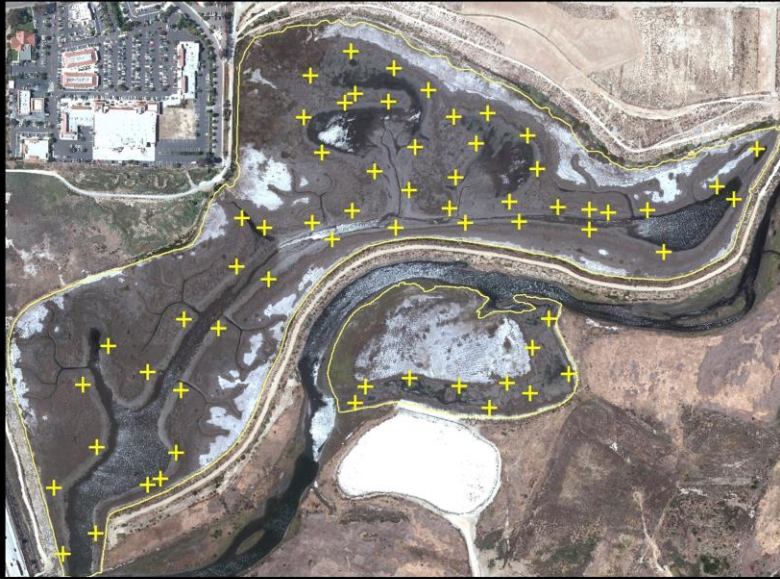
Planting Locations of Cordgrass in San Dieguito Wetlands

+ Cordgrass planted November 2008, April 2009, November 2011

- Cordgrass, about 20,000 plants, was planted widely throughout the restoration site with the latest planting in November 2011.
- This slide shows planting locations, indicated by the yellow crosses in the portion of the wetland on the east side of freeway where most of the planting occurred.

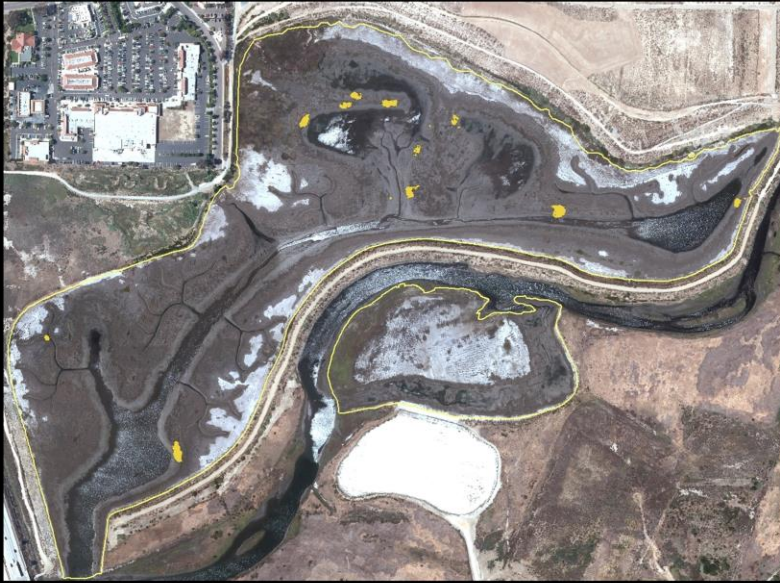
Cordgrass patches 2013

- For the first couple of years following planting, cordgrass performed poorly.
- You can see the distribution and size of cordgrass patches that became established, scattered in the portion of the restoration site on the east side of the freeway in 2013.

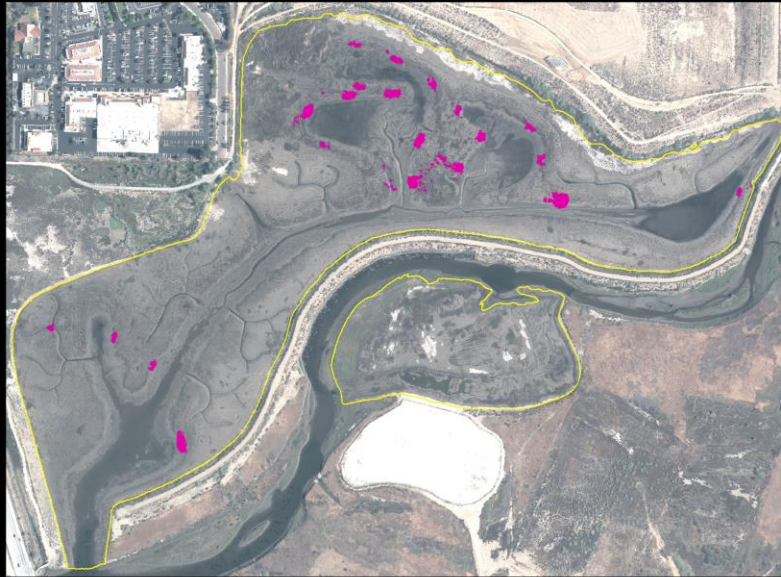
Cordgrass patches 2014

- However, cordgrass establishment has become more promising. This slide for 2014 shows the distribution and size of cordgrass patches has expanded over the past year and now encompasses over 1.1 acres for the restored site.

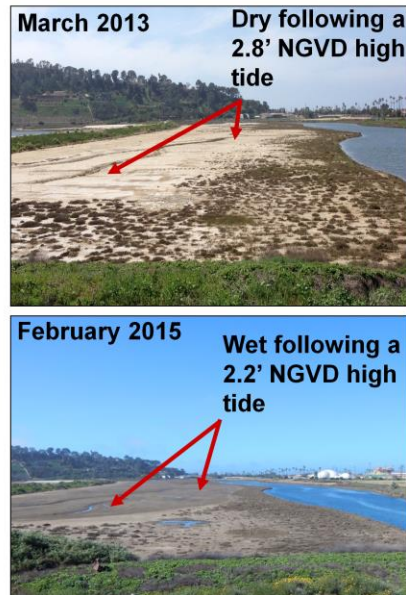
Salt Marsh Vegetation Adaptive Management

- Salt marsh vegetation has underperformed in portions of the restoration site.
- Monitoring has identified high tidal elevation and poor drainage as the cause of sparse vegetation.
- SCE has re-graded some of these areas lower to increase tidal inundation and improve drainage.

- While the development of vegetation has been promising in some areas, it has under performed in other portions of the restoration site, most noticeably on the west side of the freeway.
- In the top photo, taken in March 2013, you can see pickleweed that has colonized lower elevations, while the higher elevations were bare.
- This area remained exposed following a 2.8' NGVD high tide.
- Monitoring suggested that high elevation of the marsh plain and poor drainage were the cause of sparse vegetation in this area
- SCE was aware of this problem, and the area on the west side of the freeway was re-graded in March of last year to lower elevation of the marsh plain to increase the frequency of inundation, and re-contoured to improve drainage, which should lead to the establishment of vegetation.
- You can see in the bottom figure that this area is now wetted by even lower high tides.

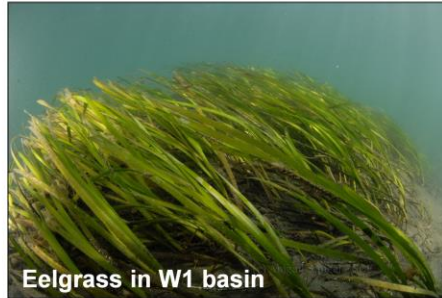
Eelgrass in W1 basin

- Eelgrass recruited to inlet channel and entrance to the W1 basin prior to the final inlet opening in September 2011.
- Eelgrass removed for final inlet channel construction was transplanted to W1 in January 2011.
- Eelgrass covered ~80% of the bottom in W1 in 2013 and continues to cover most of the bottom in 2014.

- Eelgrass, which provides habitat for invertebrates and fish, recruited to the inlet channel and entrance to the basin, W1 prior to the final inlet opening in September 2011.
- Eelgrass removed for final inlet channel construction was transplanted to W1 in January 2011.
- There also has been considerable recruitment of eelgrass.
- Eelgrass covered ~80% of the bottom of the W1 basin in 2013, and continues to cover most of the bottom in 2014.

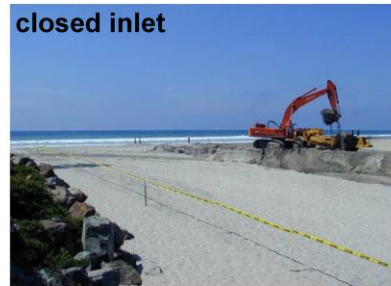
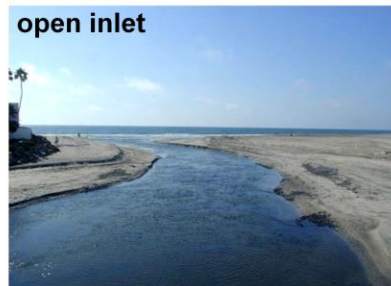
Inlet Maintenance

- Inlet closure can adversely affect dissolved oxygen concentration.
- Partial blockage of the inlet by sand can affect drainage during low tides, leading to ponding.
- SCE has a maintenance plan to keep the inlet open to tidal exchange.
- Maintenance dredging of the inlet is scheduled for October 2015.

- There remain important on-going management tasks associated with ensuring that the restoration project is successful.
- One task concerns inlet maintenance.
- By halting tidal flushing, inlet closure can adversely affect dissolved oxygen concentration in the lagoon and lead to invertebrate and fish kills.
- Even partial blockage of the inlet by sand can affect drainage during low tides, leading to ponding, and the death of cordgrass, which requires good tidal flushing and cannot tolerate continued submergence.
- SCE has an inlet maintenance plan that will keep the inlet open to avoid degradation in water quality, ponding, and loss of biological resources.
- Maintenance dredging of the inlet is scheduled for mid October 2015.

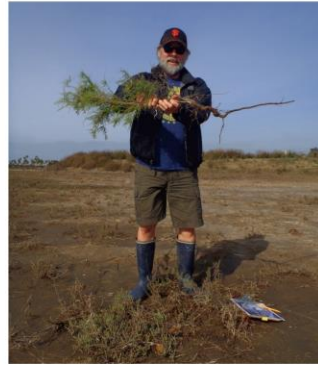
Non-native Species

- **Non-native species of plants are present around the edges of the restoration site.**
- **Some non-native species such as tamarisk tolerate high soil salinity and can move into the restoration site.**
- **SCE has an active weed abatement program to control weeds on the berms and disposal sites.**

- Another on-going management task is the control of non-native plants, which are present around the edges of the restoration site.
- Some non-native species such as tamarisk can tolerate high soil salinity and could move into the restoration site.
- SCE has an active weed abatement program to control weeds on the berms.
