**Annual Report of the Status of Condition A:  
Wetland Mitigation**

**SAN ONOFRE NUCLEAR GENERATING STATION (SONGS)  
MITIGATION PROGRAM**

*Submitted to the California Coastal Commission  
July 2017*

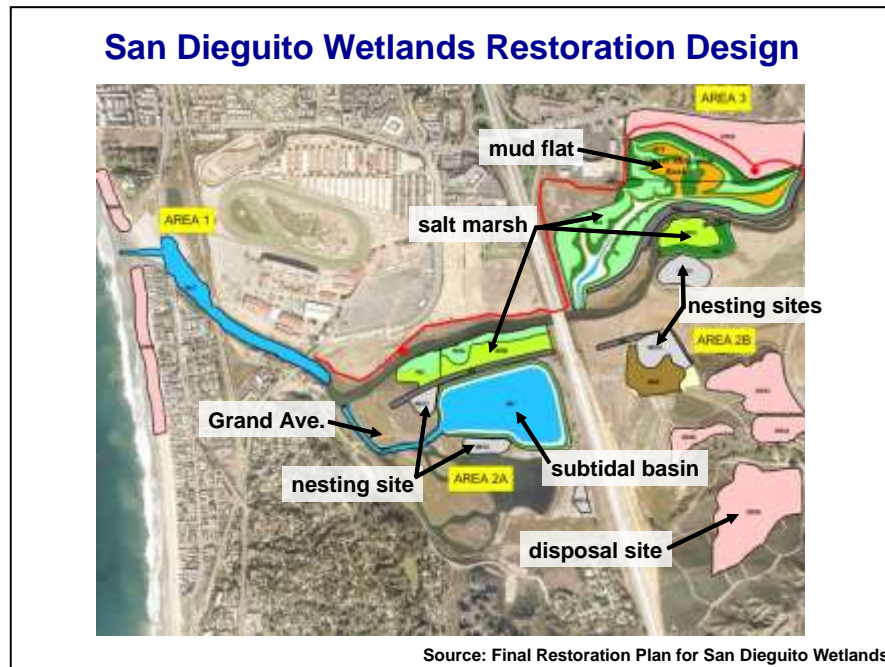
Figure 3.1.1. The design plan view of the restoration project that was approved by the CCC. The project included the creation of tidal salt marsh, indicated by shades of green, mudflat, indicated by the light brown, and subtidal basin, indicated by blue. In addition, four nesting sites, shown in gray, were constructed, which were not part of the SONGS mitigation requirement. The areas in pink are disposal sites. Dark gray linear features are berms along the effective flow area of the San Dieguito River. The yellow boxes that indicate Areas 1, 2a, 2b, and 3 pertain to the staging of construction activities.

Construction began in September of 2006 with most excavation and grading completed by the end of 2008 (Fig. 3.1.2, 3.1.3ab). Construction of the large subtidal and intertidal basin (44 acres) in Area 2A west of Interstate 5 commenced in December 2006 and was completed with the opening to tidal exchange in January 2008. Construction of wetland habitat commenced in other areas within the restoration site in April 2007. This included modules on the east side of Interstate 5, both north (Area 3) and south (Area 2B) of the San Dieguito River that were graded to create high and middle salt marsh and intertidal mud flat habitat. Excavation and grading, including the construction of tidal creek networks, was completed in Area 3 and these areas were opened to tidal exchange in December 2008. Excavation and grading of Area 2B was also completed in December 2008. Initial grading of

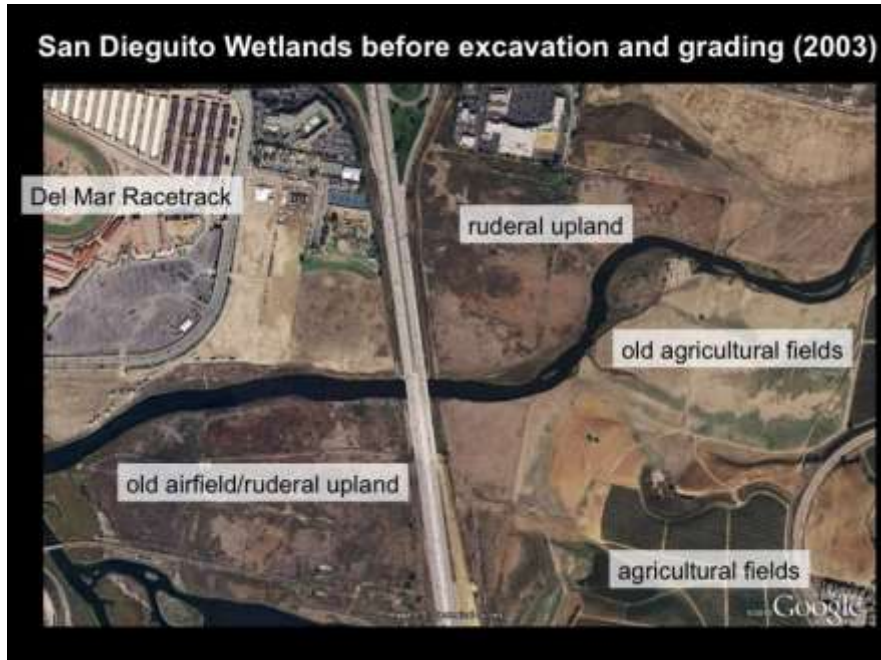
Figure 3.1.3a. Satellite view of the project site before excavation and grading. Highlighted is the San Dieguito River and adjoining ruderal upland, including the site of an old WWII dirigible airfield, old agricultural fields, and a portion of the Fish and Game Basin constructed in 1978 visible at the bottom of the image.

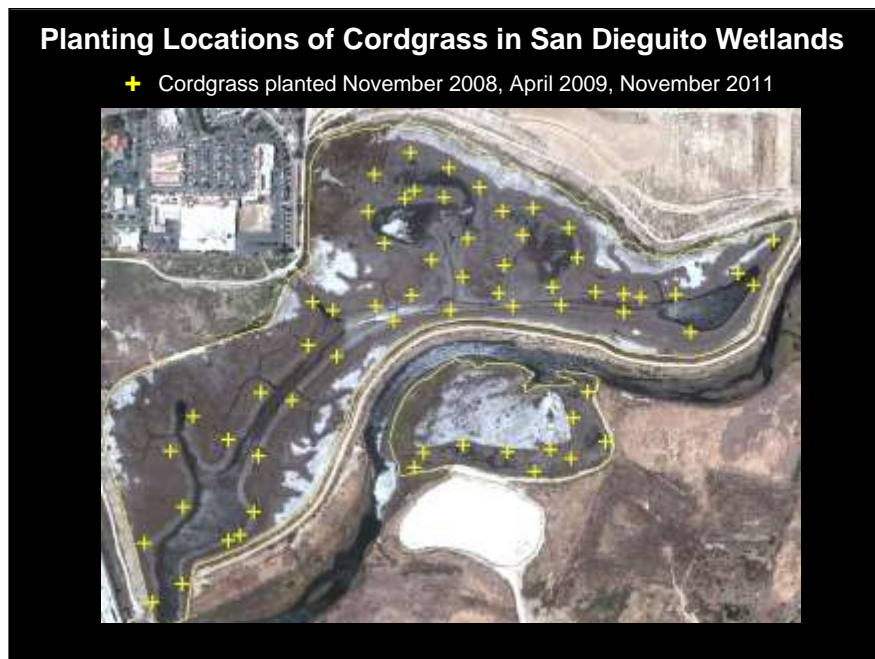
Figure 3.2.1. Planting locations, indicated by the yellow crosses in the portion of the wetland on the east side of freeway where most of the planting occurred.

About 20,000 cordgrass plants were planted widely throughout the restoration site with the latest and largest planting in November 2011 (Fig. 3.2.1). For the first couple of years following planting, cordgrass performed poorly (Fig. 3.2.2a). The total area of cordgrass in 2013 was less than 0.5 acre.

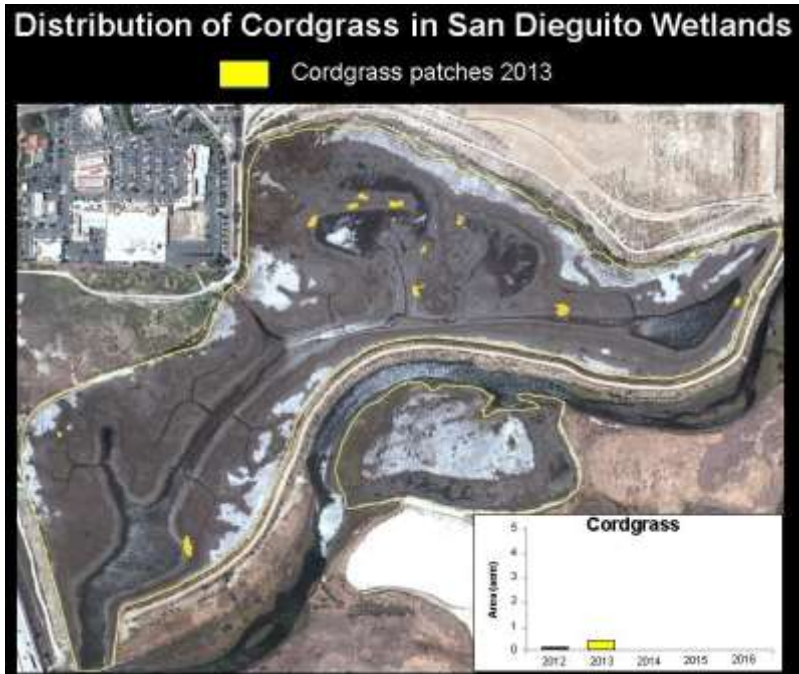
Figure 3.2.2a. The distribution and size of cordgrass patches established in the portion of the restoration site on the east side of the freeway in 2013.

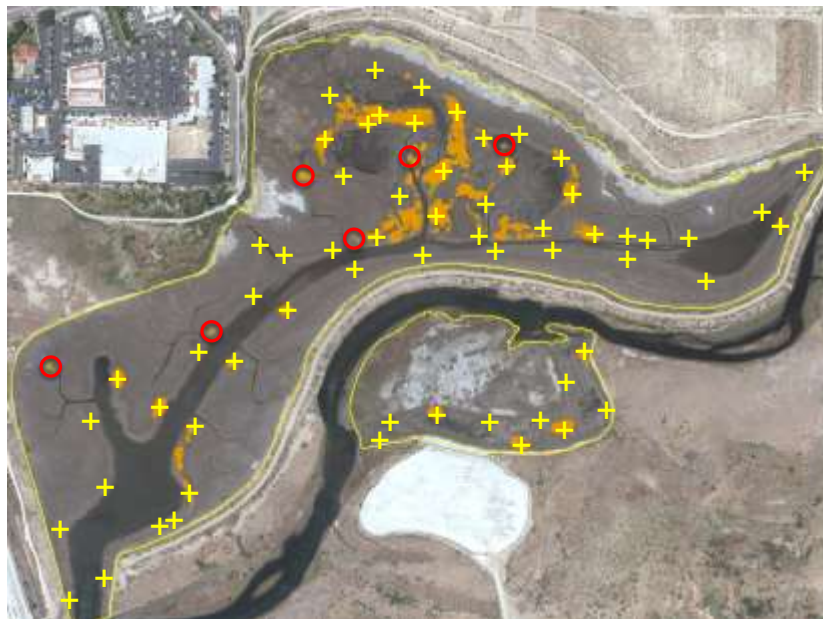
Figure 3.2.2d. The location of current patches relative to the original planting sites and to some locations not originally planted (circled in red).

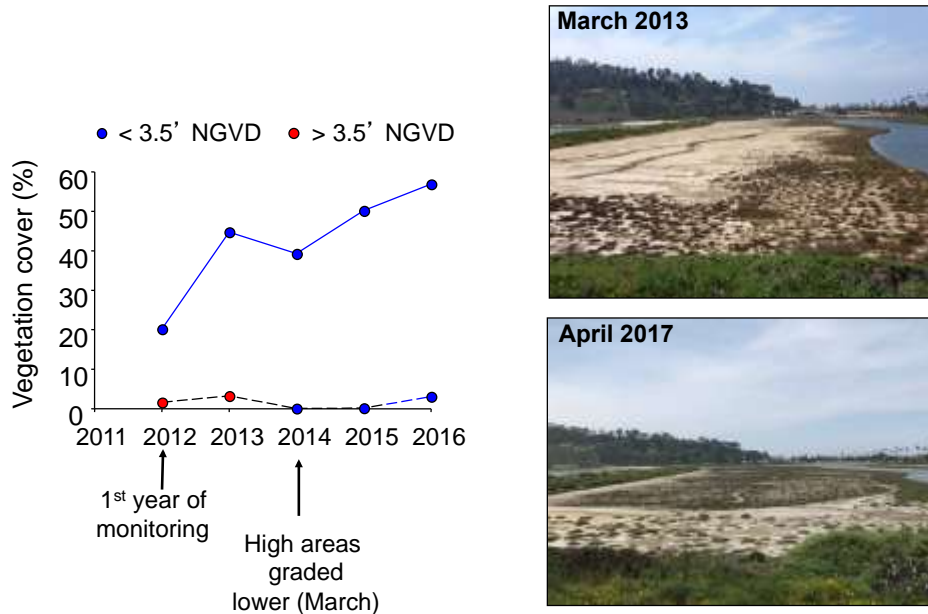
Figure 3.2.3. Panel on the upper right shows much greater vegetation cover at lower tidal elevations near the river channel in module W2/3 in March 2013 compared with areas graded higher. Panel on the lower right shows this area in April 2017. Re-grading in March 2014 lowered the elevation of the marsh plain to generally < 3.5' NGVD and re-contoured the surface to improve drainage. Vegetation development remains poor in areas not re-graded (foreground).

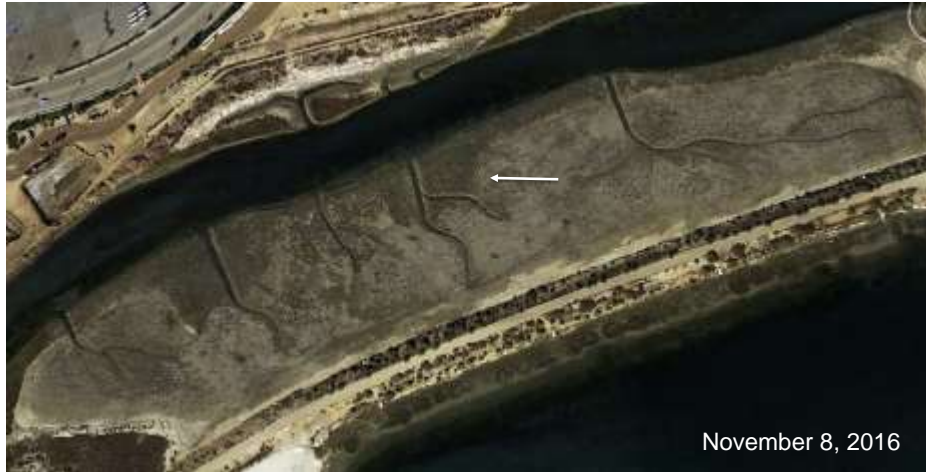
Figure 3.2.4. Vegetation cover was highest in furrows created during construction at lower elevations.

In addition to the importance of elevation, drainage, and time to vegetation establishment, smaller scale heterogeneity has influenced vegetation development. Furrows created during construction are more vegetated than adjacent higher areas (Fig. 3.2.4). It is possible that the furrows retain moisture or trap seeds, and topographic heterogeneity is something to consider during construction or re-grading.

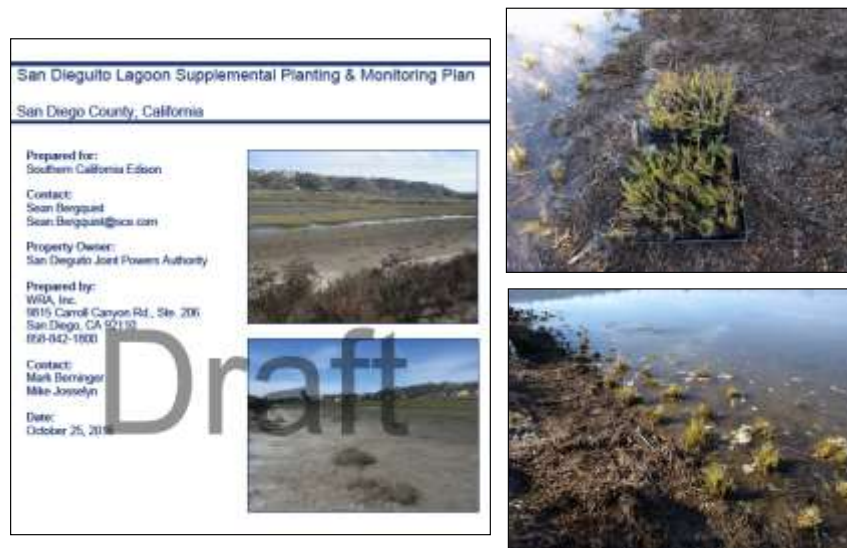
Figure 3.2.6. Adaptive management to improve the establishment of vegetation is on-going through a planting program targeting high areas of low vegetation cover.

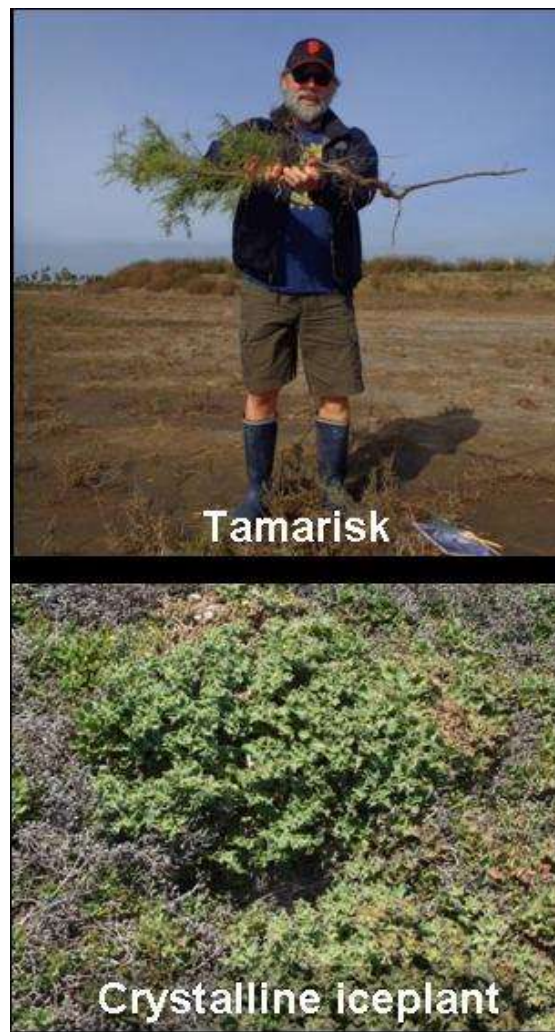
Figure 3.4.1. Tamarisk is a non-native plant that can invade salt marsh habitat. Crystalline iceplant is tolerant of salty soils and abundant in some areas on berms surrounding the restored wetland.

Another on-going management task pertains to the control of non-native plants, which are present around the edges of the restoration site. Some non-native species such as Tamarisk and Crystalline Iceplant can tolerate high soil salinity and could move into the restoration site (Fig. 3.4.1). A Tamarisk plant was recently removed from tidally influenced habitat by CCC contract scientists. Continued vigilance is necessary to ensure that non-native species do not invade tidally influenced habitat. SCE currently has an active weed abatement program to control weeds on the berms and disposal sites.

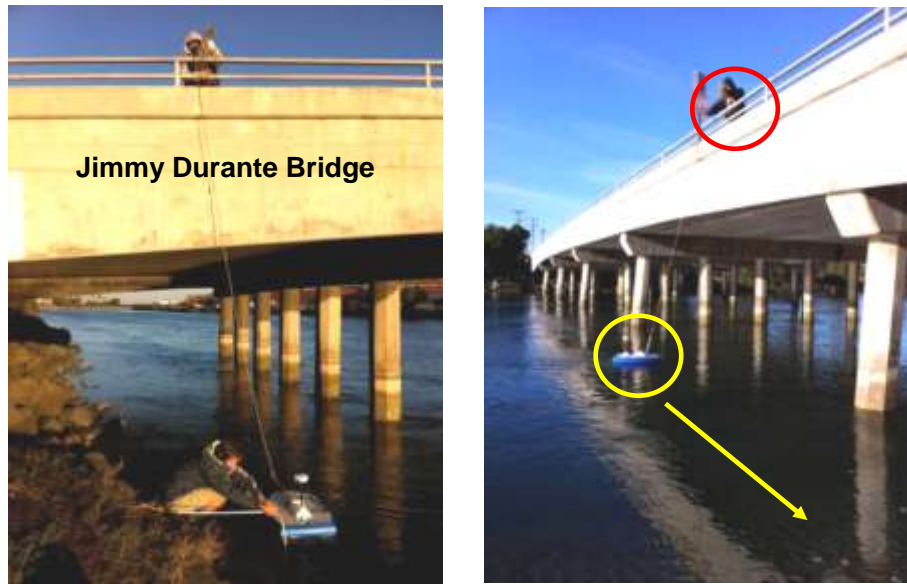
**River Surveyor--Acoustic Doppler Current Profiler (ADCP)**

Figure 5.1.1. Measurements of tidal flows are taken at Jimmy Durante Bridge (0.9 km from the inlet) using a portable Acoustic Doppler Profiler/discharge measurement system that is towed back and forth across the width of the channel every 15 minutes during an incoming tide.

Approach: The tidal prism standard, as an absolute standard, is evaluated only to the San Dieguito Wetlands restoration. The tidal prism is the amount of water that flows into and out of an estuary with the flood and ebb of the tide, excluding any contribution from freshwater inflows (Hume 2005). Numerical modeling suggested that after restoration, the tidal prism in the lagoon would increase. However, predictions of tidal prism from this modeling are likely to differ from actual values for the as-built wetland since they do not include the effects of friction, which could contribute to a smaller than predicted tidal prism and are not based on the actual as-built topography. Therefore, the tidal prism of the restored wetland was measured in July 2012 following completion of construction and is used as the standard of comparison to detect changes in this performance variable during subsequent monitoring.

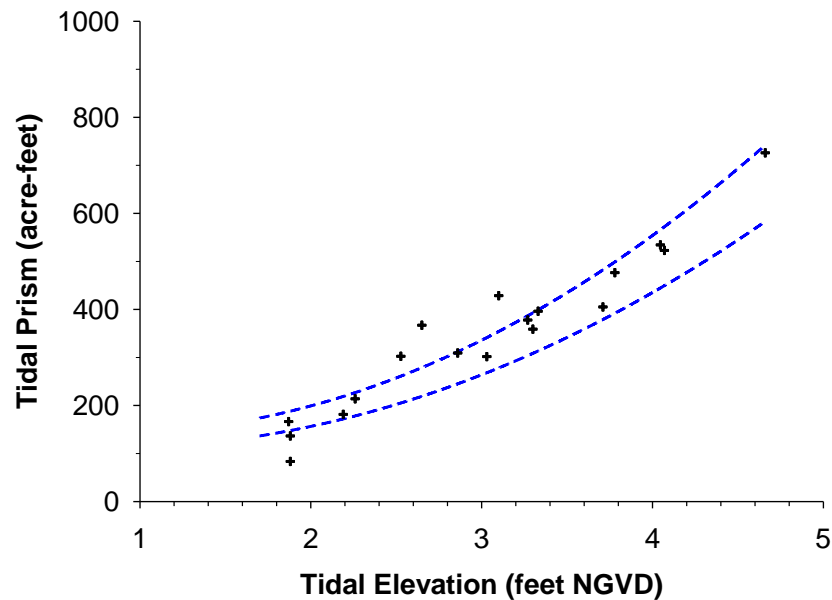
Figure 5.1.2. The regression fit to the tidal prism measurements taken January-December 2016 must fall within the dashed blue lines, which represent 88% and 112% of the as-built prism, for the tidal prism to be maintained.

Since tidal prism can influence the area of wetland habitat inundated by the tides, the tidal prism standard is evaluated, in part, using criteria set forth in the habitat areas standard, which provides that the areas of the different habitats (subtidal, intertidal mudflat, vegetated salt marsh) shall not vary by more than 10%. The planned tidal volume-elevation relationship indicated that a decrease in tidal prism of greater than 12% could result in a reduction in the area of tidally inundated planned salt marsh habitat (1.3 to 4.5' NGVD) of greater than 10%. Since the area of planned intertidal salt marsh habitat may not differ by more than 10% from the as-built area (see section Habitat Areas below), the tidal prism can not be less than 88% of the as-built prism to ensure no more than 10% of planned salt marsh habitat remains exposed during a 4.5' tide. However, since a larger than planned tidal prism could potentially increase erosion within the restored wetland, the prism shall also not be larger than 112% of the as-built prism.

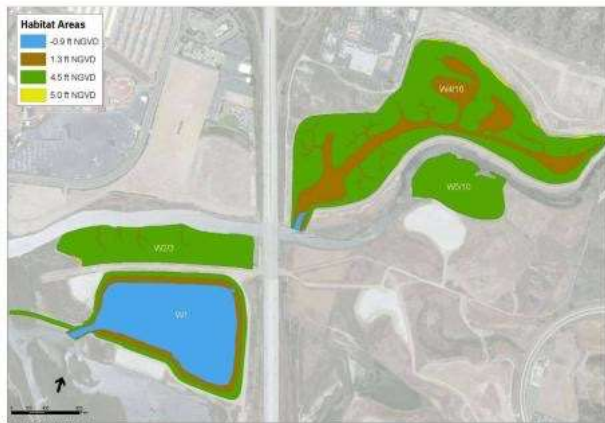
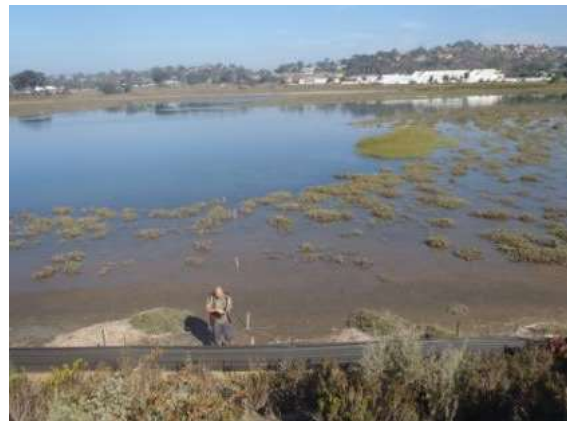
**Planned acres\*:**

**Salt marsh:** green 92.6 acres  
**Mudflat:** brown 24.9 acres  
**Subtidal:** blue 32.0 acres

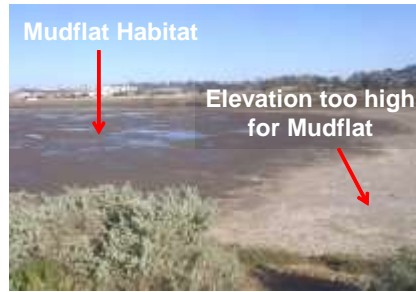
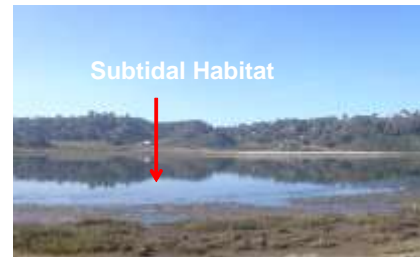
**Assessed as Mudflat Habitat if:**

- Intertidal and  $\leq 3.5'$  NGVD
- $< 5\%$  cover of vegetation (mudflats are defined as intertidal and unvegetated)

**Assessed as Subtidal Habitat if:**

- Continuously submerged

Figure 5.1.4. Criteria used to classify areas of the restoration project as mudflat and subtidal habitat.

Subtidal habitat is defined as continuously submerged. Mudflat habitat is defined as intertidal, occurring lower than 3.5' NGVD to provide for frequent tidal inundation, and as sparsely vegetated (< 5% cover of vegetation) since mudflats are by definition unvegetated (Fig. 5.1.4). The upper elevation limit for mudflat was based on the observation of surface salt deposits above this level in some areas indicating infrequent tidal inundation. The lower elevation was determined using continuously recording data loggers that measure water level height in a restored portion of the wetland. Salt marsh habitat is defined as intertidal, occurring at or below 4.5' NGVD, the upper elevation limit of tidally influenced habitat for this project, with at least 30% cover of salt marsh plants in a minimum plot size of 10 x 10 m<sup>2</sup> (Fig. 5.1.5). This minimal cover of vegetation will provide perches and bare space for foraging of the State listed endangered Belding's Savannah Sparrow and other species. Elevation contours at 3.5' and 4.5' NGVD are determined using a Real Time Kinematic (RTK) global positioning system (GPS) with a vertical and horizontal accuracy of a few centimeters (typically < 3 cm). Habitats are assessed within 10 x 10 m<sup>2</sup> plots superimposed on multispectral aerial images of the restoration site taken annually in late spring to early summer. The acreages of subtidal, mudflat, and salt marsh habitats are computed with the aid of ArcMap and ArcGIS software and compared to the planned acreages in the Final Plan to determine whether they are within 10% of planned values.

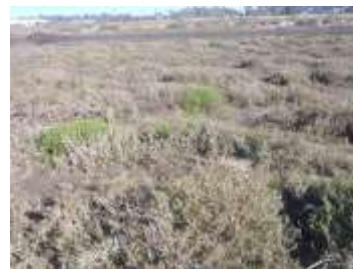
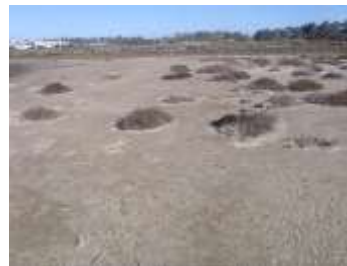
**Habitat assessed as Salt Marsh if:**

- Intertidal and  $< 4.5'$  NGVD
- $\geq 30\%$  cover of vegetation evaluated using aerial imagery

Insufficient cover of vegetation for Salt Marsh

Figure 5.1.5. Criteria used to classify portions of the restoration project as salt marsh habitat, and examples of an area assessed as salt marsh habitat and an area where cover of vegetation was insufficient to be assessed as salt marsh.

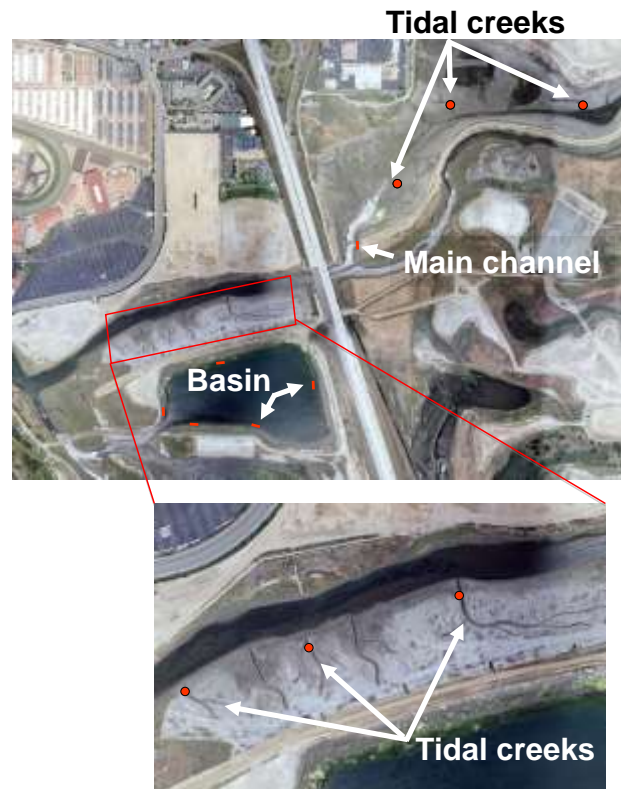
Figure 5.2.2. Location of tidal creeks and sections of main channel and basin sampled in San Dieguito Wetlands.

San Dieguito Wetlands and the three reference wetlands are sampled in the early fall in order to avoid the nesting season of the California Least Tern. Six tidal creeks and six sections of main channel/basin are sampled in each wetland (Fig. 5.2.2). A potential concern for the monitoring design was that basins of the type constructed in the San Dieguito Wetlands Restoration do not occur naturally in southern California wetlands, and thus cannot be compared to natural reference sites. However, data collected by Marine Ecological Consultants (1993) on fish abundance from different habitats at San Dieguito Lagoon prior to restoration found that fish assemblages were similar in basin and main channel habitats and thus it is biologically reasonable to treat the constructed basin as main channel habitat in post-construction monitoring. The sampled creeks or sections of main

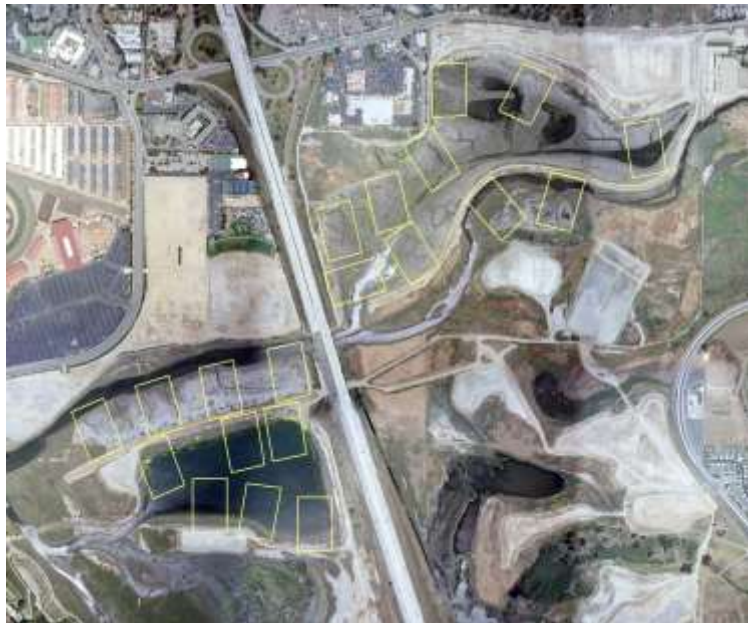
Figure 5.2.7. Distribution of the 20-100 x 150 m bird sampling plots in the San Dieguito Wetlands.

Approach: Birds are sampled by walking within clear viewing distance (using binoculars or spotting scope) of 20 replicate rectangular plots of 100 x 150 m spread throughout the wetlands (Fig. 5.2.7 shows distribution of plots in the San Dieguito Wetlands) and visually identifying and counting all birds sighted within each plot. The time spent identifying and counting birds within each plot is five minutes to standardize sampling effort. Bird sampling is conducted during the same period of the tide cycle (falling and low tide) to reduce the potential effects of this variable on bird abundance. All wetlands are sampled within a few days of one another to reduce the potential effects of weather, and other factors that might vary among wetlands over time, on bird density and species richness.

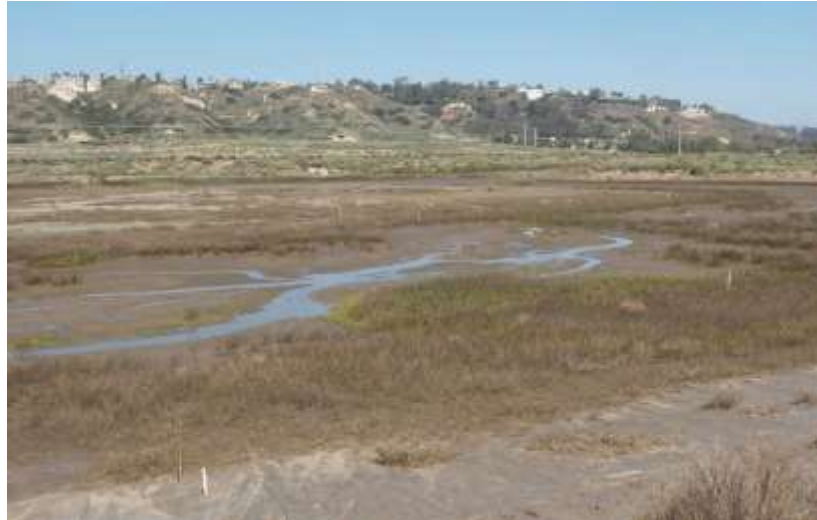
Figure 5.2.10. View of San Dieguito Wetlands modules W5 & W10 in March 2016 showing cordgrass (in center) and mudflat below it.

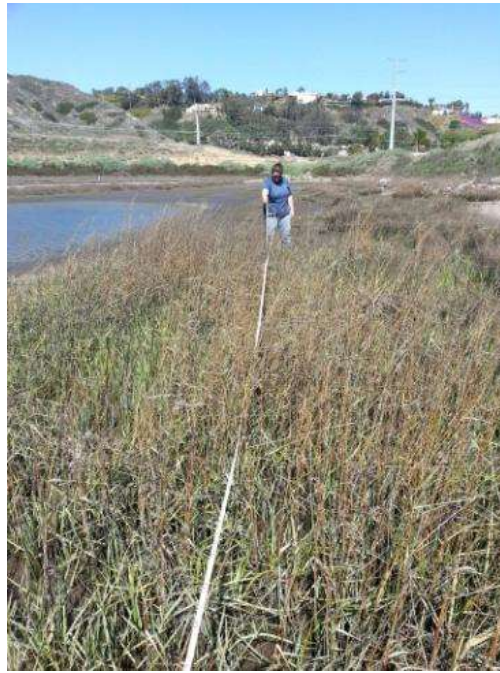
Figure 5.2.13. View of sampling transect overlying a patch of cordgrass in module W4. Cordgrass is sampled in 0.1 m<sup>2</sup> quadrats placed every two meters along the 20 m long transect line.
