Salt Marsh Vegetation Lessons Learned and Adaptive Management

San Dieguito Wetlands
March 2016

Salt Marsh Vegetation - Cordgrass Lessons Learned

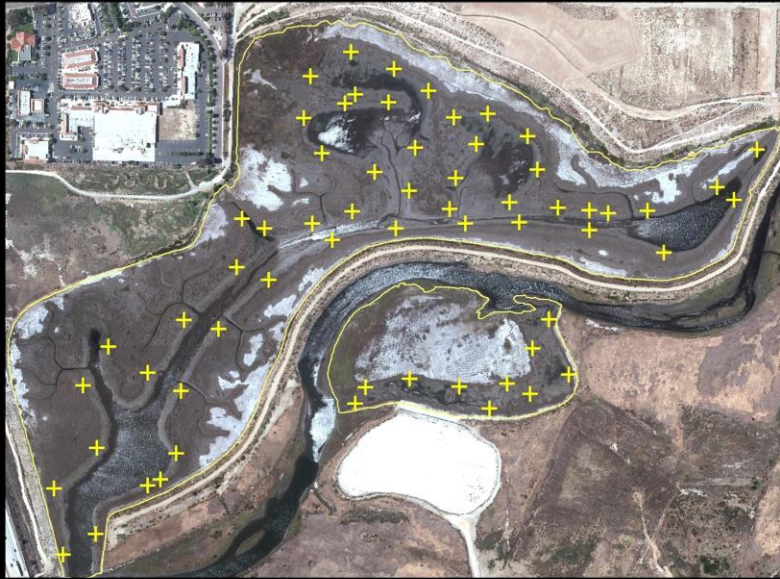
Planting Locations of Cordgrass in San Dieguito Wetlands

+ Cordgrass planted November 2008, April 2009, November 2011

- Cordgrass, about 20,000 plants, were planted widely throughout the restoration site with the latest and largest planting in November 2011.
- This slide shows planting locations, indicated by the yellow crosses in the portion of the wetland on the east side of freeway where most of the planting occurred.

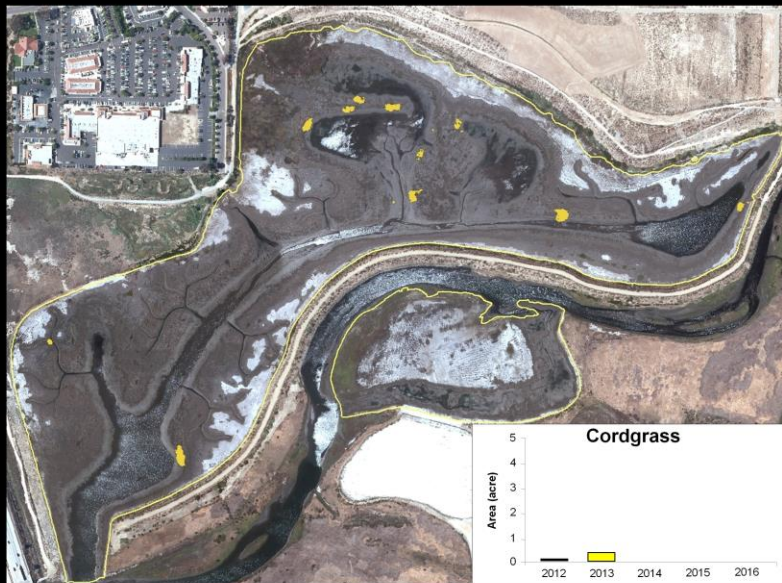
Distribution of Cordgrass in San Dieguito Wetlands

■ Cordgrass patches 2013

- For the first couple of years following planting, cordgrass performed poorly.
- You can see the distribution and size of cordgrass patches that became established, scattered in the portion of the restoration site on the east side of the freeway in 2013.
- The total area of cordgrass in 2013 was less than 0.5 acre 2 years after the last planting.

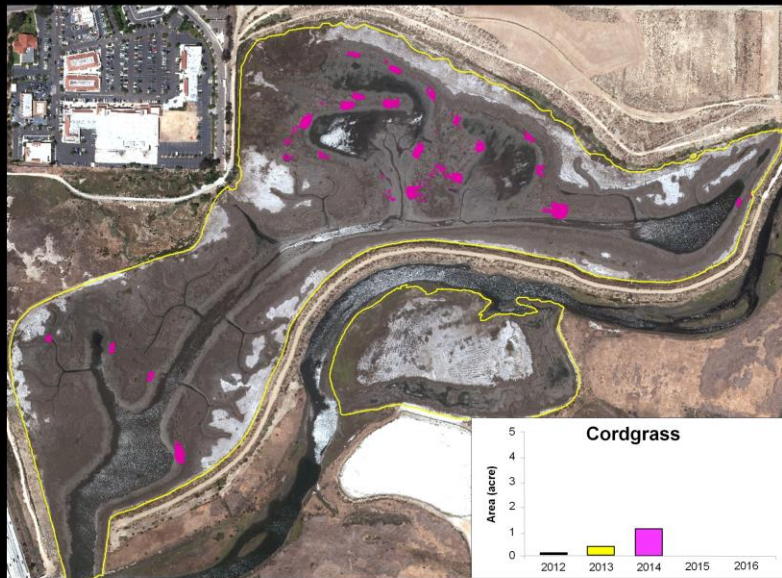
Distribution of Cordgrass in San Dieguito Wetlands

■ Cordgrass patches 2014

- However, cordgrass establishment become more promising in 2014.
- This shows that the distribution and size of cordgrass patches had expanded in 2014 to encompass about 1.2 acres for the restored site.

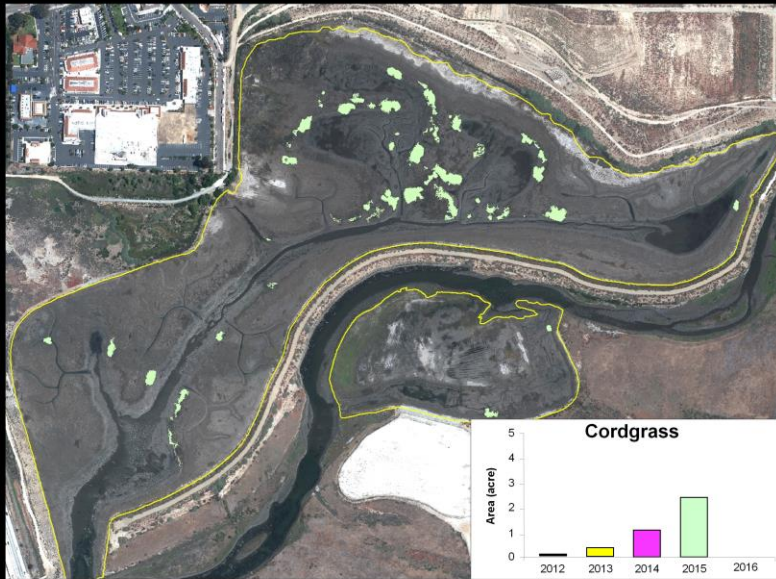
Distribution of Cordgrass in San Dieguito Wetlands

Cordgrass patches 2015

- The area of cordgrass continued to expand and encompassed about 2.5 acres for the restored site in 2015 .

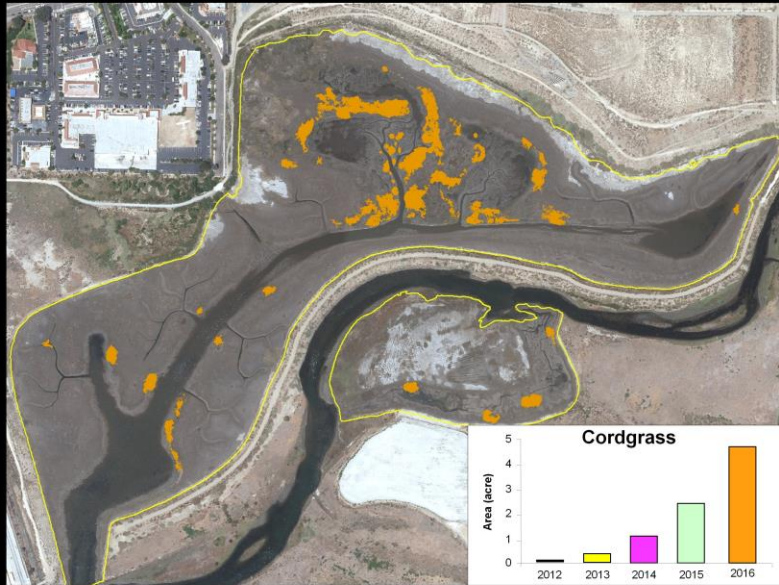
Distribution of Cordgrass in San Dieguito Wetlands

+ Planted cordgrass

■ Cordgrass patches 2016

- Currently, monitoring this past year revealed that the area of cordgrass is nearly 5 acres for the restored site.
- It's currently expanding into area that was planned mudflat in the Final Restoration Plan.
- Although there was initial concern that the plantings might not lead to cordgrass establishment, and we were worried about rabbit and insect grazing, one lesson learned is that may take time, > 2-3 years for it to become visibly established following planting.

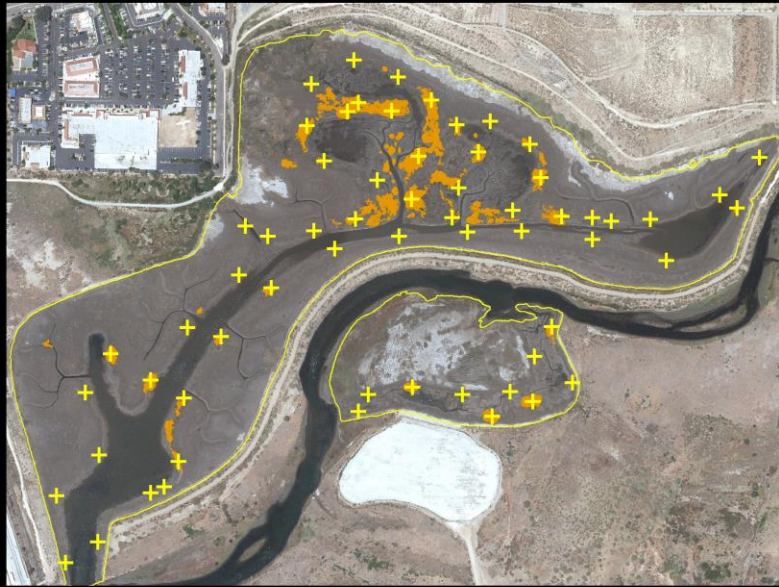
Distribution of Cordgrass in San Dieguito Wetlands

+ Planted cordgrass

■ Cordgrass patches 2016

- This slide shows the location of current patches relative to the original planting sites.
- You can see that the cordgrass has spread away from the original planting sites, but that it also has recruited to a few sites that were not planted.
- This is worth noting because the natural recruitment of *Spartina* by seed is generally thought to be rare.

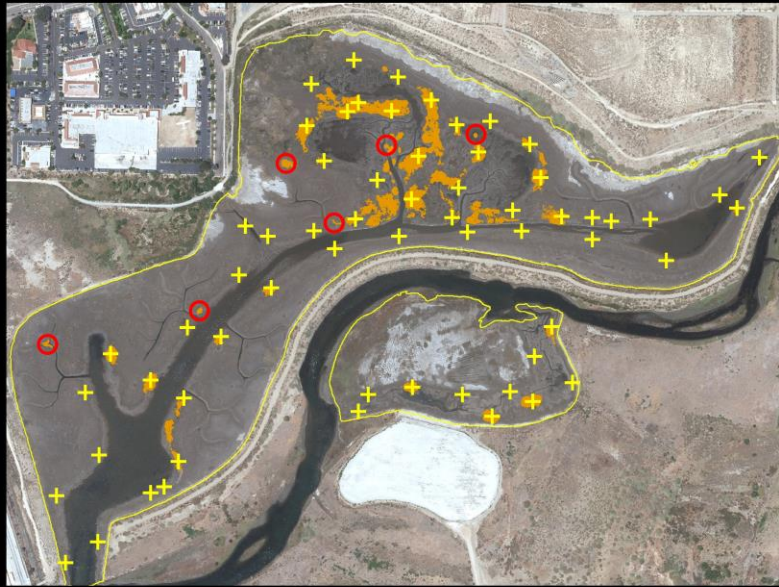
Distribution of Cordgrass in San Dieguito Wetlands

+ Planted cordgrass

■ Cordgrass patches 2016

- This slide shows the location of current patches relative to the original planting sites.
- You can see that the cordgrass has spread away from the original planting sites, but that it also has recruited to a few sites that were not planted.
- This is worth noting because the natural recruitment of *Spartina* by seed is generally thought to be rare.

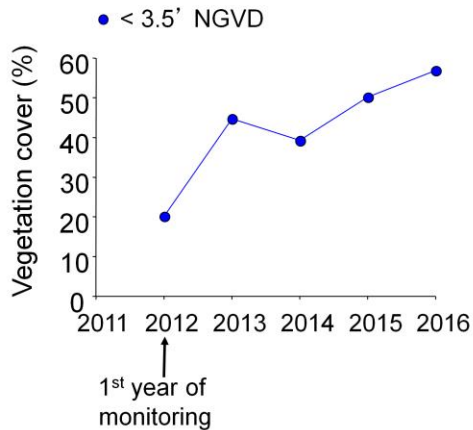
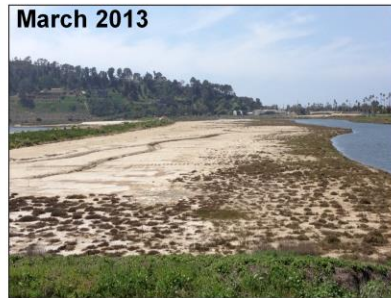
Elevation, Drainage, and Time Important to Vegetation Establishment

Vegetation cover vs. year at lower elevations

Construction grading of W2/3 low areas completed in 2008-2010

- Performance monitoring has revealed that elevation, drainage and time are important to vegetation establishment in SDW.
- Construction grading of module W2/3 on the west side of the freeway was completed in 2008 – 2010.
- Performance monitoring of the San Dieguito Wetlands Restoration Project began in 2012.
- The cover of vegetation at lower elevations of < 3.5' has increased steadily over time.
- Photo shows vegetation cover at lower elevations as it appeared in 2013.

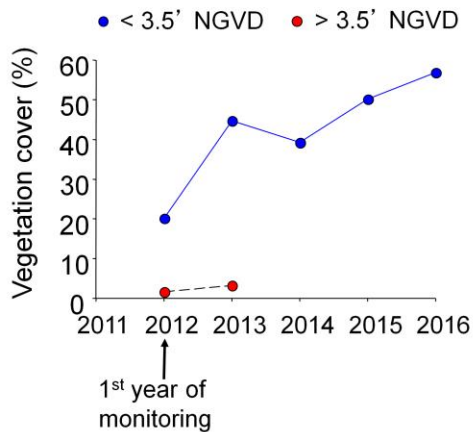
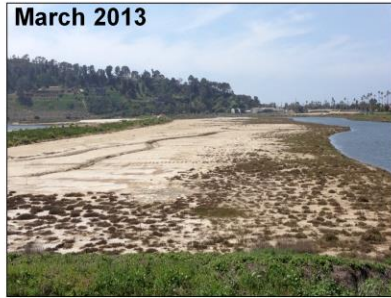
Elevation, Drainage, and Time Important to Vegetation Establishment.

Vegetation cover vs. year at lower and higher elevations

March 2013

Construction grading of W2/3 low areas completed in 2008-2010

- However, vegetation was much slower to develop in the first two years of monitoring, indicated by the red dots, at elevations initially graded higher than ~3.5' and that were relatively flat.
- This area of sparse vegetation is very evident in the 2013 photograph.

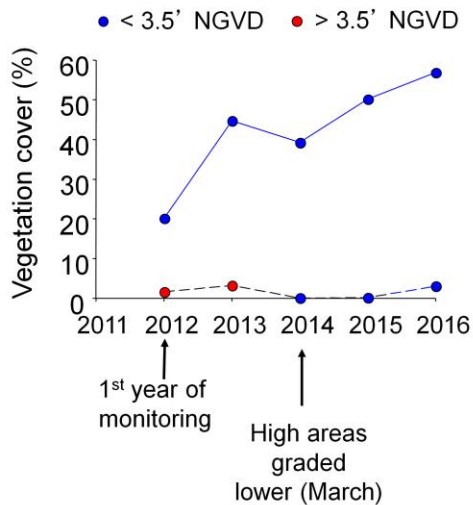
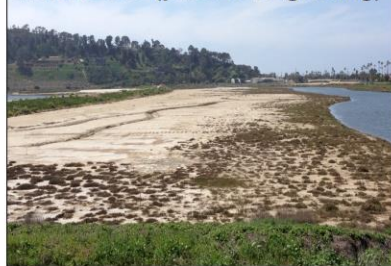
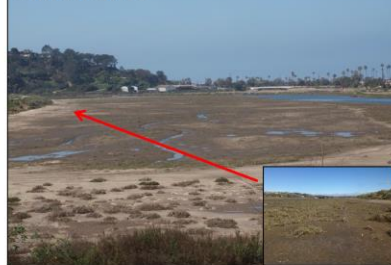
Elevation, Drainage, and Time Important to Vegetation Establishment

Vegetation cover vs. year at lower and higher elevations

March 2013 (prior to re-grading)

March 2016

- SCE was aware of the problem and much of the higher elevations in this module were re-graded to lower elevations, indicated by the blue dots, with more slope in March 2014.
- Some seedlings were present in 2015, and some vegetation was present in the re-graded areas in 2016, but cover generally remained sparse in 2016.

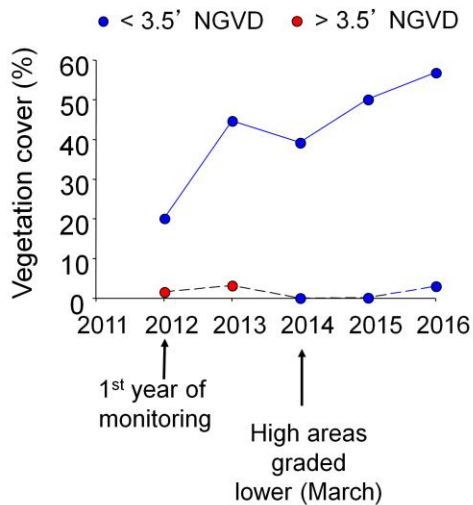
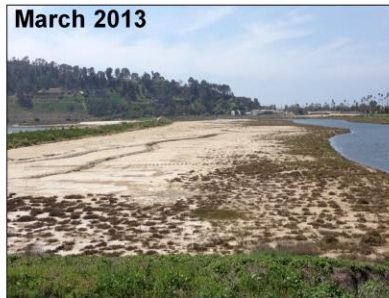
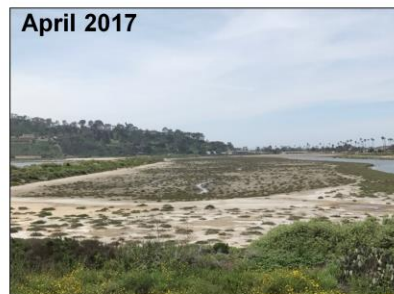
Elevation, Drainage, and Time Important to Vegetation Establishment

- Good news, vegetation is coming in as evident in the recent photo taken last month.
- So, the lesson learned here is that even after grading lower, it takes time, it will have been > 3 years for the vegetation to start filling in.
- In the foreground, you can see an area that was not re-graded, and the sparse vegetation in comparison with the 2013 photo.
- It is possible that the 4 years of drought in combination with the high elevation had a negative effect on vegetation cover at this location.

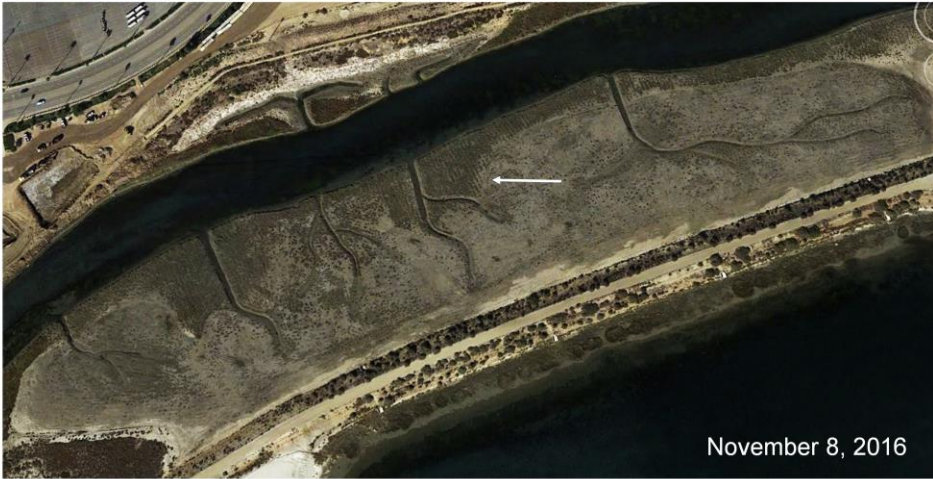
Habitat Heterogeneity and Vegetation Establishment

Vegetation cover highest in furrows created during construction

- It is interesting to point out, that smaller scale heterogeneity has influenced vegetation development, even at lower elevations.
- Not as evident from just walking around the marsh in this area.
- In this google earth image from 2016 furrows created during construction are more vegetated than adjacent areas.
- Could be that the furrows retain moisture or trap seeds.
- This is something to consider during construction or re-grading.

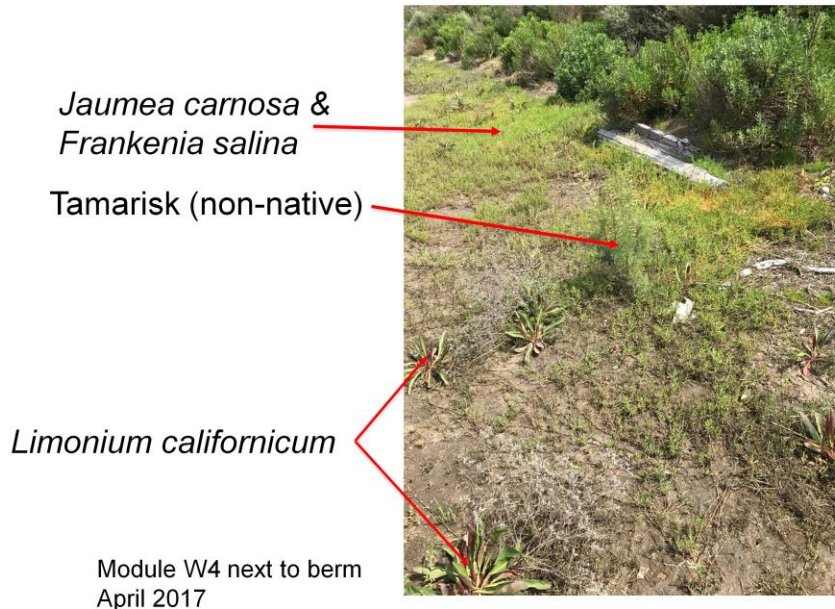
Recruitment of Species Other Than *Salicornia*

- Finally, plant species other than pickleweed will recruit to higher elevations in the restored site as evidenced by this photo taken next to the berm in a module on the east side of the freeway.
- Here you can see a mix of species, including the native sea lavender, *Limonium californicum*, considered regionally rare in some areas.
- Also see a tamarisk plant, an exotic species that recruited—have to be vigilant.
- The soil was moist in this photo—maybe due to local groundwater inputs.
