Salt Marsh Vegetation and Habitat Areas Status Update

May 3, 2023

SONGS Mitigation Monitoring Project

Marine Science Institute, University of California Santa Barbara

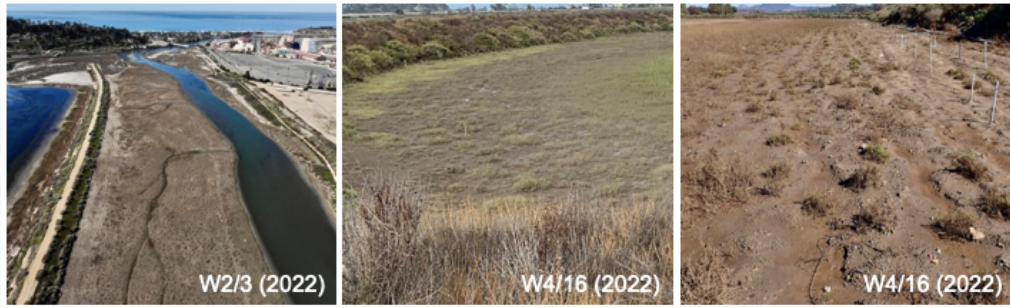
Standards that have consistently underperformed in San Dieguito Wetlands

- Both the absolute standard for Habitat Areas and the relative standard for Vegetation Cover have yet to be met.
- 2015 is the first year we have a four year running average for the evaluation of the vegetation cover standard, which is why the circles are unfilled until 2015.

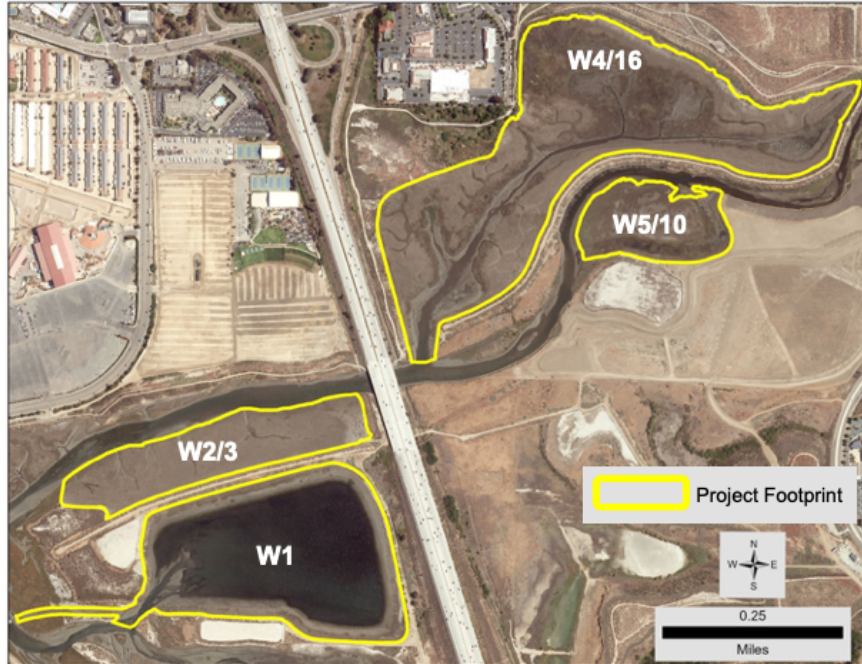
What are the cover patterns at the module level?

- Evaluation of the habitat areas and vegetation cover standards is done wetland-wide, but looking at individual modules within the restoration project is useful for identifying areas with persistently low cover, and areas where cover has increased from year to year.
- The next two slides look at the vegetation cover, broken down by the habitat type for W2/3 and W4/16.
- As Rachel mentioned in the previous talk, these habitat categories are mudflat, salt marsh, and other.

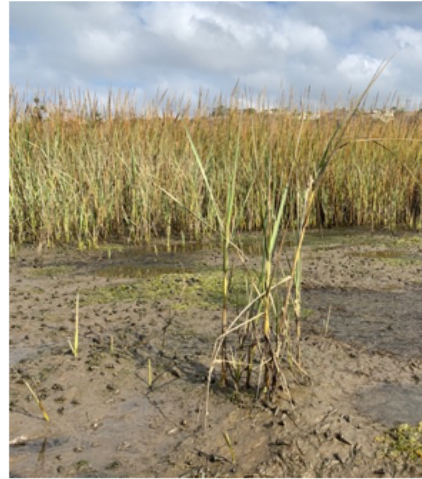
San Dieguito Wetlands, W4 mudflat (2022)

Declining trend in mudflat habitat at San Dieguito Wetlands

- As Rachel mentioned in the Performance Talk, we have seen a decline in mudflat habitat at San Dieguito Wetlands in recent years.
- As of 2022, we are -6.4 acres short of meeting the minimum mudflat acres (20.16) required by the Habitat Areas Standard.
- The photo on the right, taken from well within one of San Dieguito's mudflats, shows the encroachment of low marsh species, mainly *Spartina foliosa*, into mudflat habitat.
- Given these trends, we asked—how many mudflat acres are lost due to salt marsh encroachment?
- To begin to answer this question, we will focus the remainder of the presentation on the planned mudflat area as indicated in the Final Restoration Plan, which I showed on the previous slide.

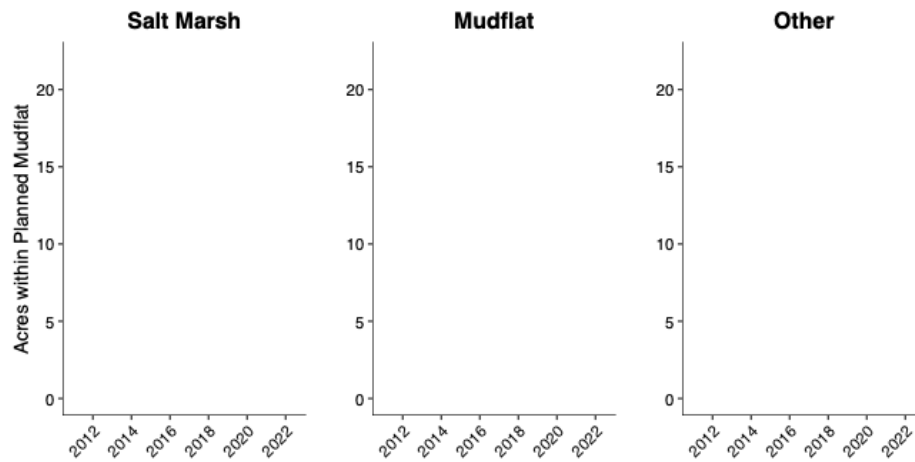
Salt marsh encroachment into planned mudflat habitat

- This figure will show from left to right--the conversion of acres of planned mudflat to salt marsh, acres remaining of planned mudflat, and other over the longer term, from 2012 to 2022.

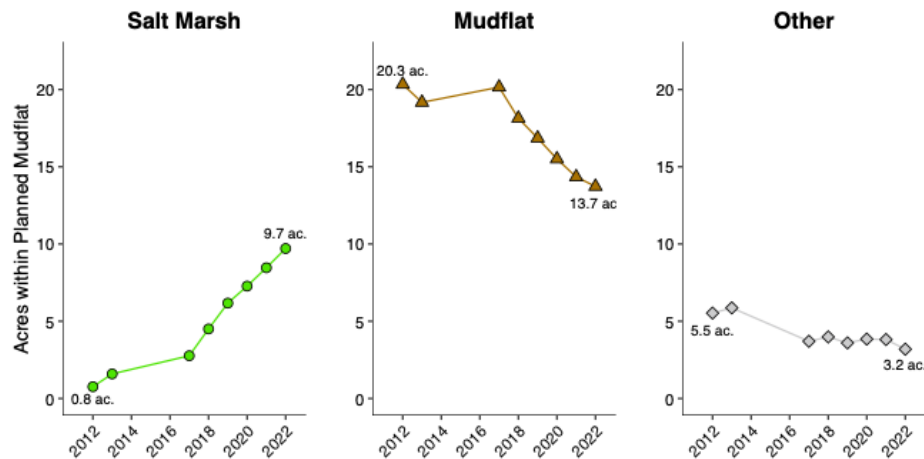
Within planned mudflat: dramatic increase in salt marsh, decrease in mudflat

~40% of **planned mudflat** habitat in 2012 has been **converted to salt marsh** in 2022

- Starting on the left, you can see that what we classify as salt marsh, i.e., greater than or equal to 30% cover of vegetation has increased in planned mudflat and now occupies 9.7 acres of former mudflat.
- Moving now to the middle figure, we see a concurrent loss in acres of mudflat from 20.3 acres to 13.7 acres.
- Lastly, the 2.3 acre decrease in other, which was within the area of planned mudflat was also converted to salt marsh, further contributing to the loss of mudflat.
- Together, ~40% of **planned mudflat** habitat in 2012 has been **converted to salt marsh** in 2022
