## Annual Public Workshop

San Onofre Nuclear Generating Station Wetland Mitigation Project  
Power House, Del Mar, CA  
May 9, 2016

### **Annual Review Workshop for SONGS Wetland Mitigation**

**SONGS Mitigation Monitoring Project  
Marine Science Institute, University of California Santa Barbara**

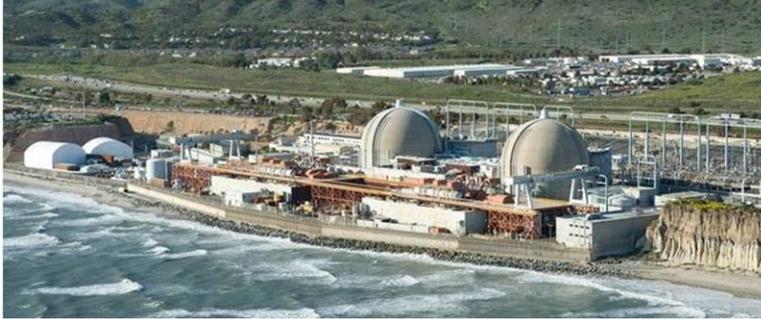
## SONGS Units 2 & 3 Operating Conditions

**1983: Unit 2 operations begin**

**1984: Unit 3 operations begin**

**2012: Units 2 and 3 operations suspended**

**2013: Units 2 and 3 operations permanently ceased**

- This slide provides a timetable of SONGS operations.
- Operations of SONGS Units 2 and 3 were suspended in January 2012 due to premature wear of replacement steam generators.
- SCE decided to permanently cease power operations in June 2013
- SCE's operating license has been modified to "possession only" and they are no longer authorized to operate the reactors

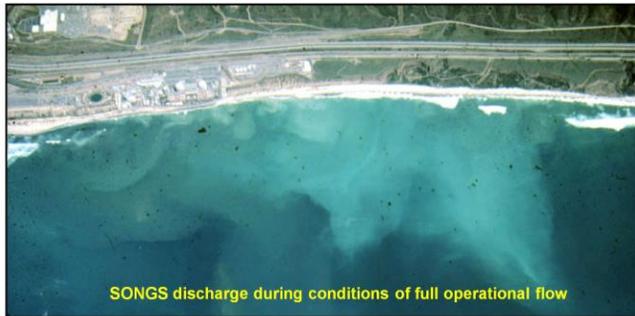
## SONGS Units 2 & 3 Intake Flows

- 1,287 Million Gallons per Day (MGD) per unit = 2,574 MGD total
- Represents total allowable flows

- 49 MGD per unit = 98 MGD total

- 42 MGD per unit = 84 MGD total

- Under normal operating conditions the flow rate of the cooling water systems of each Unit is about 1300 million gallons per day,
- This amounts to about 2.6 billion gallons a day for both units.
- Since the shutdown, the flow in each unit has been reduced to about 49 million gallons a day or roughly 4% of the normal operating flow.
- Marine impacts caused by SONGS cooling water system are thus expectedly much less under the current flow conditions.

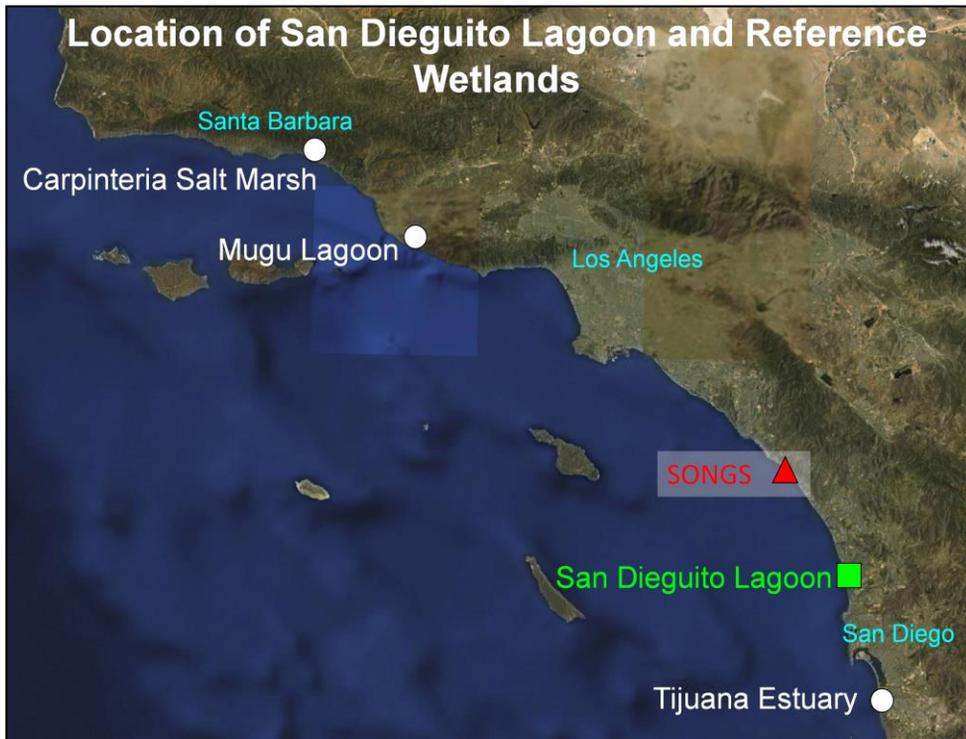
- This map shows the locations of SONGS, the impact site, the San Dieguito Lagoon, site of the San Dieguito Wetlands Restoration Project, and 3 wetlands that are used as reference sites to evaluate the performance of the restoration project: Carpinteria Salt Marsh, Mugu Lagoon, and Tijuana Estuary.

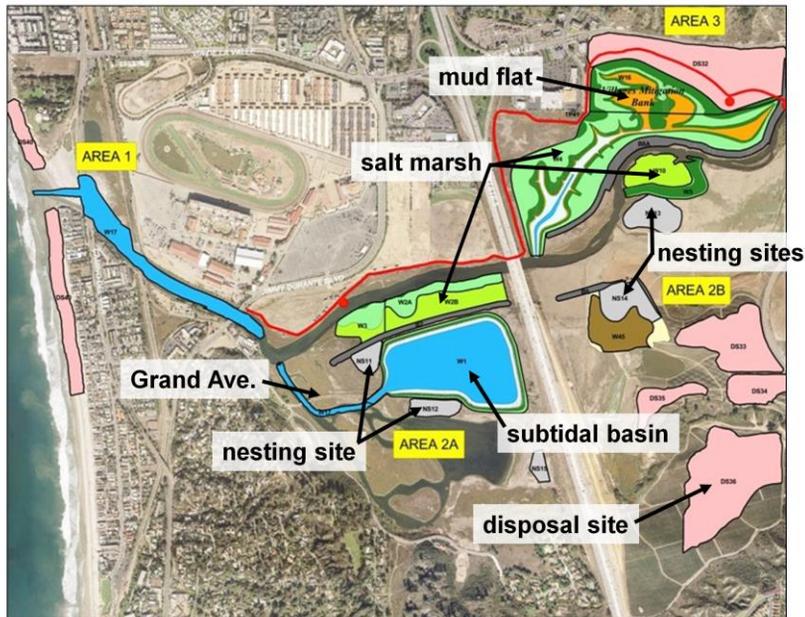
## San Dieguito Wetlands Restoration Design

- This slide reviews the San Dieguito Wetlands Restoration design that was approved by the CCC.
- For reference, the restoration project lies to the south and east of the Del Mar Racetrack.
- You can also see the location of the San Dieguito River, inlet to the Pacific Ocean, and I5 Freeway.
- The project included excavation and grading to tidal elevations capable of supporting tidal salt marsh, indicated by shades of green, mudflat, indicated by the light brown, and subtidal habitats, indicated by blue.
- In addition, 4 nesting sites, shown in gray, were constructed, which are not part of the SONGS mitigation requirement.
- The areas in pink are disposal sites that received the majority of the 2.2 million cubic yards of material excavated during construction of the wetland.
- The yellow boxes that indicate Areas 1, 2a, 2b, and 3 pertain to the staging of construction activities.

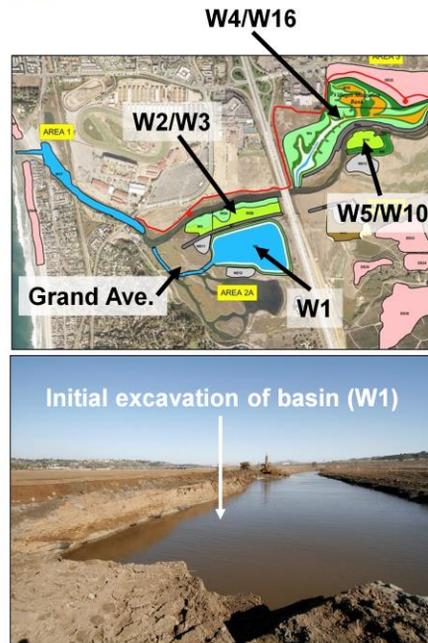
## Timeline

<b>Start date</b>	<b>September 2006</b>
<b>Project Task</b>	<b>Completion Date</b>
<b>Construction:</b>	
All modules	November 2010
Additional wetland (Grand Ave)	February 2011
Re-grading of W2/W3	March 2014
<b>Planting:</b>	November 2008, 2009, 2011
<b>Final inlet dredging</b>	<b>September 2011</b>
Maintenance inlet dredging	November 2015

- This slide summarizes the construction timeline.
- Construction began in September of 2006.
- Wetland construction was organized by area and module -- most excavation and grading was completed by 2008, with the addition of tidal creeks in W2/3 completed in November 2010, and re-grading of this area to lower elevations in March 2014.
- Planting of salt marsh plants, including cordgrass, *Spartina* in the low marsh was completed in 2011.
- Final inlet channel dredging was completed in September 2011.
- We've completed the fourth year of performance monitoring, which is what we will be talking about today.

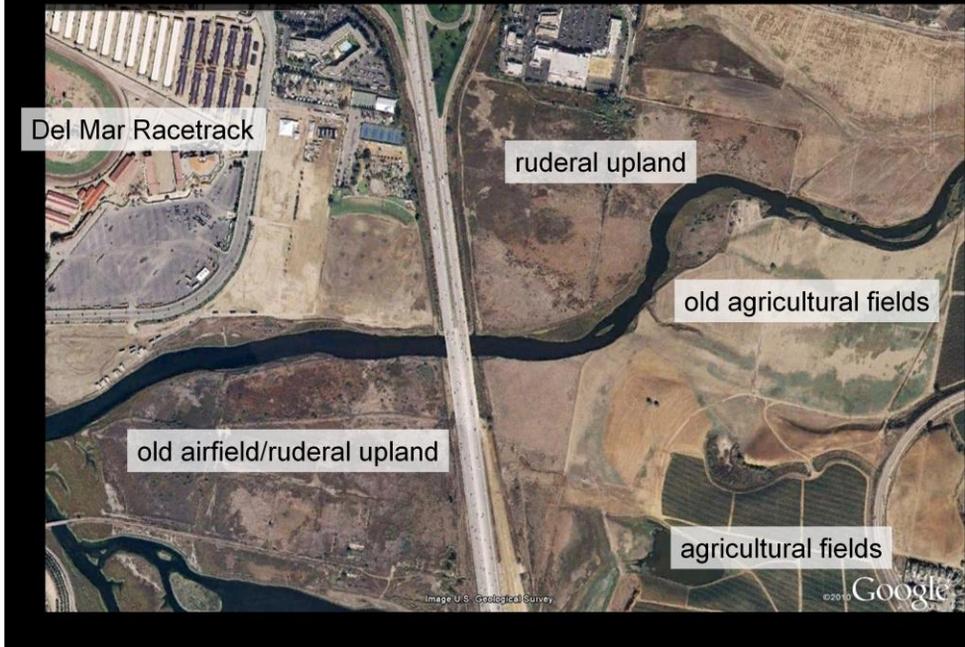
## San Dieguito Wetlands before excavation and grading (2003)

- This slide shows a satellite view of the project site before excavation and grading.
- You can see the San Dieguito River and adjoining ruderal upland, including the site of an old WWII airfield, and old agricultural fields.
- You can also see a portion of a basin that was constructed in the 1980's termed the Fish and Game Basin.

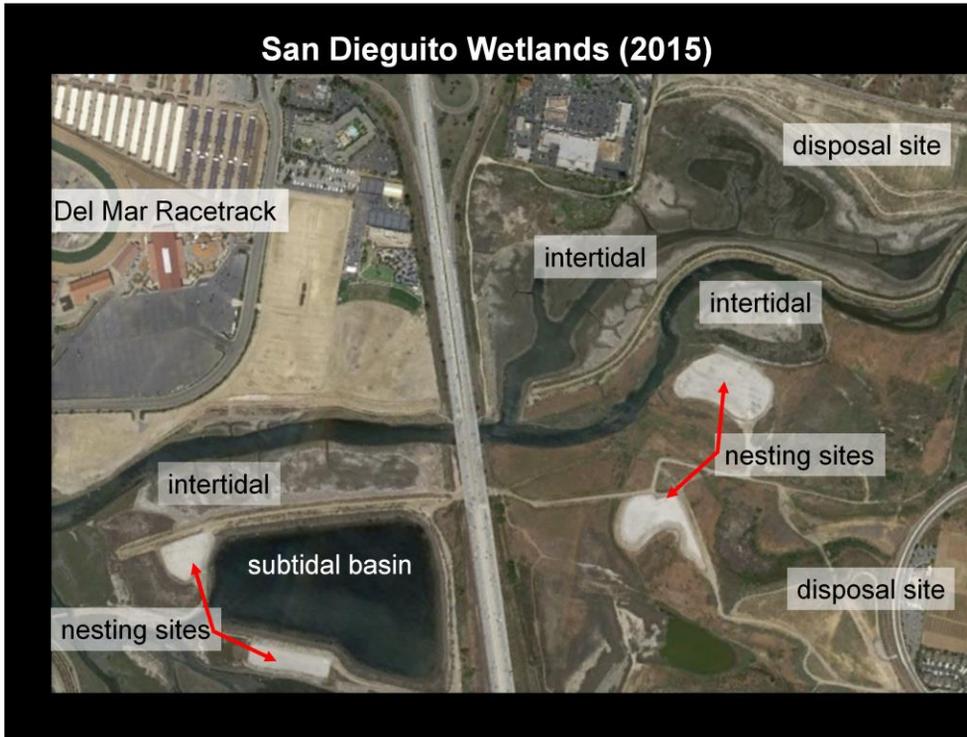
## San Dieguito Wetlands (2015)

- During construction, the ruderal areas and old agricultural fields were excavated and graded to create the planned intertidal and subtidal wetland habitats of the restoration project visible in this image taken the past year.
- In addition, you can see nesting and disposal sites.

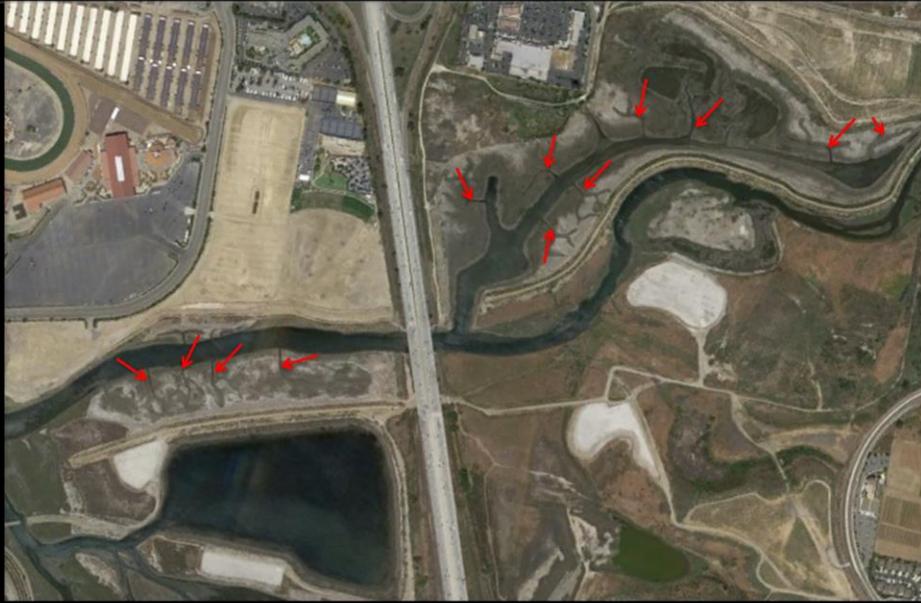
## San Dieguito Wetlands (2015)

- Notice also examples of the tidal creek networks located in restoration modules on the west and east side of the freeway.

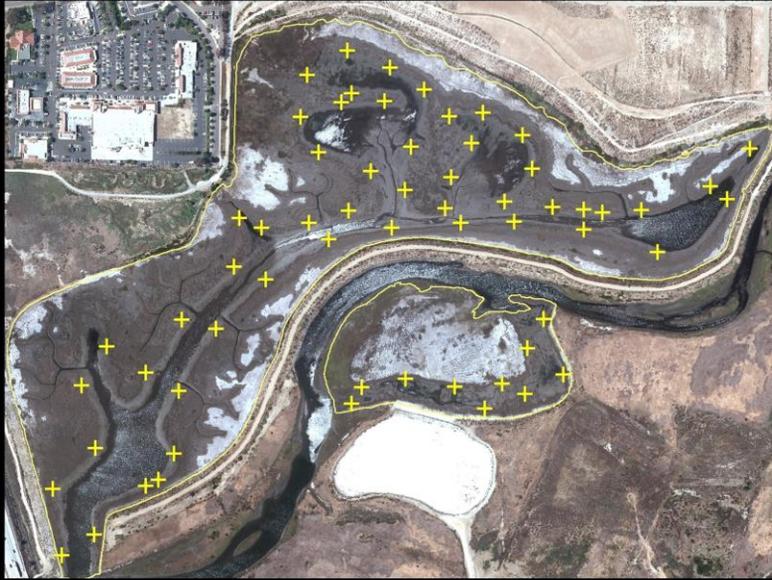
## Planting Locations of Cordgrass in San Dieguito Wetlands

- Cordgrass, about 20,000 plants, was planted widely throughout the restoration site with the latest planting in November 2011.
- This slide shows planting locations, indicated by the yellow crosses in the portion of the wetland on the east side of freeway where most of the planting occurred.

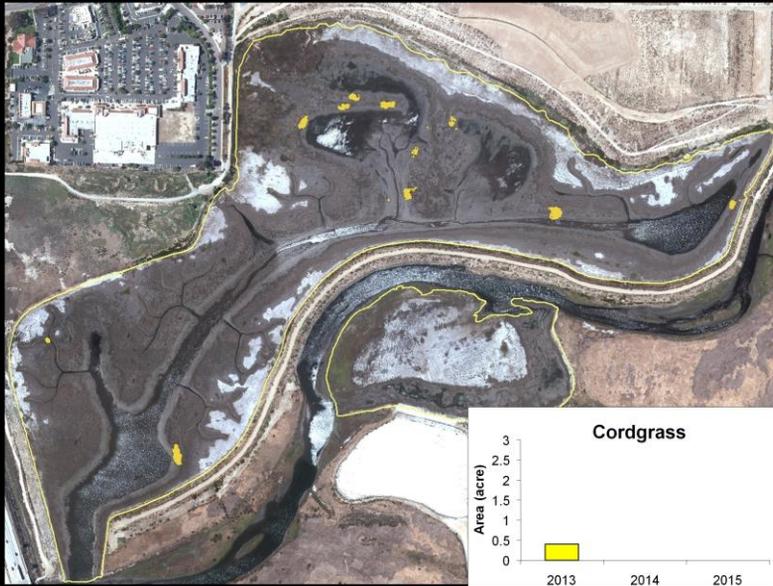
## Distribution of Cordgrass in San Dieguito Wetlands

- For the first couple of years following planting, cordgrass performed poorly.
- You can see the distribution and size of cordgrass patches that became established, scattered in the portion of the restoration site on the east side of the freeway in 2013 and the total area of cordgrass, which in 2013 was less than 0.5 acre.

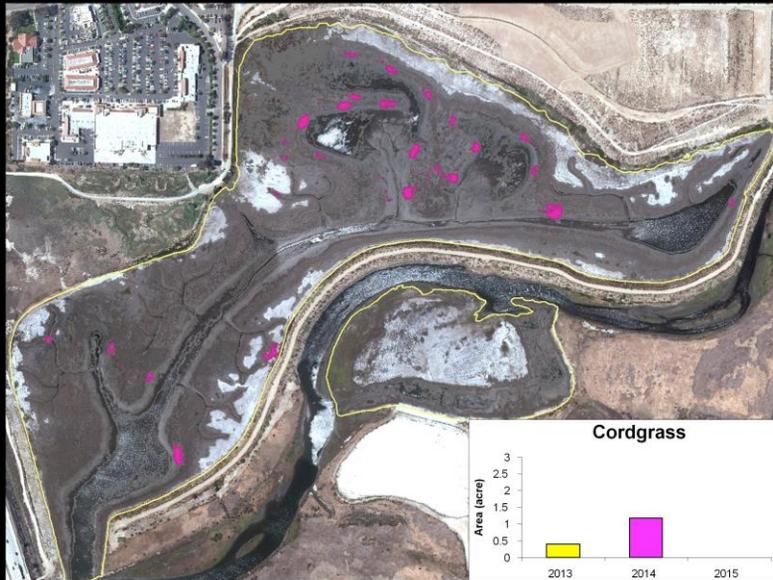
## Distribution of Cordgrass in San Dieguito Wetlands

- However, cordgrass establishment has become more promising. This shows the distribution and size of cordgrass patches had expanded in 2014 to encompass about 1.2 acres for the restored site.

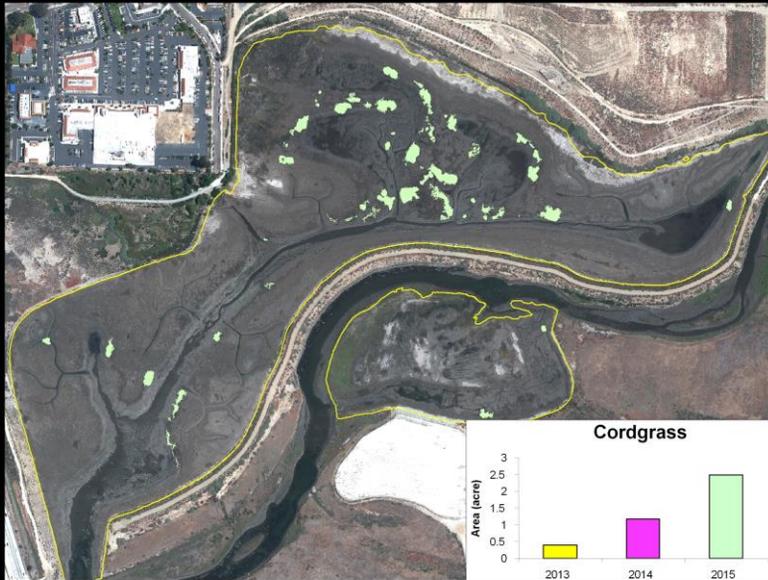
## Distribution of Cordgrass in San Dieguito Wetlands

The area of cordgrass has continued to expand and encompassed about 2.5 acres for the restored site in 2015 .

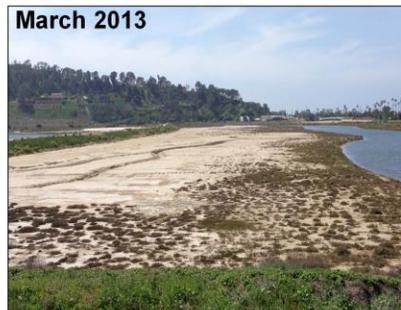
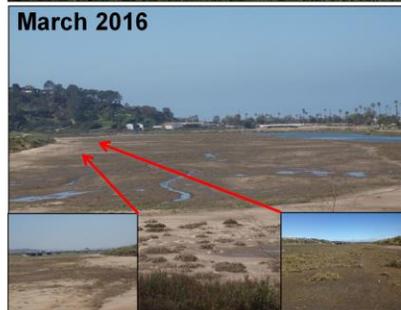
San Dieguito Wetlands Modules W2/3

- In the top photo, taken in March 2013, you can see pickleweed was very sparsely distributed and a crust of salt was evident on the surface of the constructed marsh plain.

- Monitoring suggested that high elevation of the marsh plain and poor drainage were the cause of sparse vegetation in this area
- SCE was aware of this problem, and the area on the west side of the freeway was re-graded in March 2014 to lower the elevation of the marsh plain to increase the frequency of inundation, and re-contoured to improve drainage, which should lead to the establishment of vegetation.

- This area is now hit by the tides more frequently and you can see in the bottom figure that pickleweed has become established, though still sparsely distributed.

- **Monitoring identified high tidal elevation and poor drainage as the cause of sparse vegetation in portions of the restoration site.**
- **SCE re-graded some of these areas lower in March 2014 to increase tidal inundation and improve drainage.**
- **Vegetation is colonizing the re-graded areas but is still sparsely distributed.**

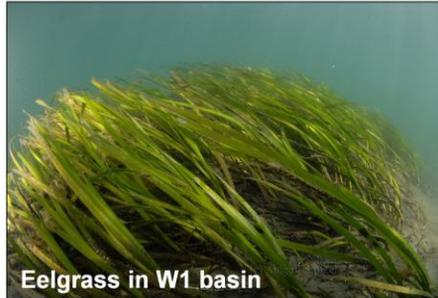
## Eelgrass in Restored Wetland

- Eelgrass recruited to inlet channel and entrance to the W1 basin prior to the final inlet opening in September 2011.
- Eelgrass removed for final inlet channel construction was transplanted to W1 in January 2011.
- Eelgrass covered ~80% of the bottom in W1 in 2014 and continues to cover most of the bottom in 2015.

- Eelgrass, which provides habitat for invertebrates and fish, recruited to the inlet channel and entrance to the basin, W1 prior to the final inlet opening in September 2011.
- Eelgrass removed for final inlet channel construction was transplanted to W1 in January 2011.
- There also has been considerable recruitment of eelgrass.
- Eelgrass covered ~80% of the bottom of the W1 basin in 2014, and continued to cover most of the bottom in 2015.

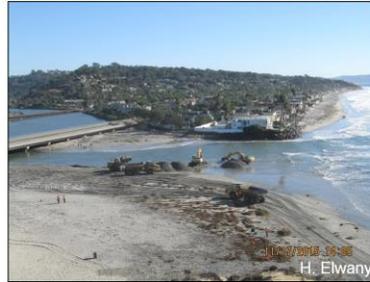
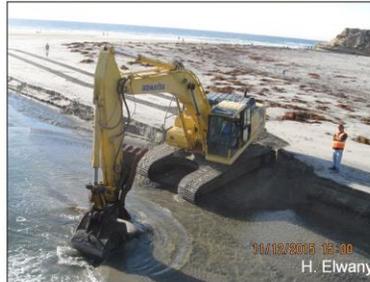
Fall 2015 dredging at San Dieguito

- Inlet closure can adversely affect dissolved oxygen concentration.
- Partial blockage of the inlet by sand can affect drainage during low tides, leading to ponding.
- SCE has a maintenance plan to keep the inlet open to tidal exchange.
- Maintenance dredging of the inlet took place November 5-17, 2015.

- There remain important on-going management tasks associated with ensuring that the restoration project is successful.
- One task concerns inlet maintenance.
- By halting tidal flushing, inlet closure can adversely affect dissolved oxygen concentration in the lagoon and lead to invertebrate and fish kills.
- Even partial blockage of the inlet by sand can affect drainage during low tides, leading to ponding, and the death of cordgrass, which requires good tidal flushing and cannot tolerate continued submergence.
- SCE has an inlet maintenance plan that will keep the inlet open to avoid degradation in water quality, ponding, and loss of biological resources.
- Maintenance dredging of the inlet was completed in November 2015.
