**Annual Report of the Status of Condition A:
Wetland Mitigation**

**SAN ONOFRE NUCLEAR GENERATING STATION (SONGS)
MITIGATION PROGRAM**

*Submitted to the California Coastal Commission
July 2022*

**By Kathryn Beheshti, Mark Page, Stephen Schroeter and
Daniel Reed**

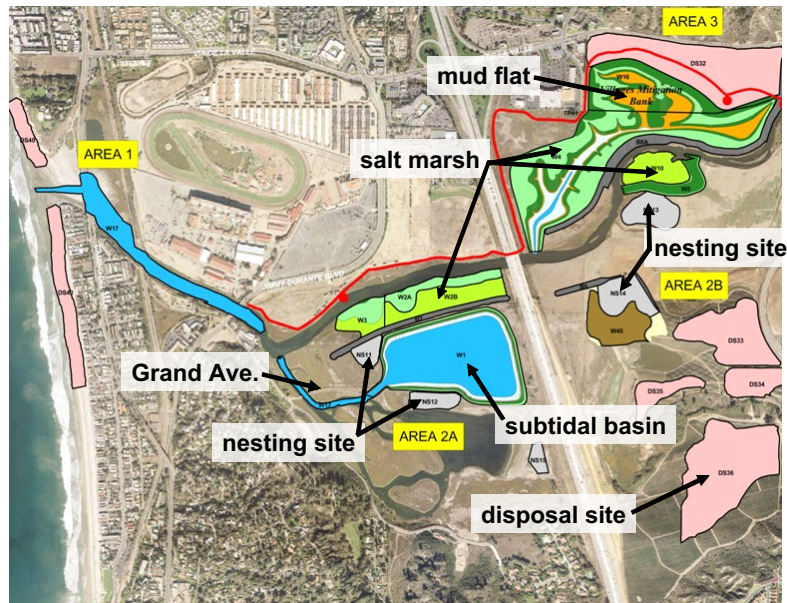
Figure 3.0.2. The design plan view of the restoration project that was approved by the CCC. The project included the creation of tidal salt marsh, indicated by shades of green, mudflat, indicated by the light brown and light blue, and subtidal basin, indicated by blue. In addition, four nesting sites, shown in gray, were constructed, which were not part of the SONGS mitigation requirement. The areas in pink are disposal sites. Dark gray linear features are berms along the effective flow area of the San Dieguito River. The yellow boxes that indicate Areas 1, 2a, 2b, and 3 pertain to the staging of construction activities. Source: Final Restoration Plan for San Dieguito Wetlands

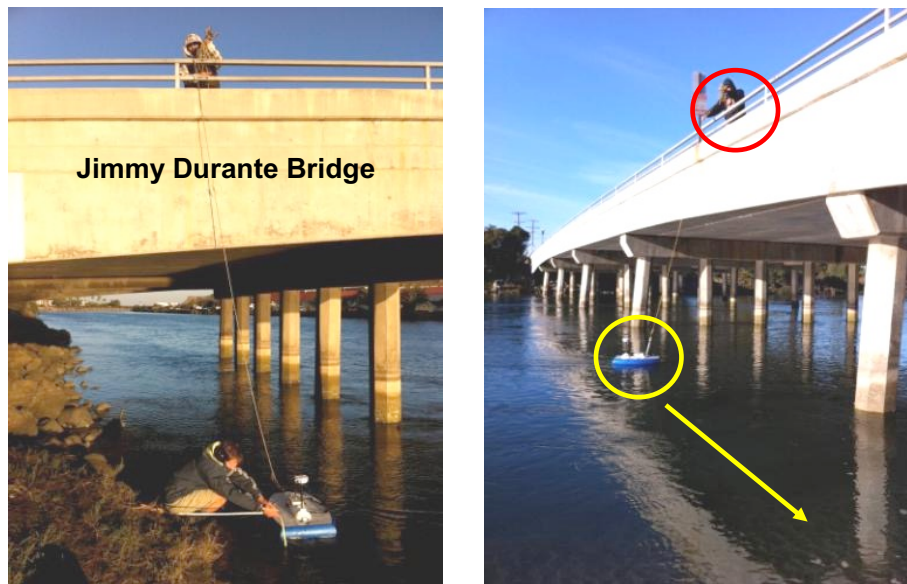
Figure 5.1.1.1. Measurements of tidal flows are taken at Jimmy Durante Bridge (0.9 km from the inlet) using a portable Acoustic Doppler Profiler/discharge measurement system (yellow circle) that is towed back and forth (indicated by the yellow arrow) across the width of the channel by monitoring staff (red circle) every 15 minutes during an incoming tide.

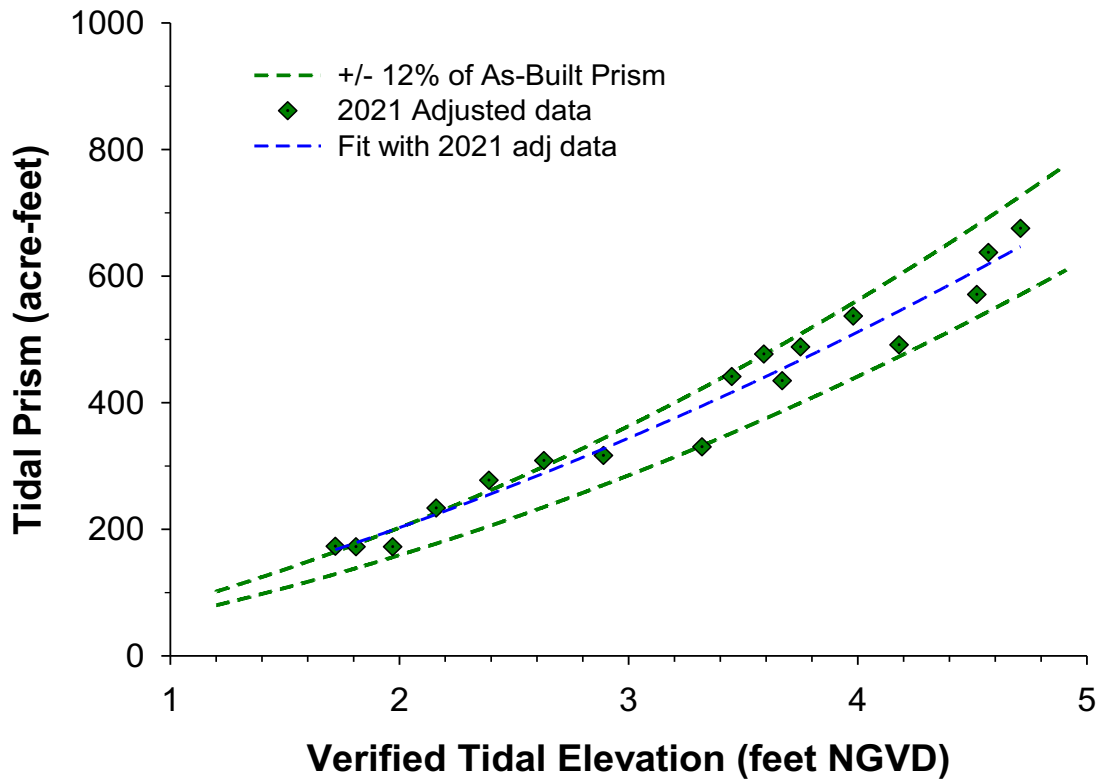
Figure 5.1.1.2. The regression fit to the tidal prism measurements taken January-December 2021 (blue dashed line) must fall within the two dashed green lines, which represent 88% and 112% of the as-built prism, for the tidal prism to be maintained. Tidal prism measurements for 2021 were adjusted for the excavation of additional wetland by the 22nd Agricultural District adjacent to the Grand Avenue Bridge.

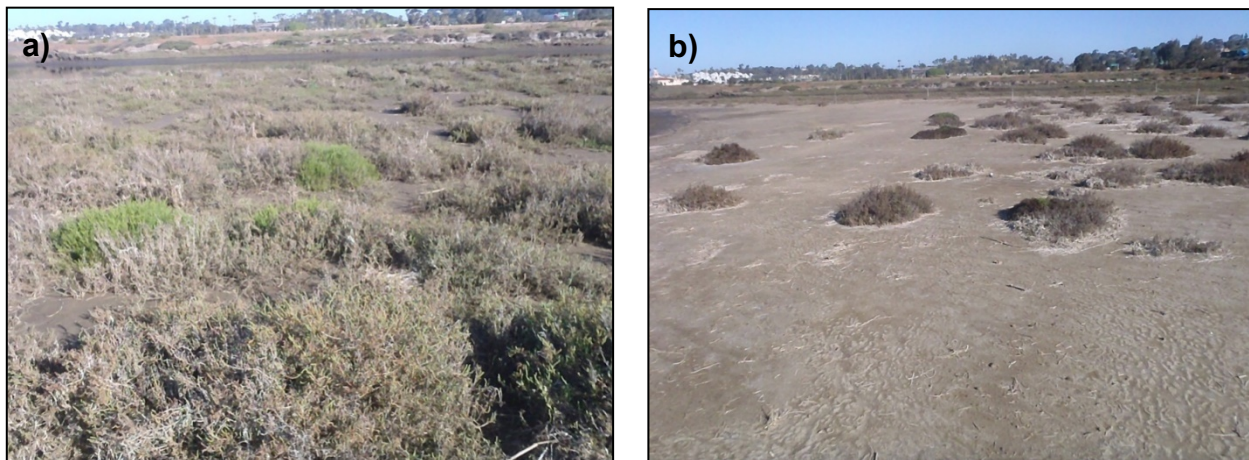
Figure 5.1.2.3. Examples of an area assessed as a) salt marsh habitat, where cover of salt marsh vegetation was $\geq 30\%$, and b) an area assessed as "other", not a planned habitat that is too high in elevation to be assessed as mudflat and too sparsely vegetated to be assessed as salt marsh.

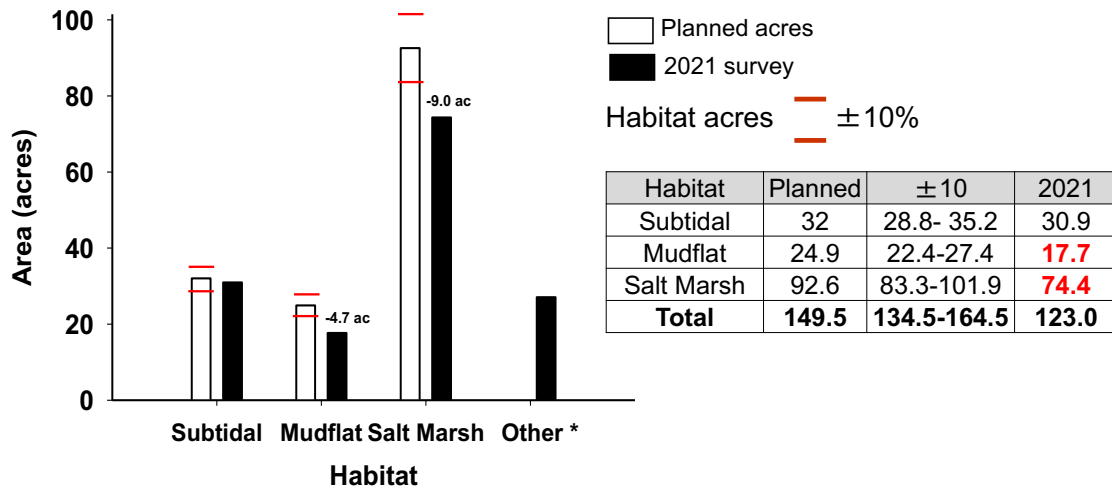
Figure 5.1.2.4. Comparison of the areas of subtidal, mudflat, and salt marsh habitat in the Final Restoration Plan to the 2021 survey. Areas assessed as “other” (*) were not assessed as one of the planned habitats provided in the Final Restoration Plan and are not included in the total acres of planned habitat.

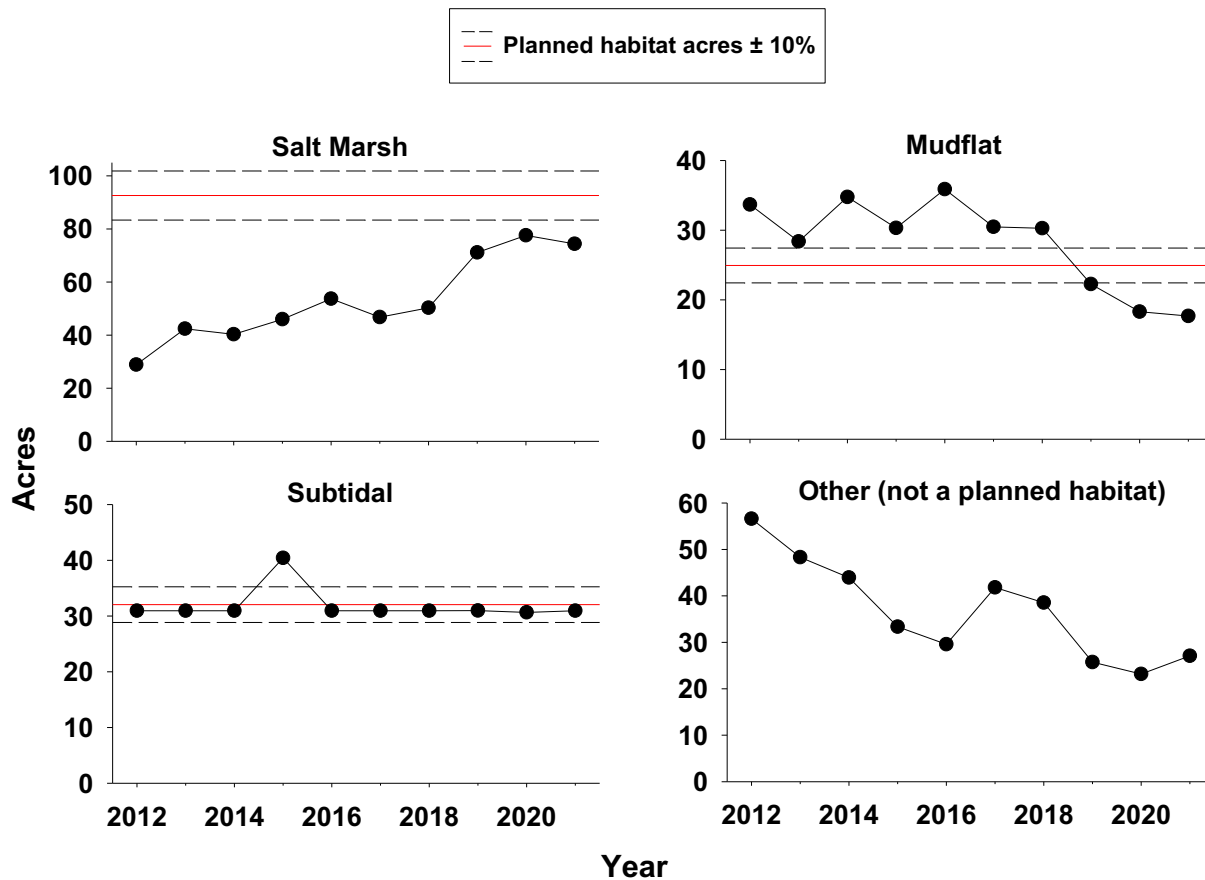
Figure 5.1.2.5 shows the trend over time in acres of the salt marsh, mudflat, and subtidal habitat categories and the “other” category, which is not a planned habitat. Despite the slight decline in salt marsh area from 2020 to 2021, there has been a slow but general increase in salt marsh habitat since 2012 and an encouraging increase from 2018 to 2020, perhaps engendered by the rainfall of 2018. There has also been an encouraging general decline in “other” since monitoring began. Area of “other” did increase slightly in 2021, which could be a consequence of drought conditions. One more recent development that may lead to failure to meet the habitat areas standard is the decrease in mudflat such that the acres of mudflat are now below 10% of the planned acres. This is due in part to the encroachment of *Spartina* into areas that are planned mudflat.

Figure 5.1.2.5. Comparison of the areas of salt marsh, mudflat, and subtidal habitat from 2012 through 2021 to the planned areas in the Final Restoration Plan (solid red line, black dashed lines $\pm 10\%$). Also shown is the change in acres of “other”, which is not a planned habitat.

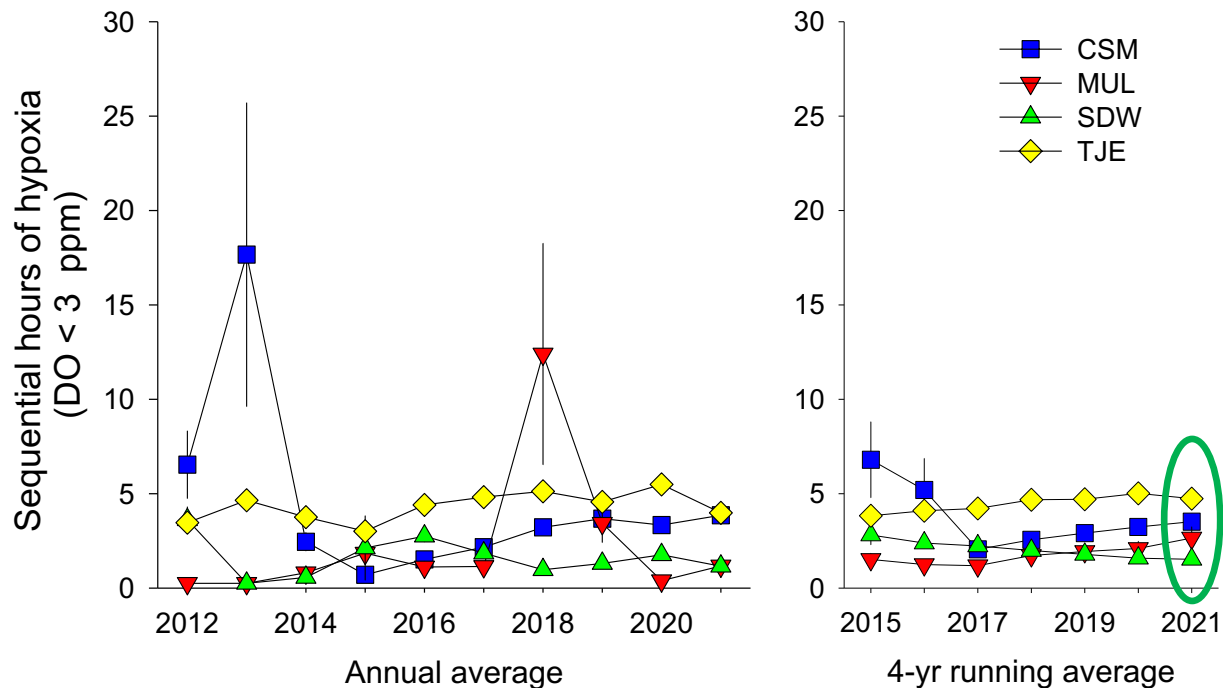
Figure 5.2.1.1. Comparison of annual mean sequential hours of hypoxia (left) and the 4-year running average used to evaluate the standard (right) between San Dieguito Wetlands and the reference wetlands. Mean length in hours of continuous hypoxia ($[O_2] < 3 \text{ mg/l (ppm)}$) in the San Dieguito Wetlands compared with the three reference wetlands. Abbreviations used in this and subsequent figures: CSM=Carpinteria Salt Marsh, MUL=Mugu Lagoon, SDW=San Dieguito Wetlands, and TJE=Tijuana Estuary. Mean values $\pm 1\text{SE}$ are shown in this and subsequent figures. Green ellipse indicates standard was met.

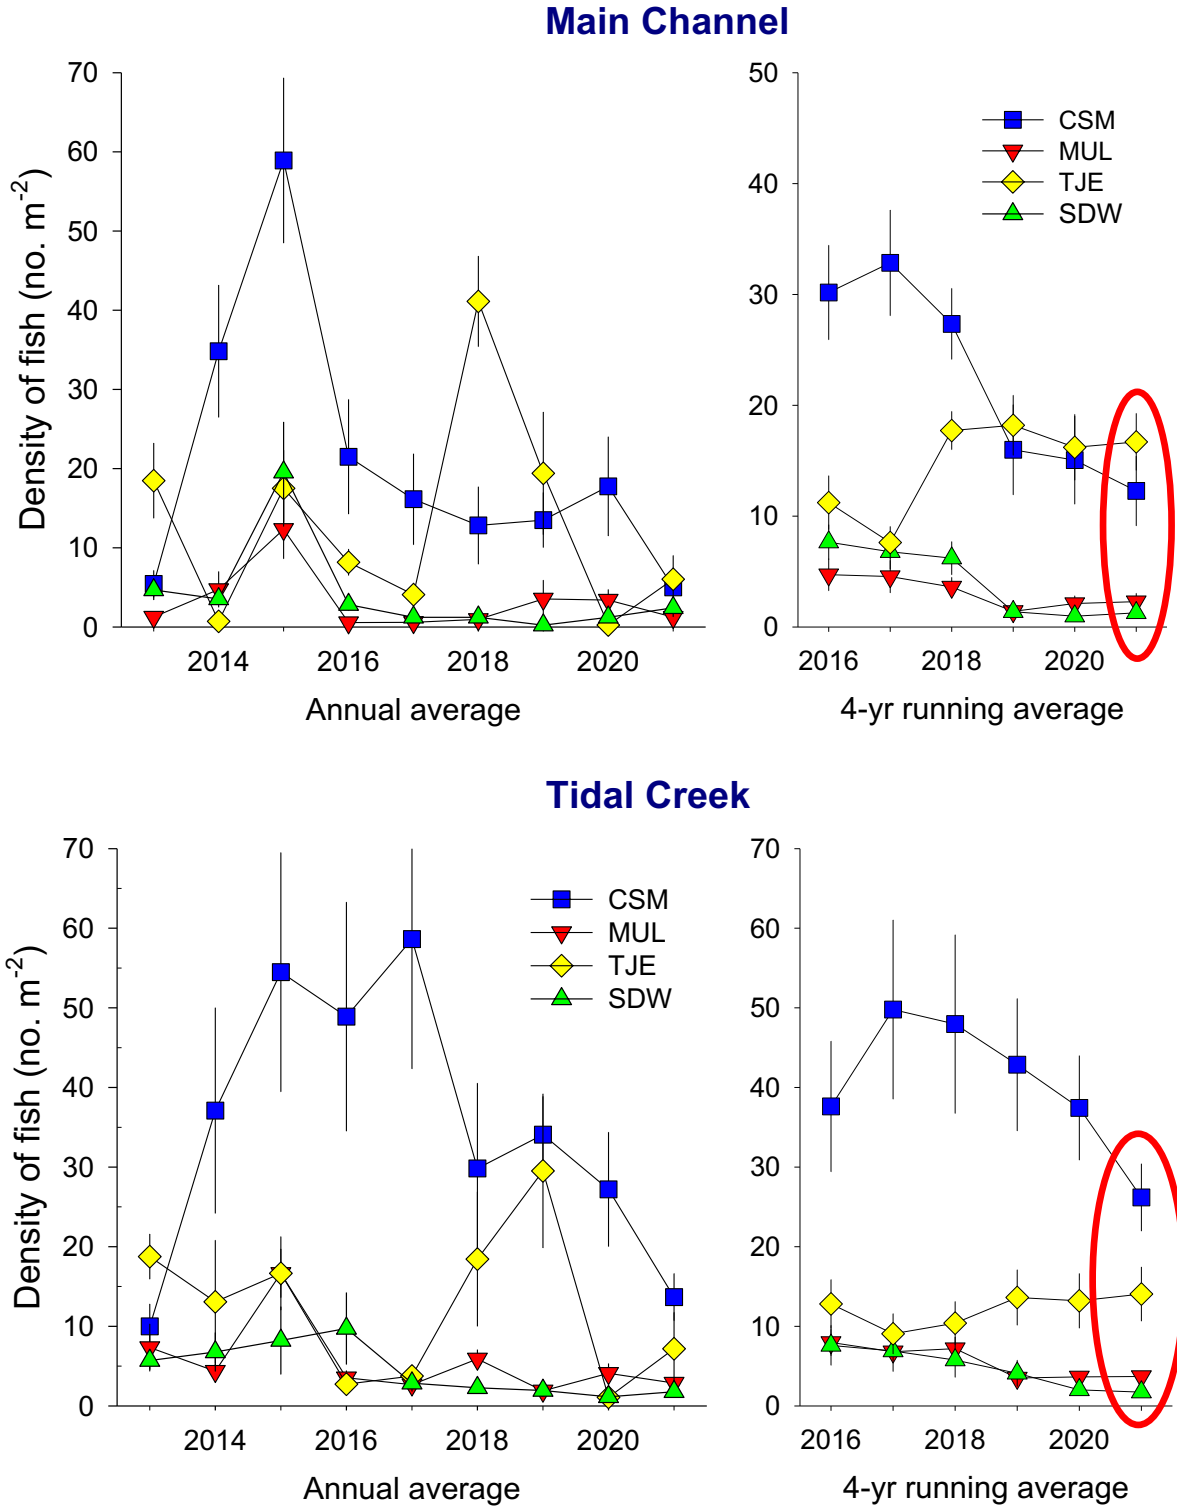
Figure 5.2.3.1. Comparison of annual fish density (left) and the 4-year running average used to evaluate the standard (right) between San Dieguito Wetlands and the reference wetlands in main channel (top) and tidal creek (bottom) habitats. Section of main channel-basin or individual tidal creek is the unit of replication (n = 6 in each habitat type). Red ellipses indicate standard was not met for 2021.

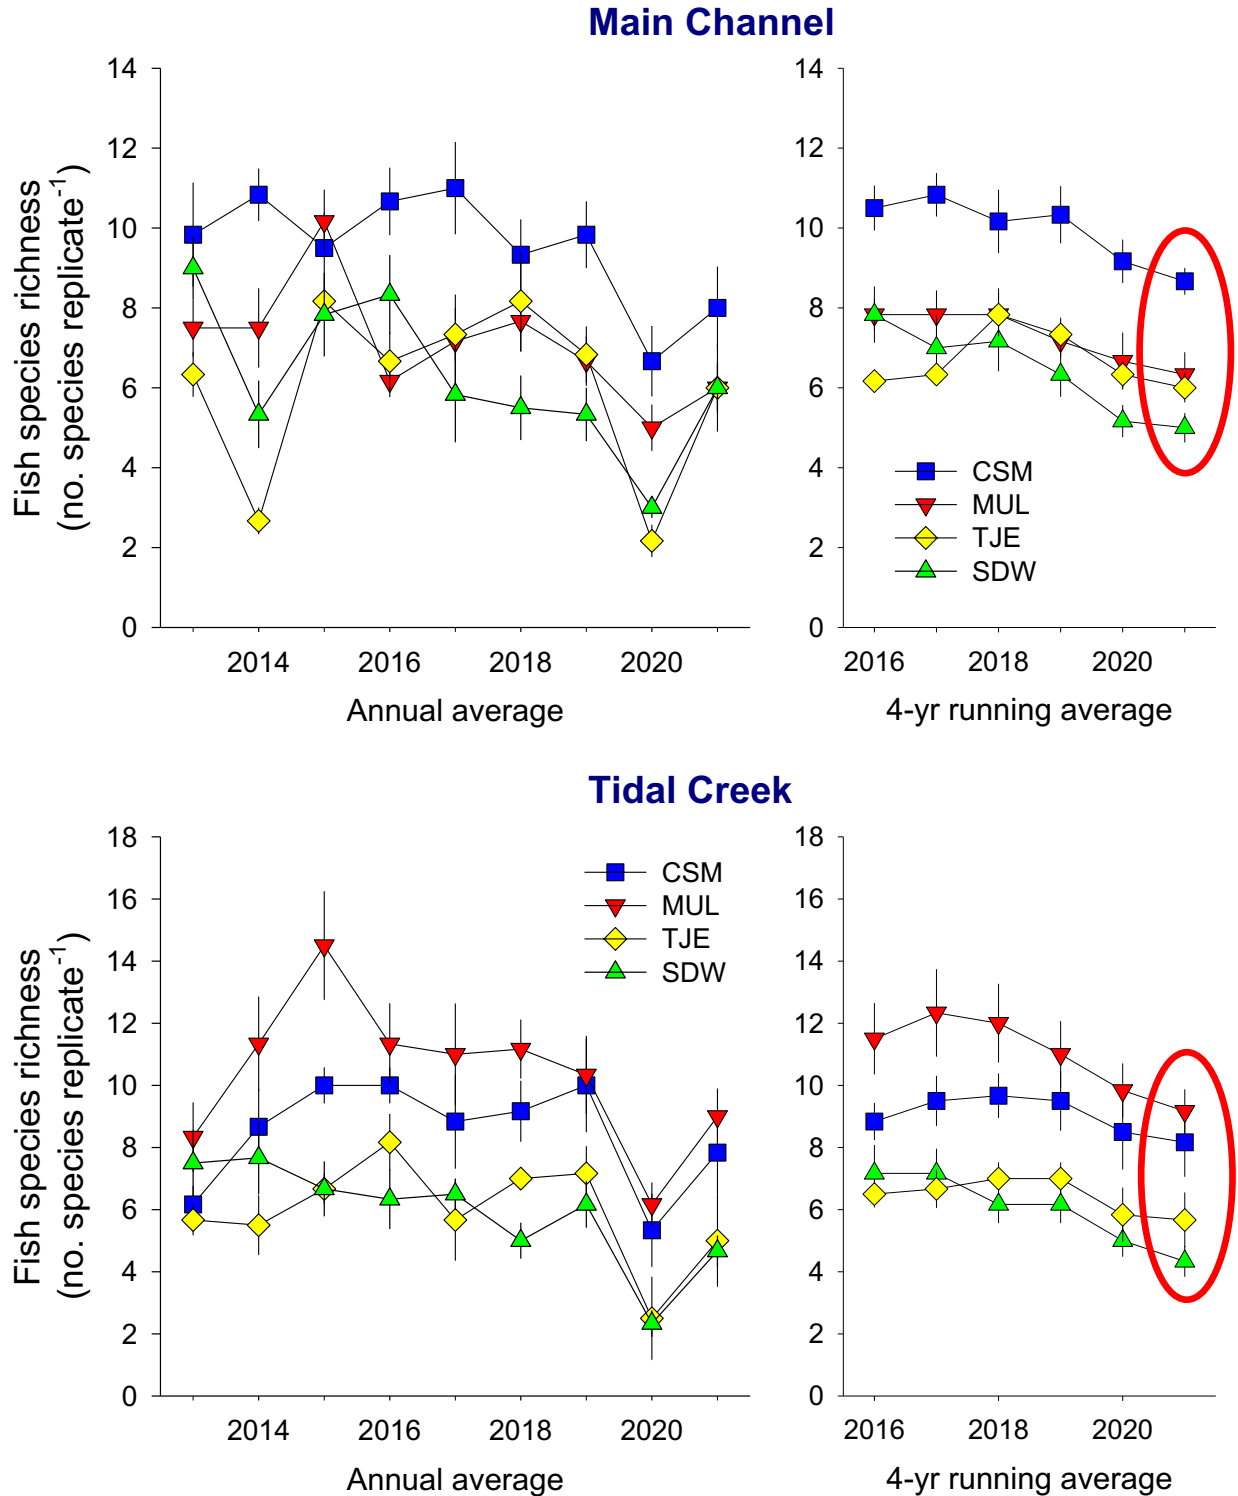
Figure 5.2.3.2. Comparison of annual fish species richness (left) and the 4-year running average used to evaluate the standard (right) between San Dieguito Wetlands and the reference wetlands for main channel (top) and tidal creek (bottom) habitats. Section of main channel-basin or individual tidal creek is the unit of replication (n=6 in each habitat type). Red ellipses indicate standard was not met for 2021.

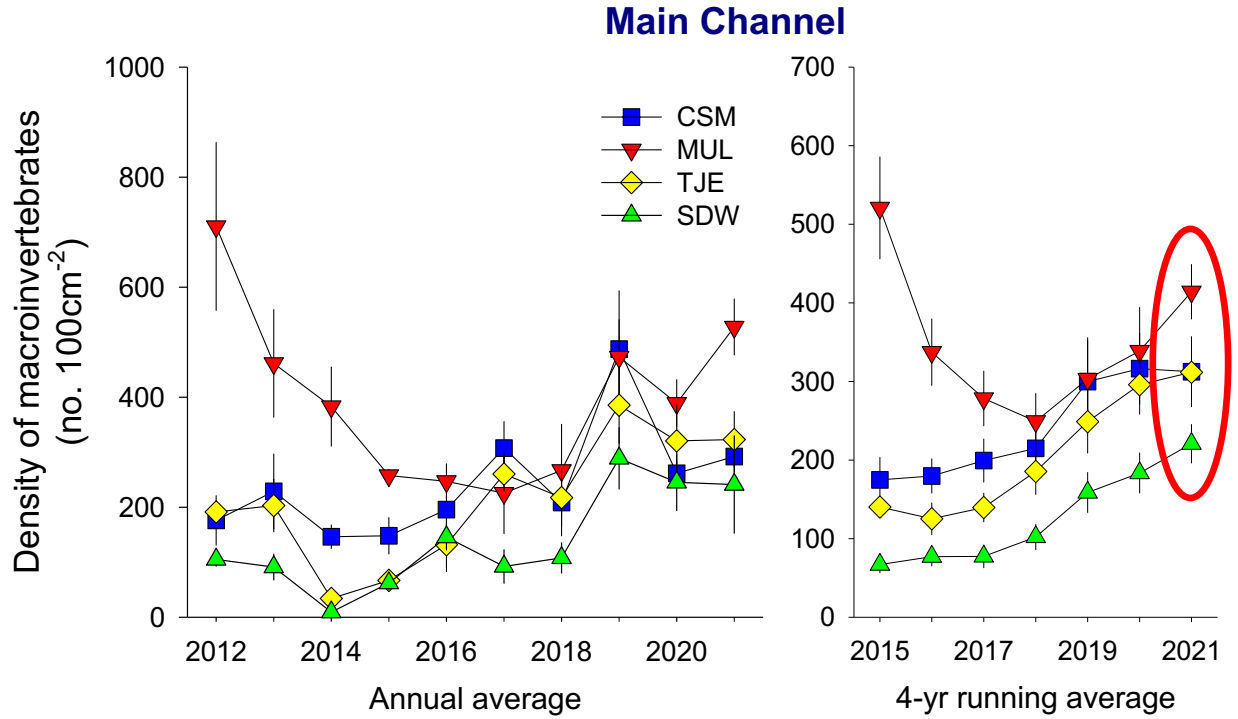
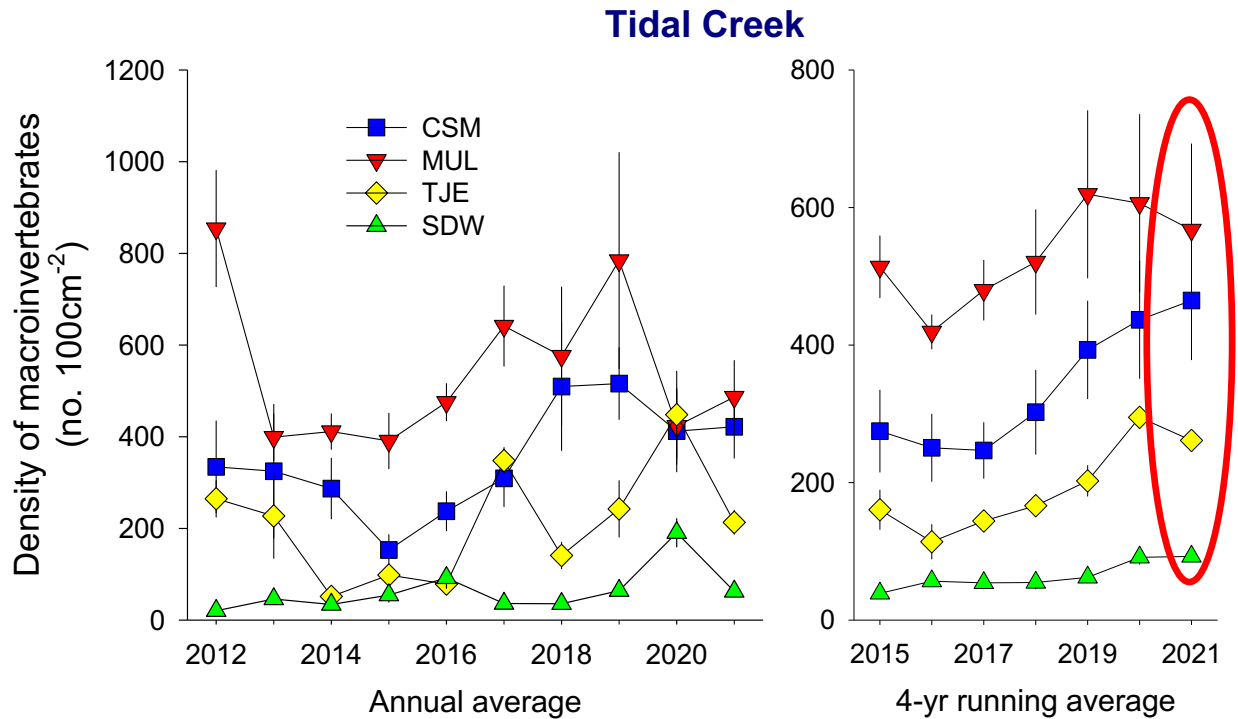
Figure 5.2.4.1. Comparison of macro-invertebrate density between San Dieguito Wetlands and the reference wetlands for main channel (top) and tidal creek (bottom) habitats. Section of main channel-basin or individual tidal creek is the unit of replication. A red ellipse indicates that the standard was not met for 2021.

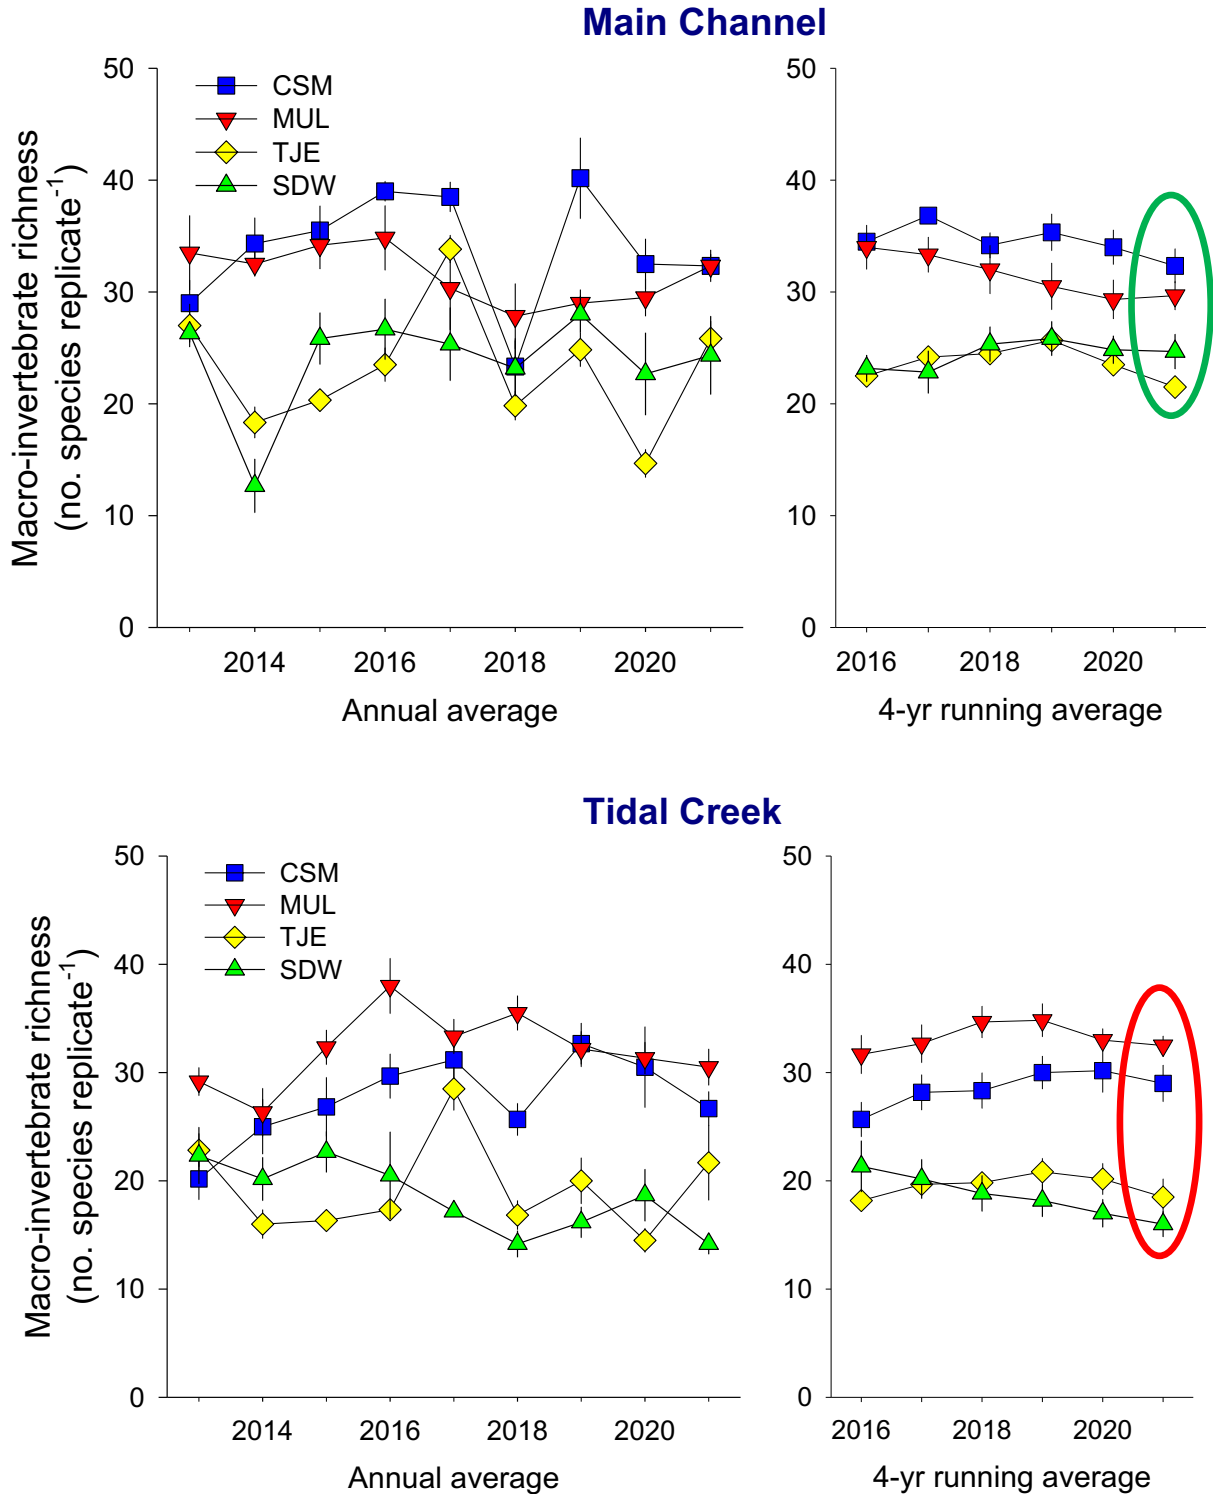
Figure 5.2.4.2. Comparison of macro-invertebrate species richness between San Dieguito Wetlands and the reference wetlands for main channel (top) and tidal creek (bottom) habitats. Section of main channel-basin or individual tidal creek is the unit of replication. Note: complete sampling was not conducted for invertebrate richness in 2012. A green ellipse indicates the standard was met and a red ellipse indicates the standard was not met for 2021.

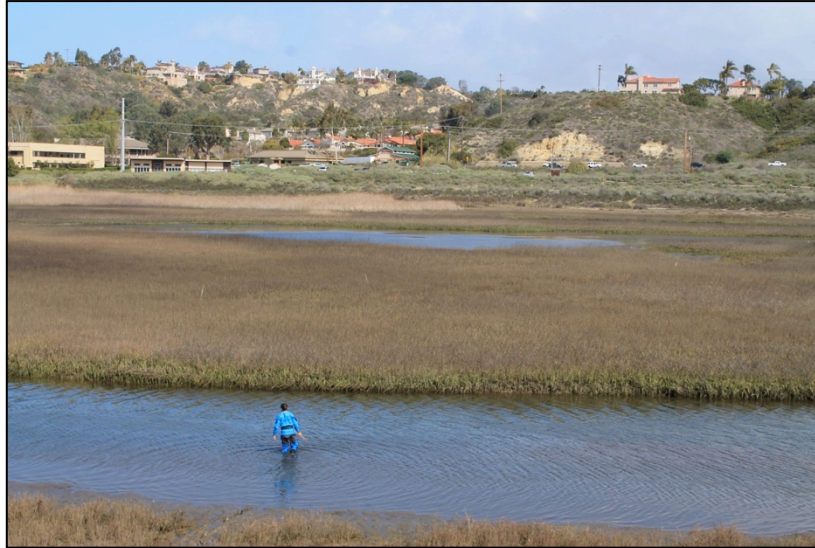
Figure 5.2.6.1. View of San Dieguito Wetlands modules W4 & W16 taken in 2020 showing extensive stands of cordgrass. Member of UCSB staff in foreground.

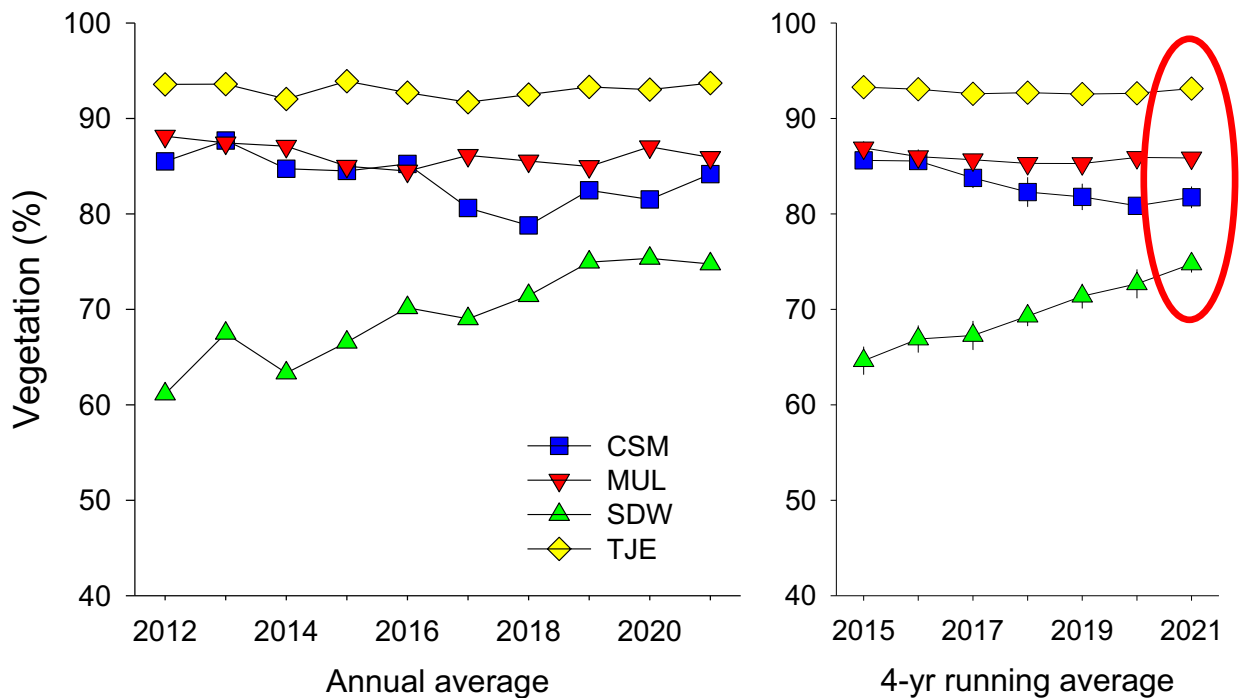
Figure 5.2.6.2. Comparison of the percent cover of salt marsh vegetation between San Dieguito Wetlands and the reference wetlands. Percent cover is evaluated in areas assessed as salt marsh habitat (at least 30% cover of vegetation). Red ellipse indicates standard was not met for 2021.

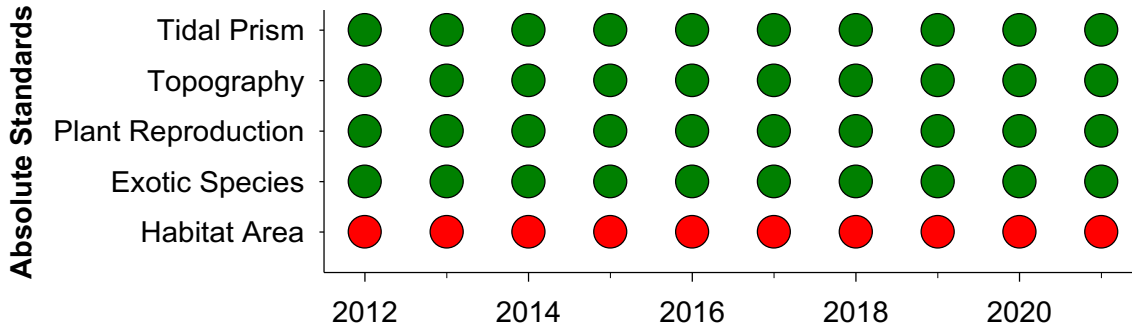
Figure 6.1.1. Summary of assessment of the absolute standards from 2012 through 2021. A [green](#) dot indicates that the San Dieguito Wetlands Restoration met the required criteria for a given absolute standard; a [red](#) dot indicates that it did not.

The San Dieguito Wetlands Restoration has met 4 of the 5 absolute standards from 2012 - 2021, but has consistently failed to meet the requirement of the habitat areas standard during this period (Fig. 6.1.1). Since the habitat areas standard was not met in 2021, and all absolute standards must be met in the current year to receive credit, the San Dieguito Wetlands did not receive mitigation credit for 2021.

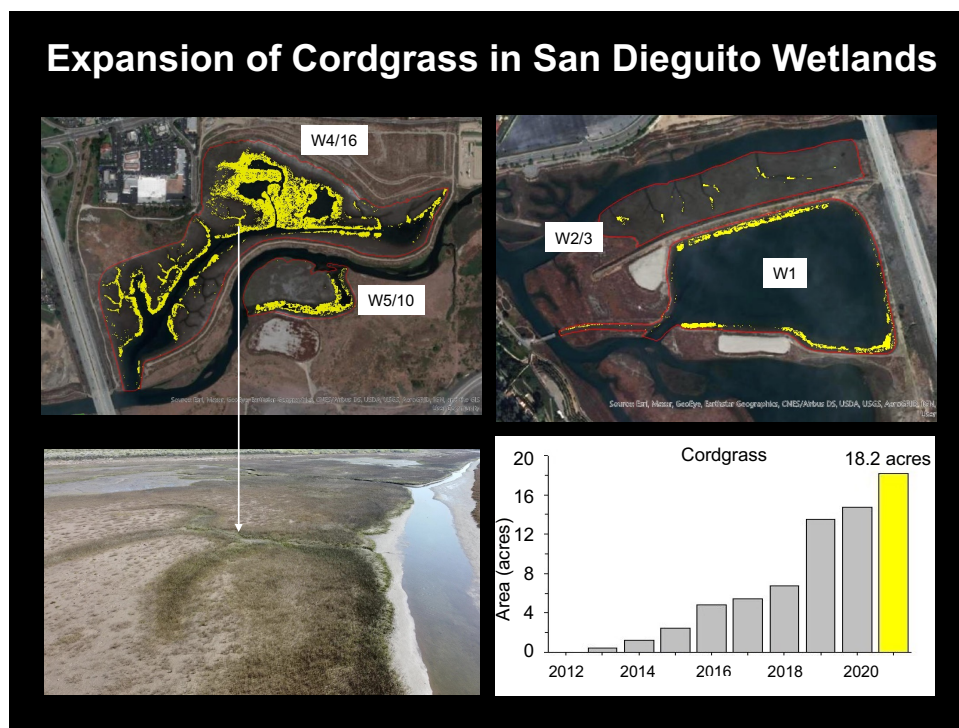
Figure 7.2.1. Distribution of cordgrass *Spartina foliosa* in San Dieguito Wetlands in 2021 (yellow) and increase in acres of cordgrass over time from 2012 to 2020 (gray).

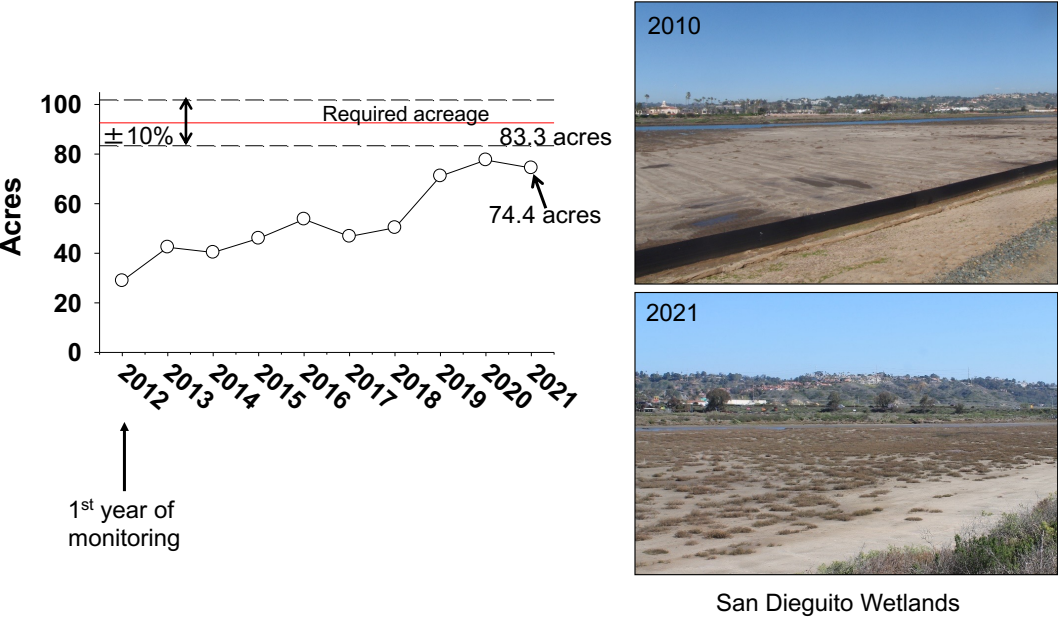
Figure 7.2.2. Change in acres of salt marsh habitat over time and the required acreage $\pm 10\%$ in San Dieguito Wetlands. San Dieguito Wetlands had a deficit of 9 acres of salt marsh habitat in 2021. The minimum required acreage of salt marsh habitat is 83.3 acres (10% lower than the design acreage of 92.6 acres).

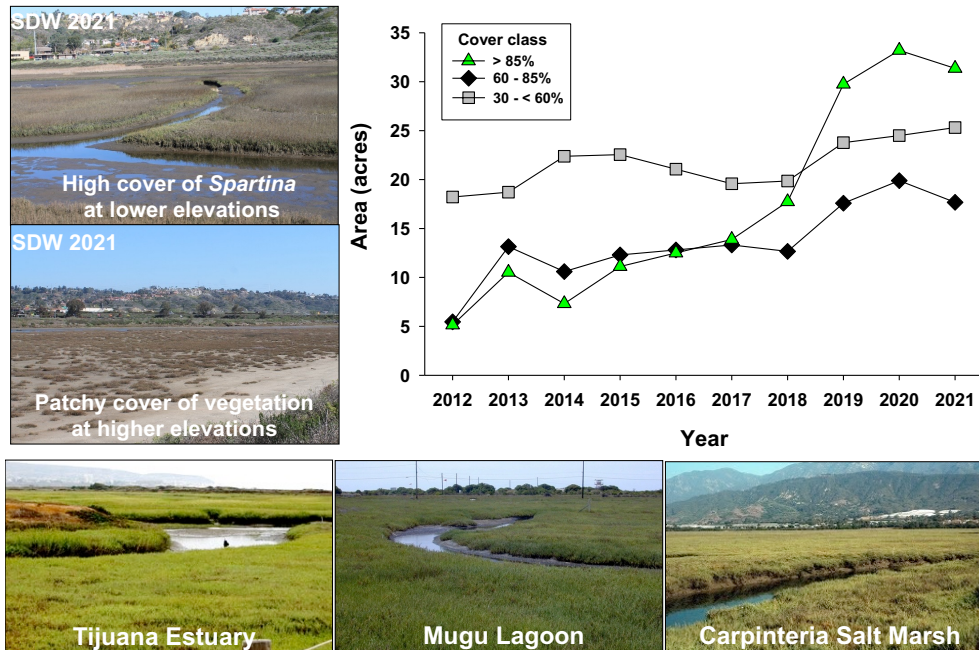
Figure 7.2.3. Change in acres of salt marsh vegetation as a function of cover class over time from 2012 – 2021. View of the high cover of vegetation in the reference wetlands along bottom, and high cover of *Spartina* at lower elevations and patchy cover of vegetation at higher elevations in San Dieguito (along left side).

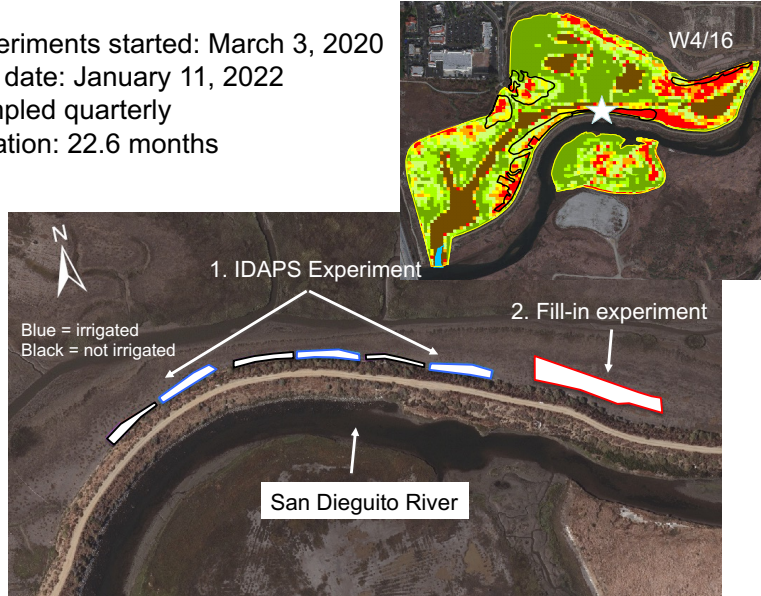
Figure 7.2.6. Locations and timetable for the IDAPS and Fill-in experiments. Inset in upper right shows the location of both experiments in Module W4 east of the I-5 freeway. Image above shows layout of each experiment in Module W4. The IDAPS experiment was conducted at higher elevations (~4.5 – 3.0 feet NGVD) and the Fill-in experiment at lower elevations (< 3.5 feet NGVD). The Fill-In experiment was also conducted in Module 2/3 on the west side of freeway (not pictured).

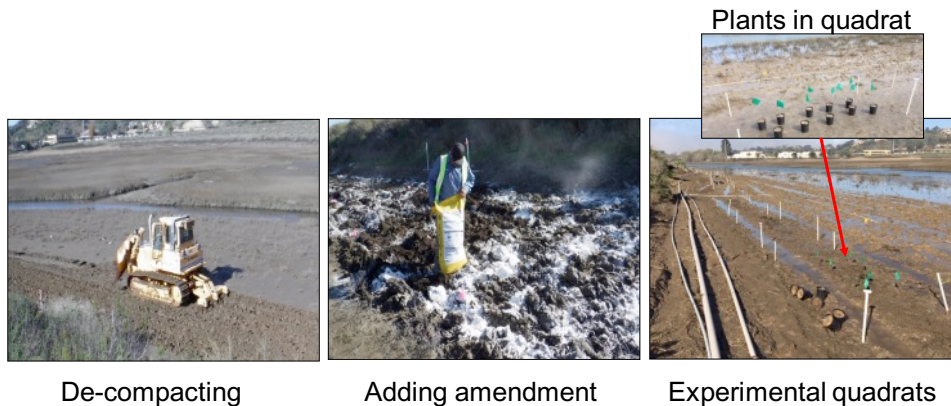
Figure 7.2.7. Images showing a tractor de-compacting soil to a depth of approximately 1.5 feet, the manual addition of soil amendments (gypsum, commercial fertilizer), and the arrangement of experimental quadrats and plants within each quadrat in the IDAPS experiment.

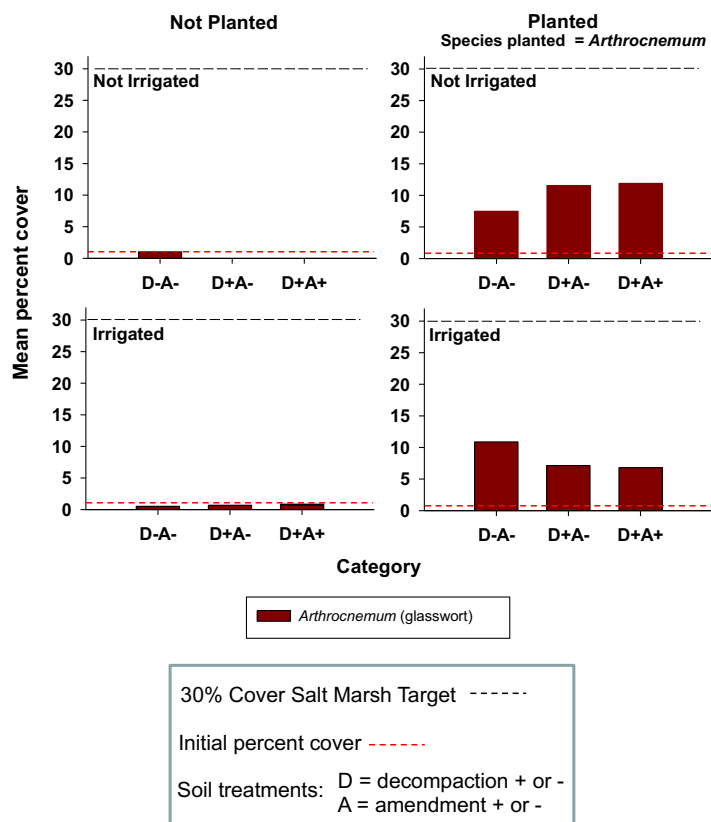
Figure 7.2.8. IDAPS experimental results for *Arthrocnemum subterminale* (maroon bars) cover across all treatments. The red dotted line indicates initial percent cover and the black dotted line indicates the 30% cover target to be classified as salt marsh habitat.

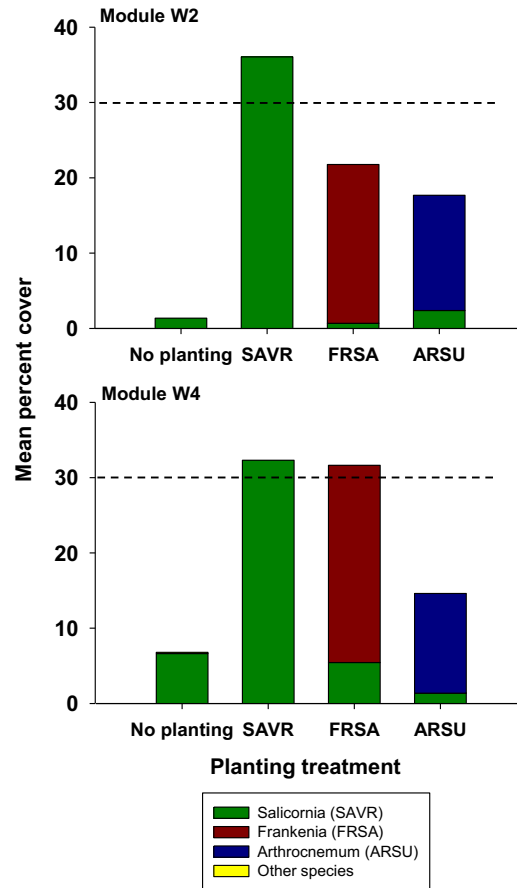
Figure 7.2.9. Fill-in experiment results across all treatments. Marsh cover was highest in *Salicornia* (green) and *Frankenia* (maroon) Planting treatments. There were slight differences in mean cover across the two locations (Module W2 and W4). The black dotted line indicates the 30% cover target to be classified as salt marsh habitat.

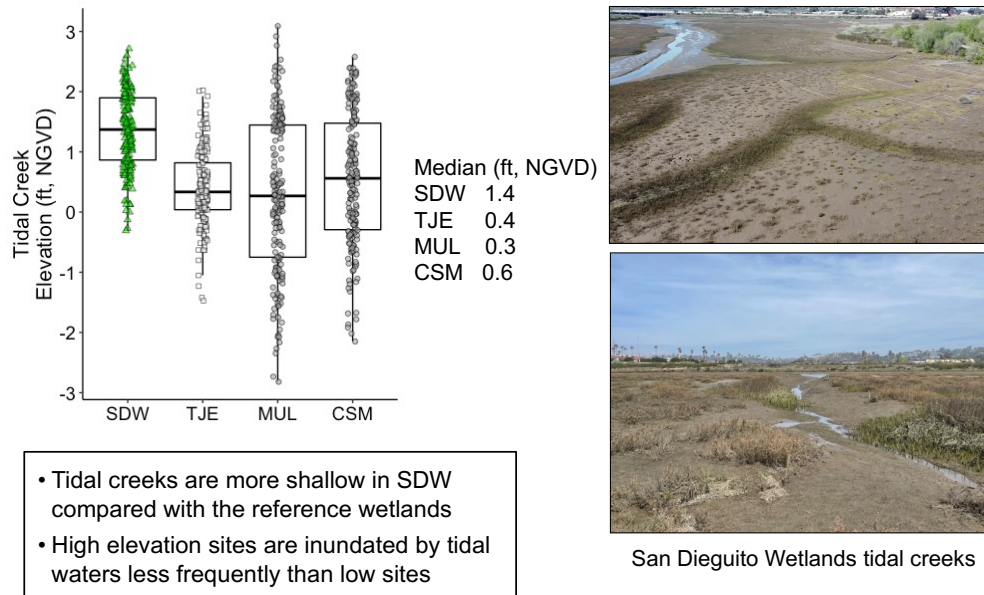
Figure 7.3.1.5. Distribution of elevation data at tidal creeks across all wetlands. Each point represents an elevation measurement taken at the tidal creek location of each of the cores collected to sample small infaunal invertebrates. The darker horizontal bars are median elevations, the boxes enclose 50% of the data, and the vertical lines encompass the range of values.

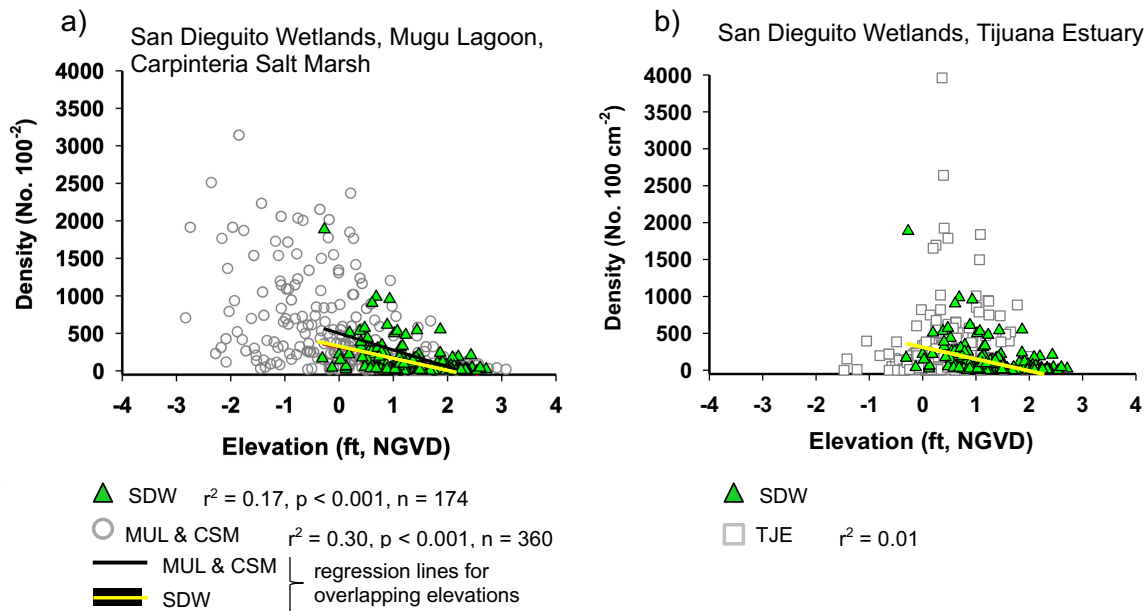
Figure 7.3.1.6. Relationship between invertebrate density and elevation in tidal creek habitat in a) SDW and MUL and CSM and b) SDW and TJE. The density-elevation relationships for MUL and CSM were not statistically different and a common regression line was computed for these sites.

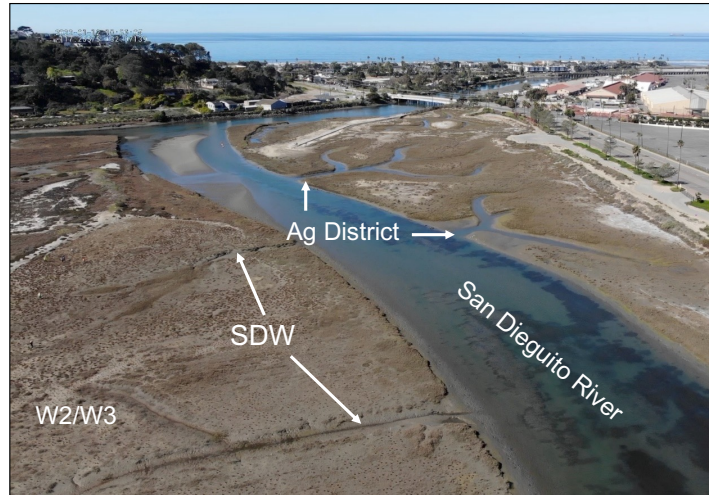
Figure 7.3.1.9. Image showing the location of deeper 22nd Ag District tidal creeks planned for sampling and the higher elevation creeks sampled during performance monitoring located in module W2/W3 in San Dieguito Wetlands.
